**DATE:** January 4, 2024  
**TO:** Historic Preservation Board  
**FROM:** Andrew Dutton, Community Development Director  
**SUBJECT:** Demolition Request – 129 North Broadway Street

129 North Broadway Street

### **I. Introduction**

### **III. Current Condition of the Building**

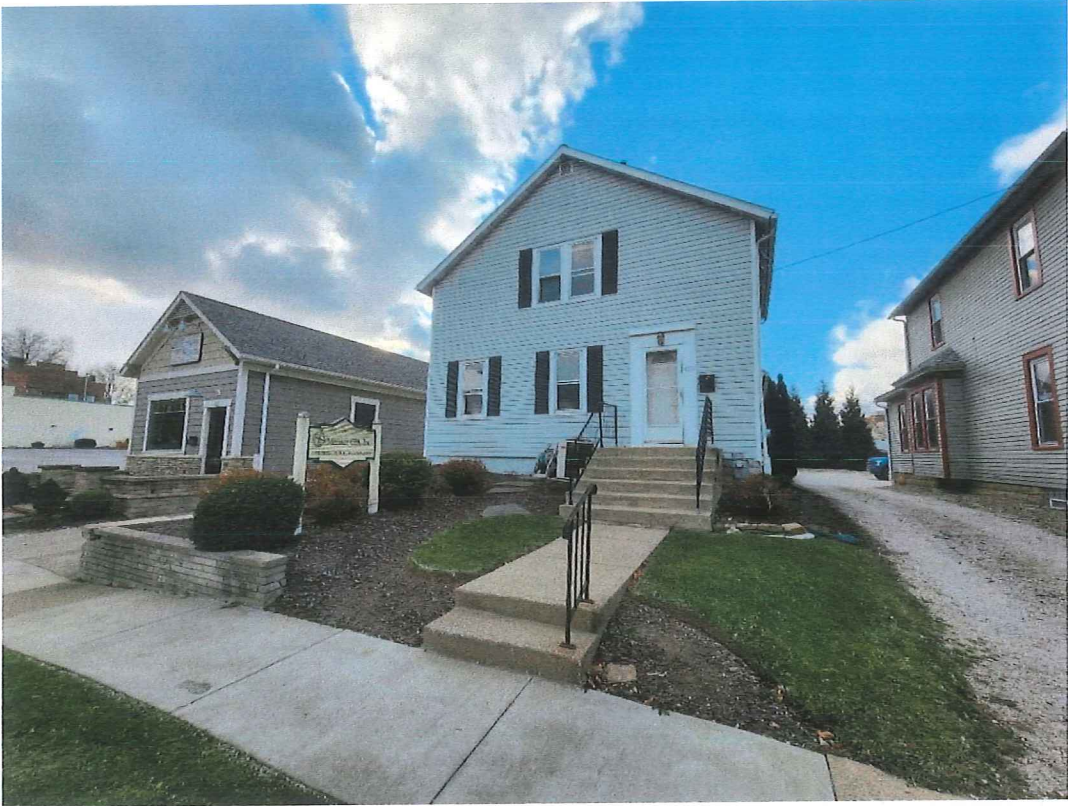
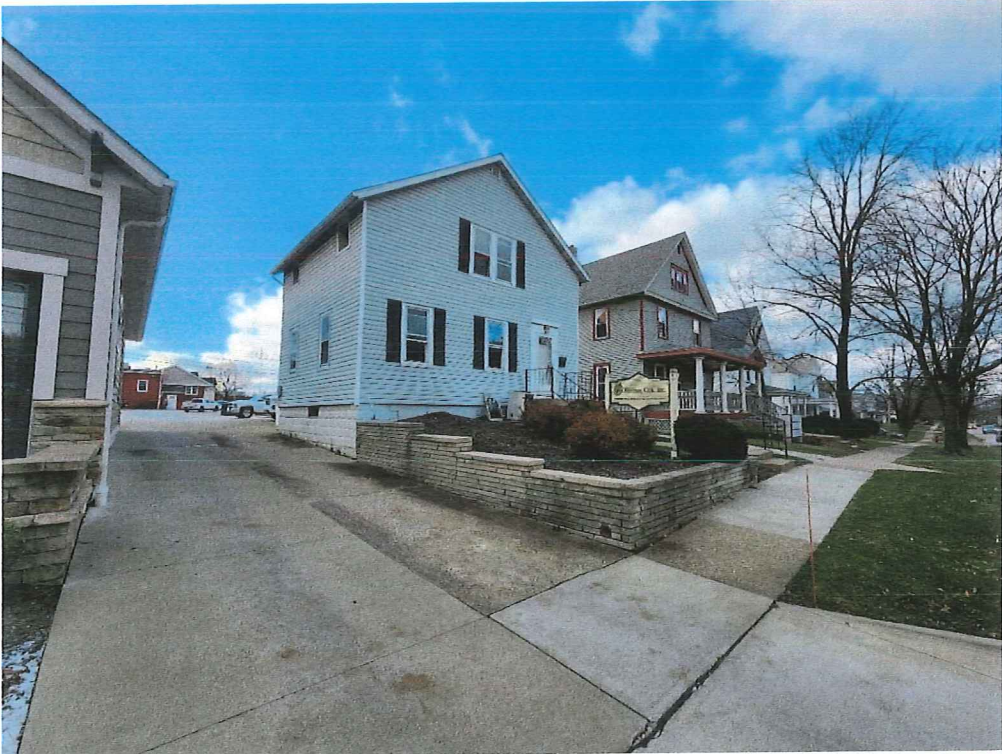
East side (North Broadway) looking west (Streetside)

Exterior siding, roofing and windows have all been damaged by the fire and would need to be replaced. The damage from the fire to the front of the home is not as apparent but the heat has ever so slightly warped the siding rendering it unmatchable to the remaining sides and would require full replacement.

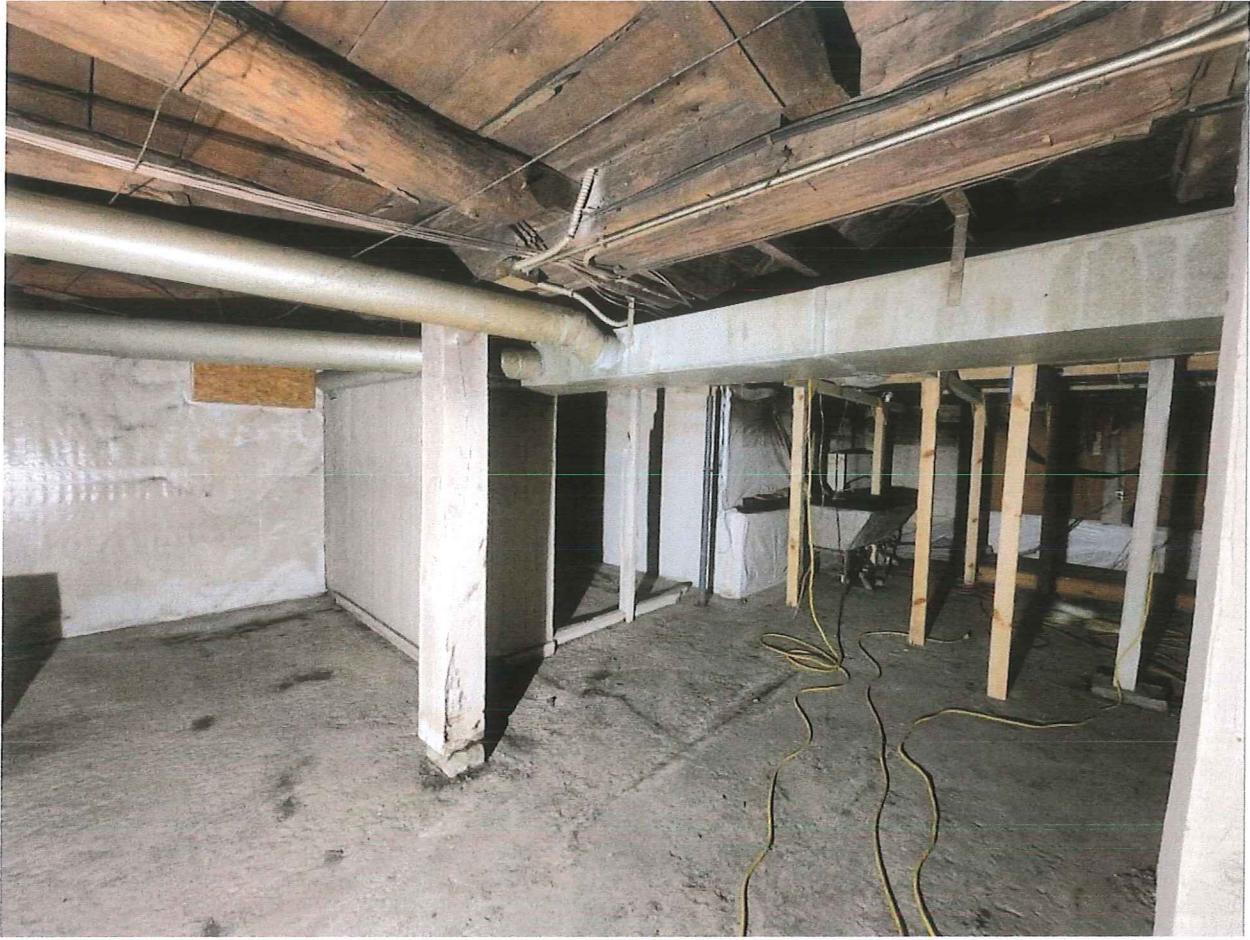
**Basement (Electric panel, Furnace)**

The HVAC system has been completely removed from the first and second floors. The remaining tin and furnace in the basement are intact but have significant smoke and fire damage. In current condition are unusable and must be removed and replaced.

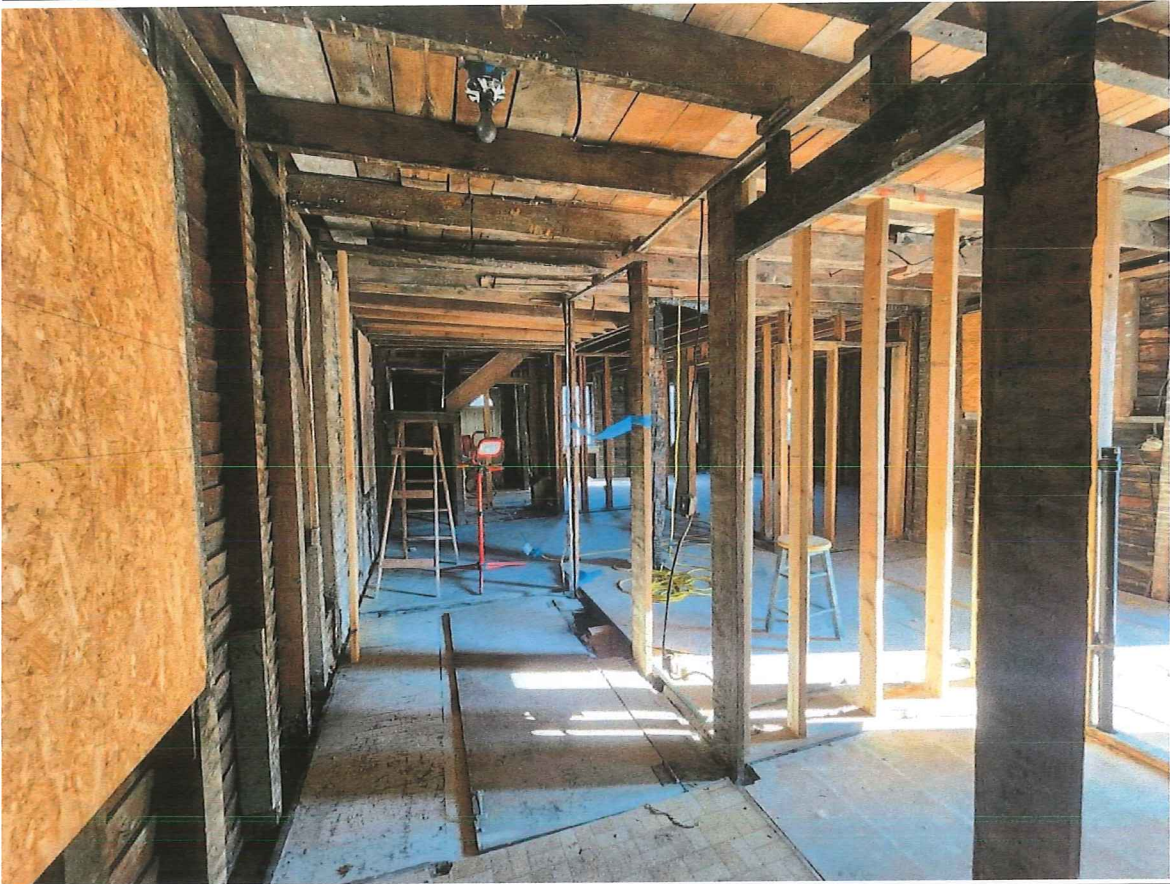
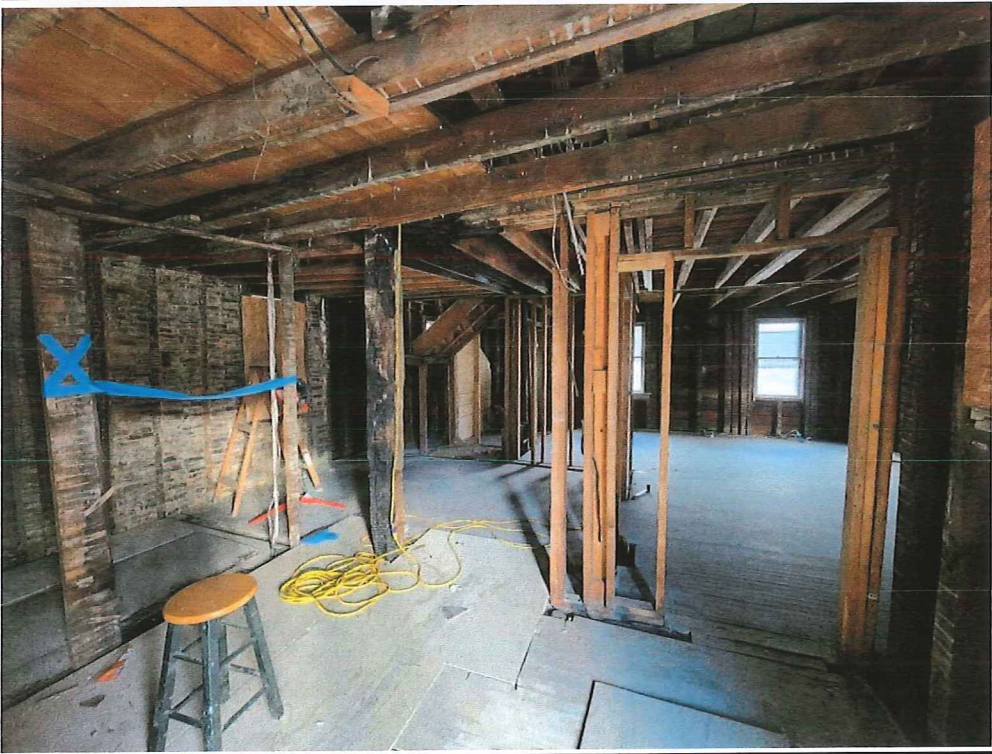
**Kitchen**

First Floor Framing – the center portion of the home between the dining room and kitchen is where the fire was prominent. The floor framing in that area is mostly gone due to the fire. Temporary bracing has been installed but would need to be replaced with conventional lumber. There is a significant amount of ‘shoring’ that has been installed as temporary bracing and would also need to be further installed to reduce the span of structural timbers, due to a spacing that exceeds the standard for adequate support.
