May 25, 2022

RE: Structural Examination  
277 South Court Street  
Medina, Ohio  
IAL No. 22275

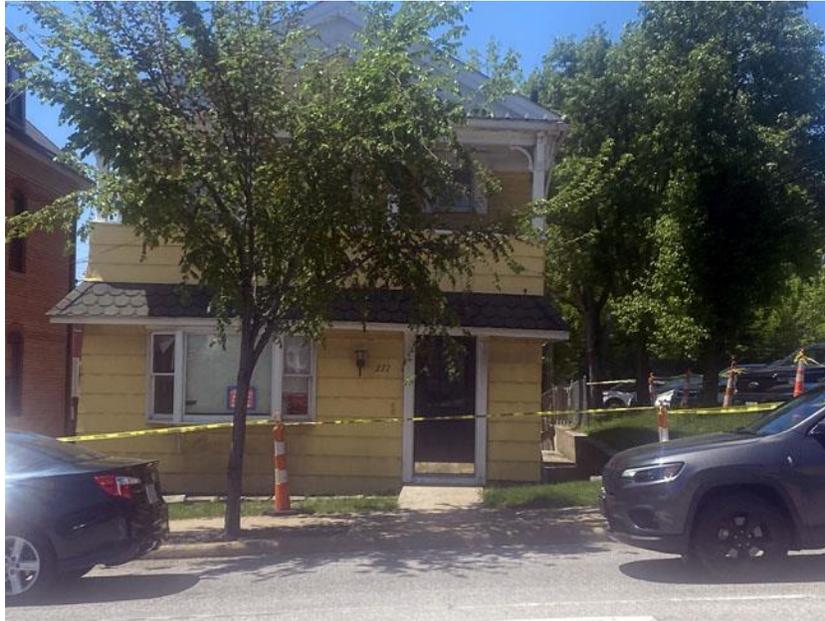
Front or east elevation of building

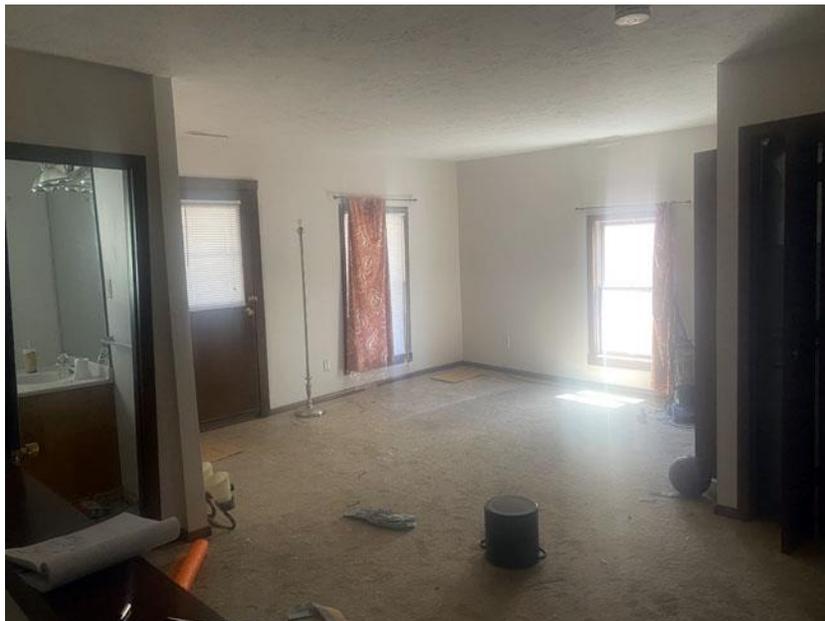
Front room on second floor. Note slanted wall on left

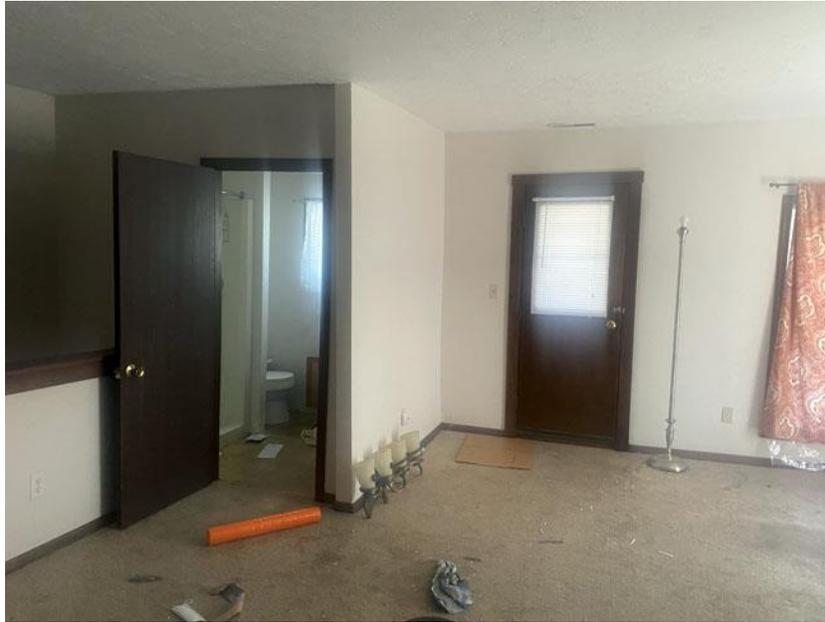
Slanted wall on second floor

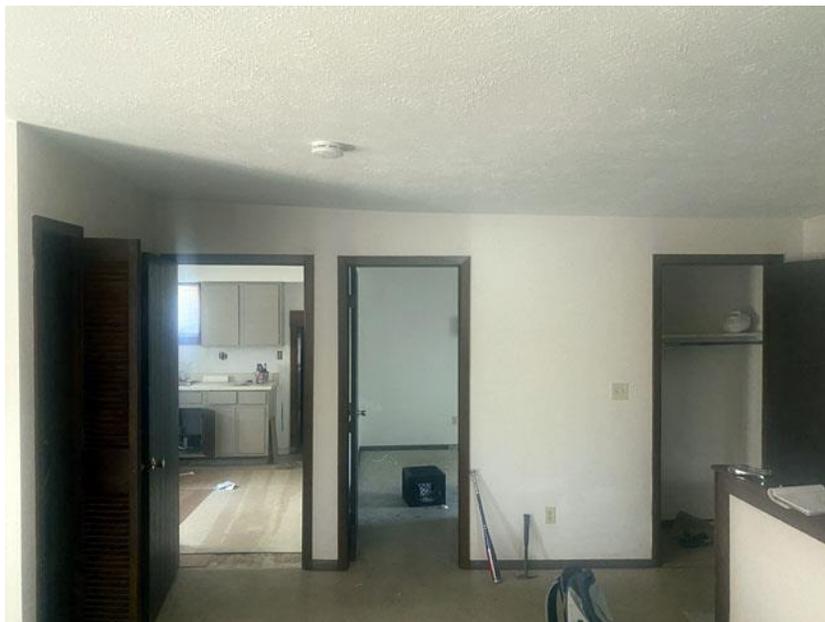
5. Access in to the rear room is through a two feet wide by five feet high doorway.
6. The walls of the front bathroom are not plumb.
7. The ceiling and walls of the rear room are not straight.

Sloping ceiling on second floor

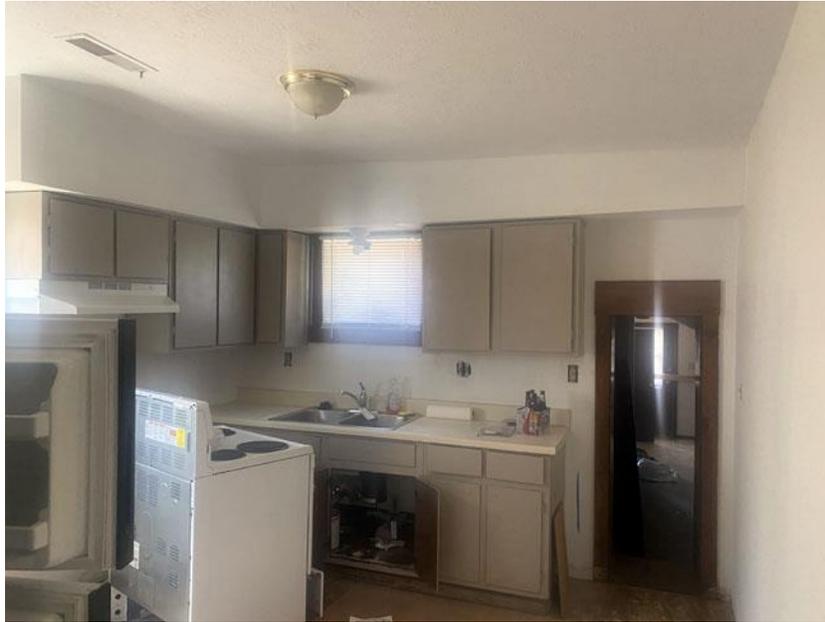
Sloping soffits on second floor

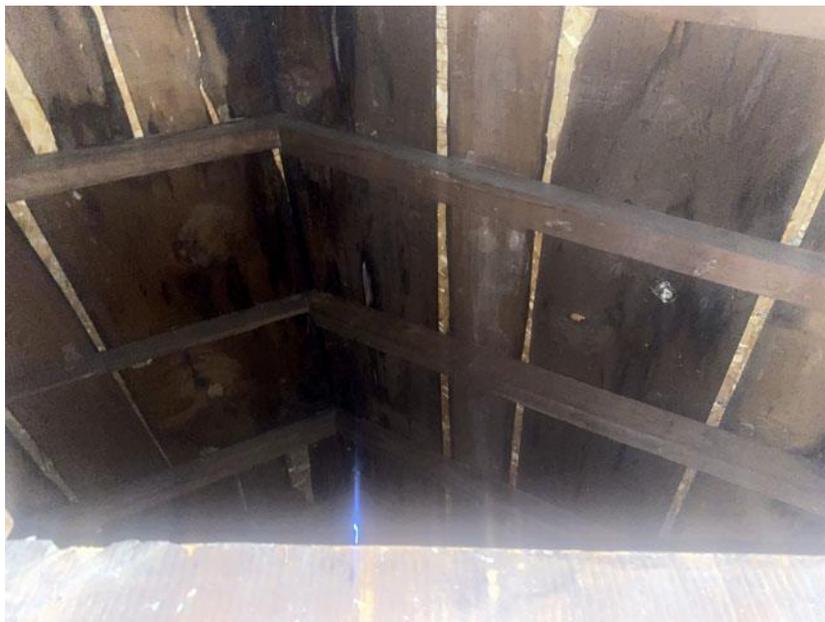
Roof structure

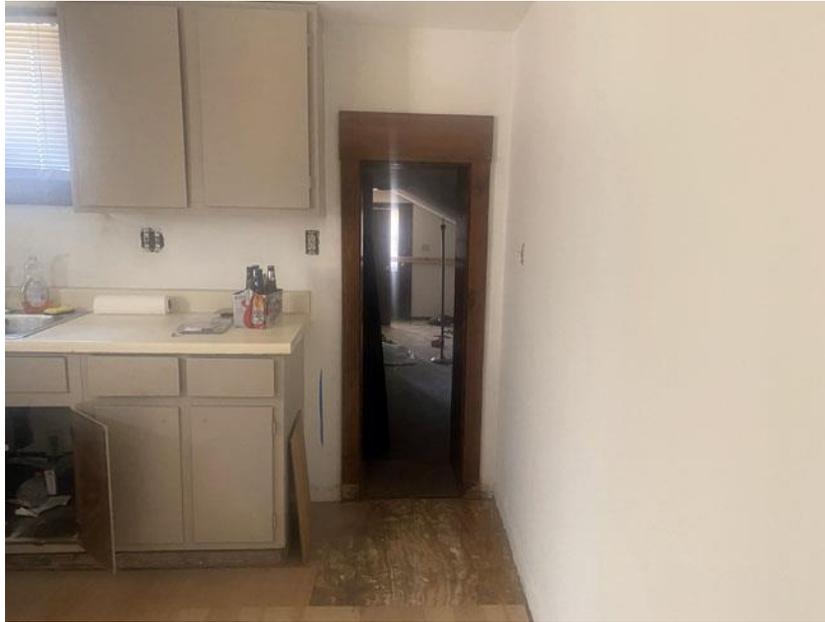
Undersized entry door to rear second floor room

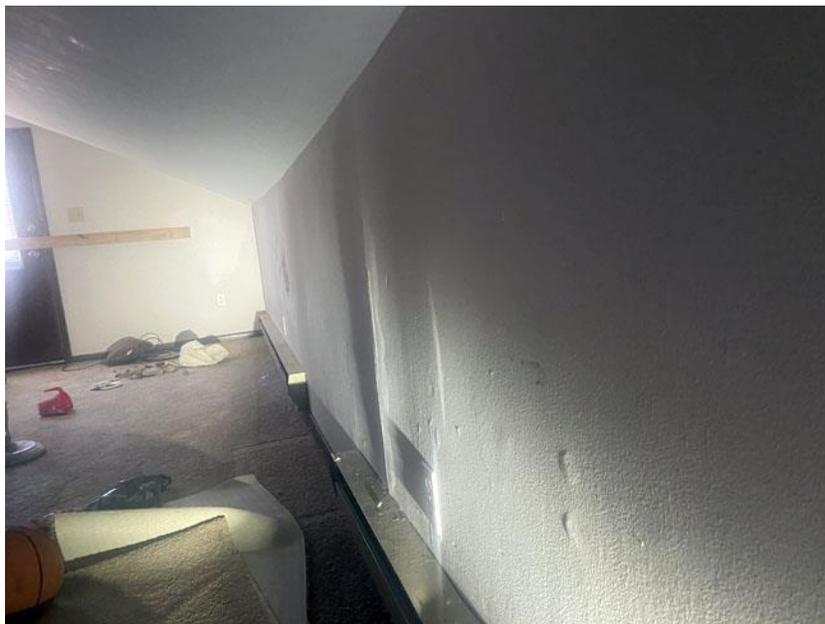
Sag in roof, and out of plumb and alignment wall, rear second floor

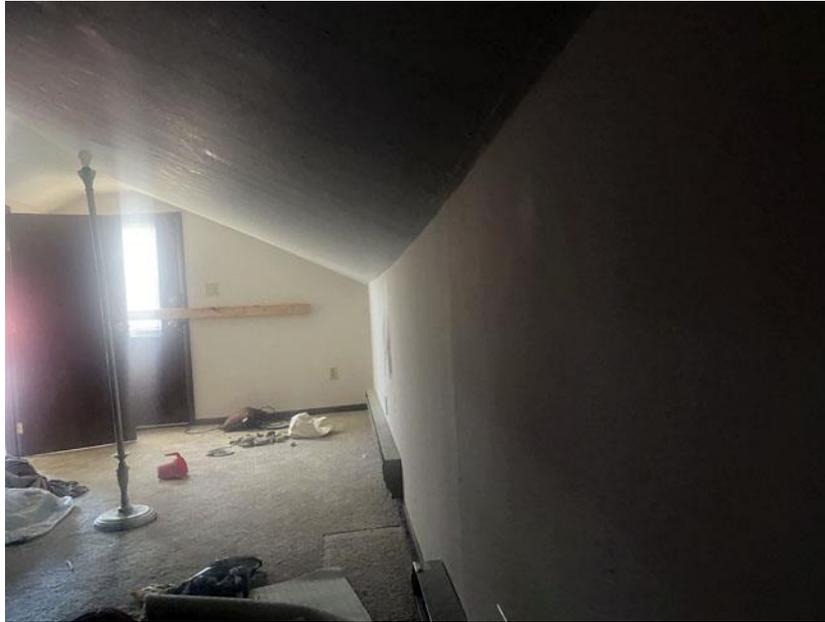
Sag in rear room ceiling

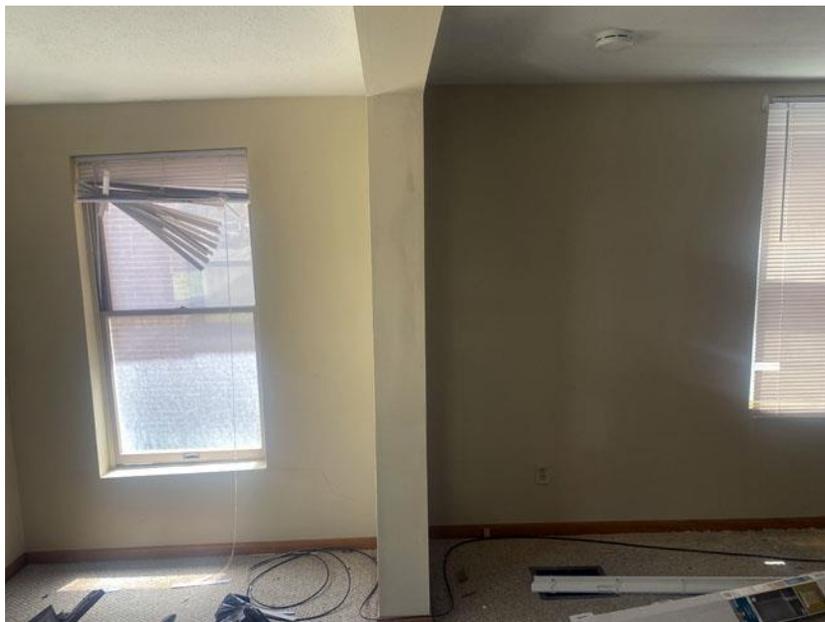
Sagged window in south first floor

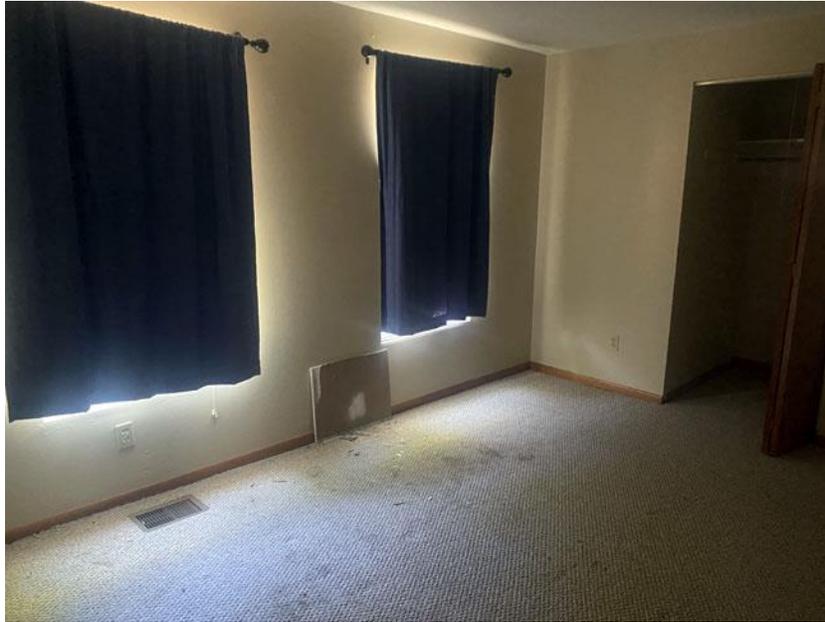
Sloping floor in north bedroom

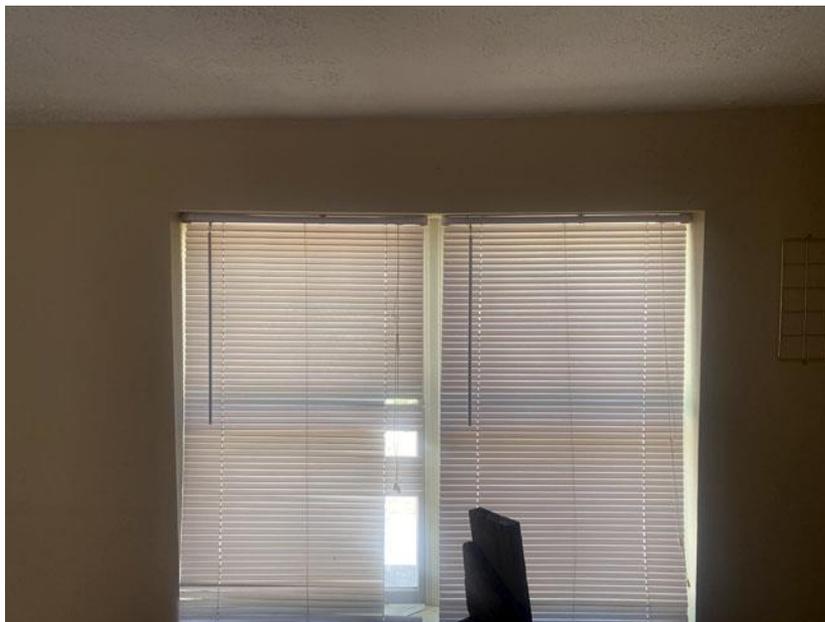
Unlevel header in north wall of kitchen

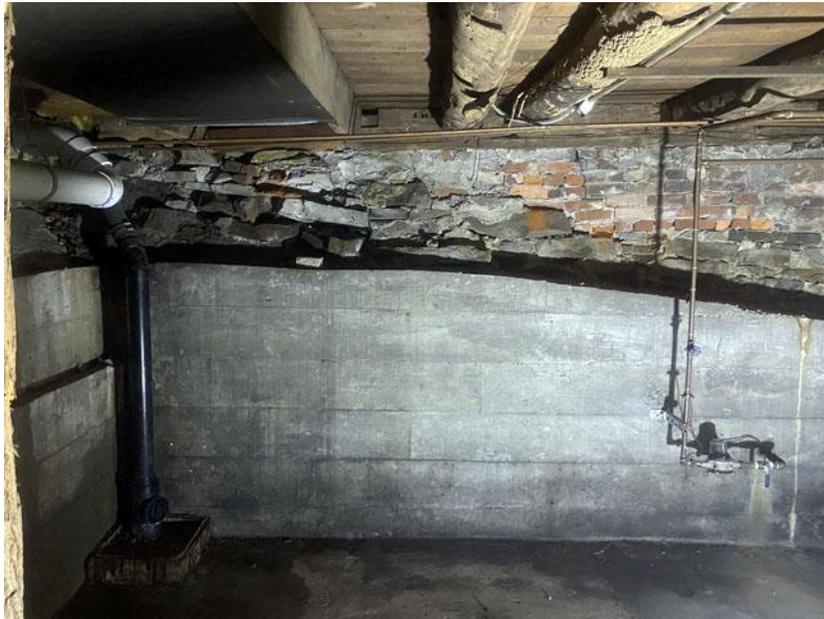
10. The stone foundation wall at the front of the building slopes downward to the north.
11. The foundation walls are in need of tuckpointing at various locations throughout the basement.

East basement wall with floor sloping down to the north.  
Mix of foundation wall materials

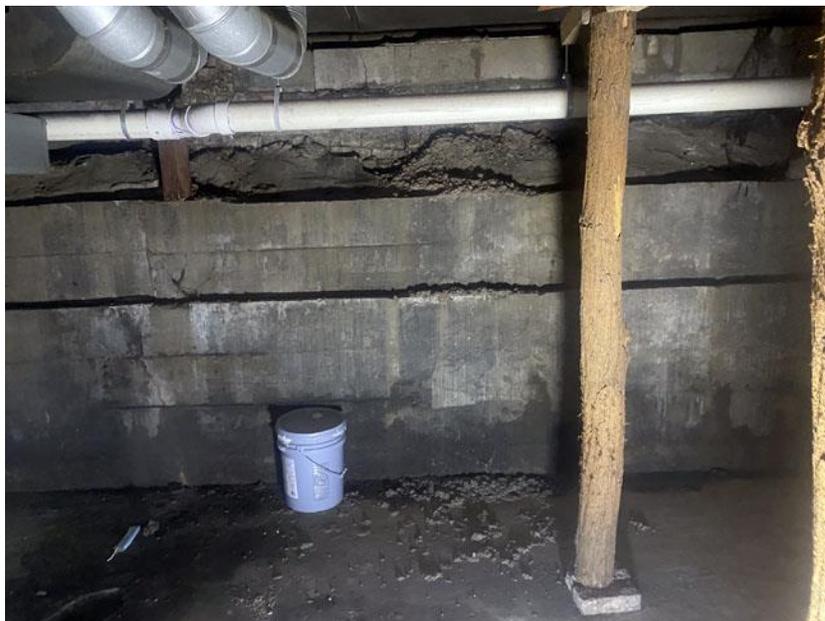
8. A large number of posts are supported on pieces of brick, pieces of concrete masonry or are placed directly on the concrete floor slab.
9. The floor has been patched in a number of places. Some of this patching shows signs of poor workmanship.

Concrete foundation wall. Note timber post on piece of concrete masonry

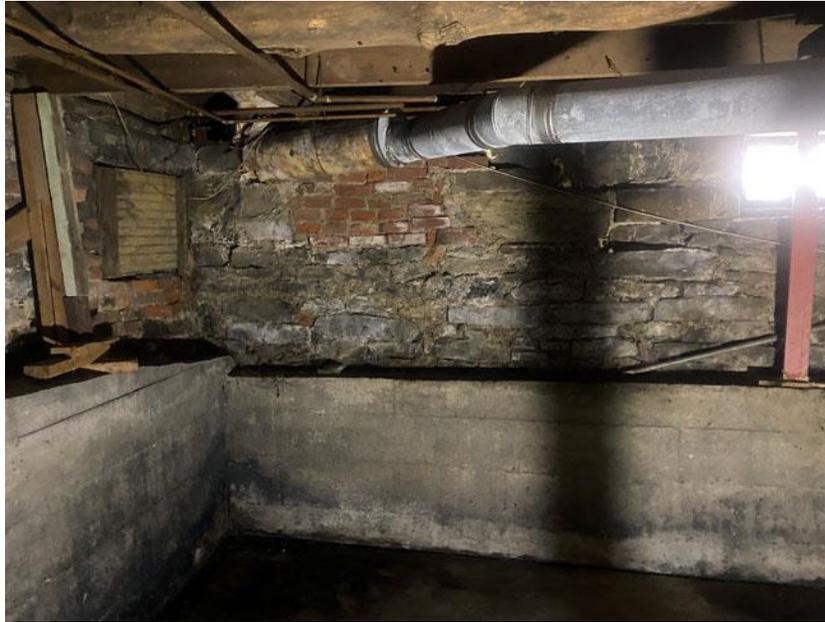
6. The basement walls consist of multiple structural elements. These include rubble stone, brick, and cast in place concrete. The cast in place concrete was placed on the interior of the masonry walls. In my experience this has been done to deepen basements, but the cause in this location is unknown.

Southeast corner of basement with mix of materials

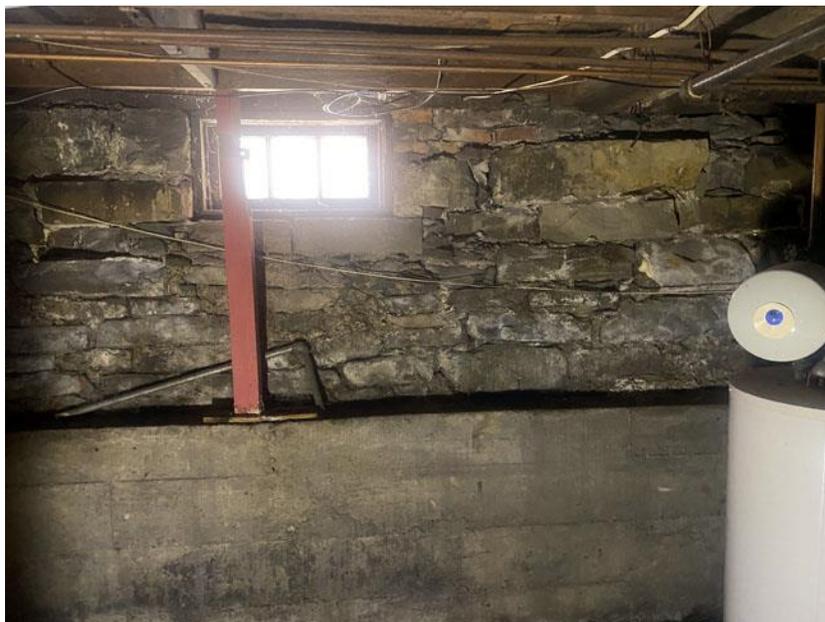
Stone foundation on south side of basement needing tuckpointing

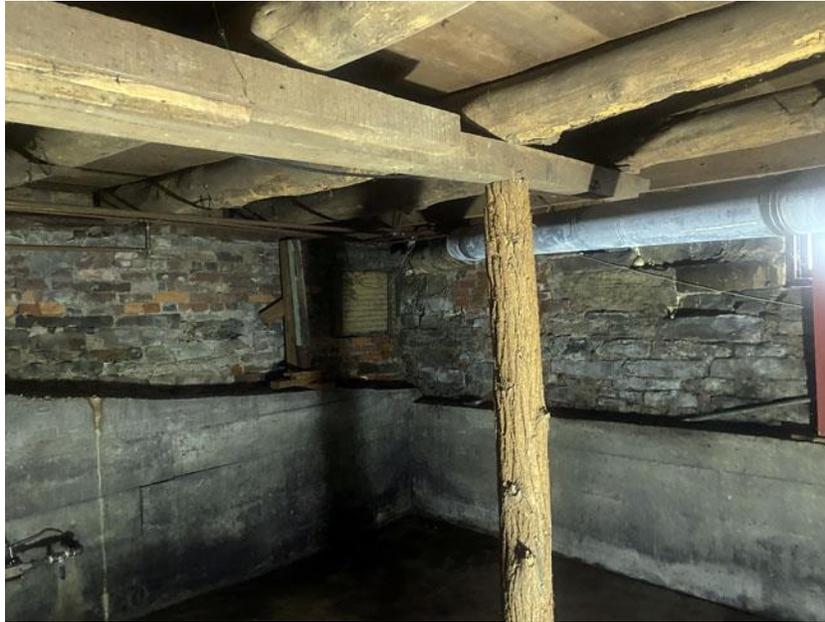
Timber post in front basement

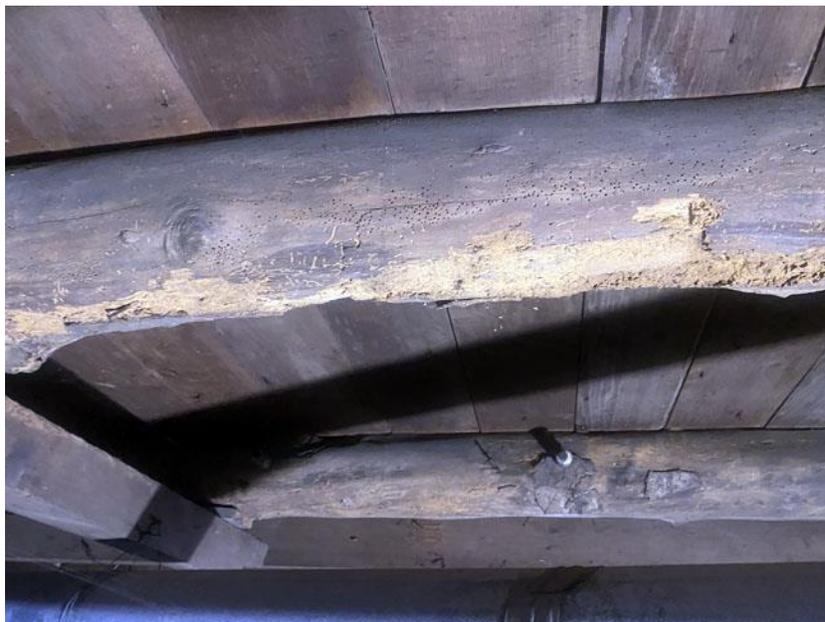
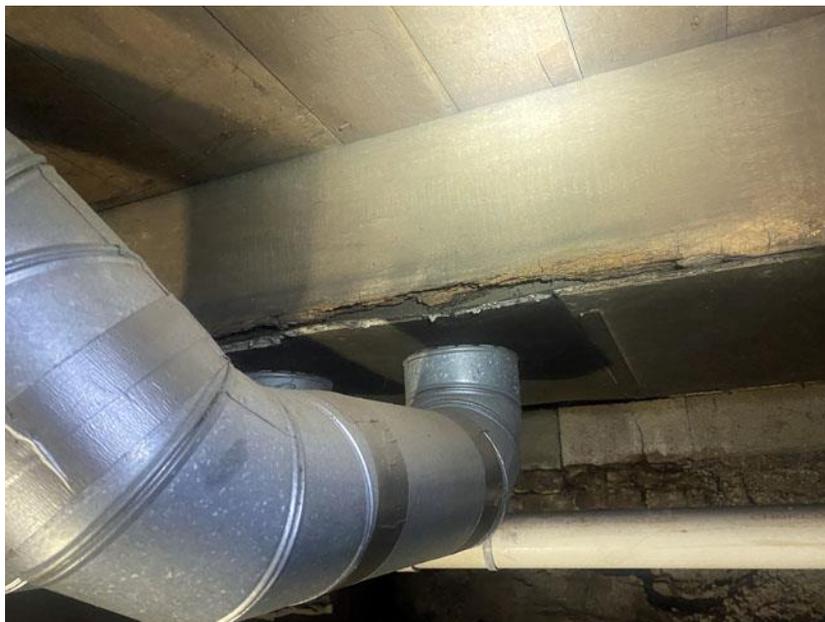
3. Evidence of both carpenter ants and termites were observed in the form of damaged wood members.
4. Three joists had small 2x4s used as posts.
5. A number of joists including tenoned half timbers have slid out of their sockets. Some of these have been resupported but not all.

Insect damaged joist

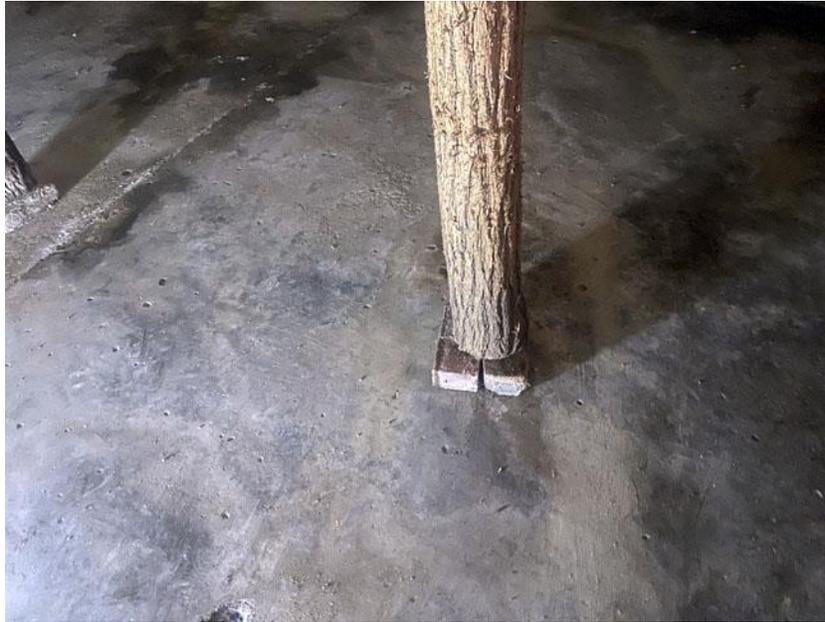
Timber post on brick on concrete floor

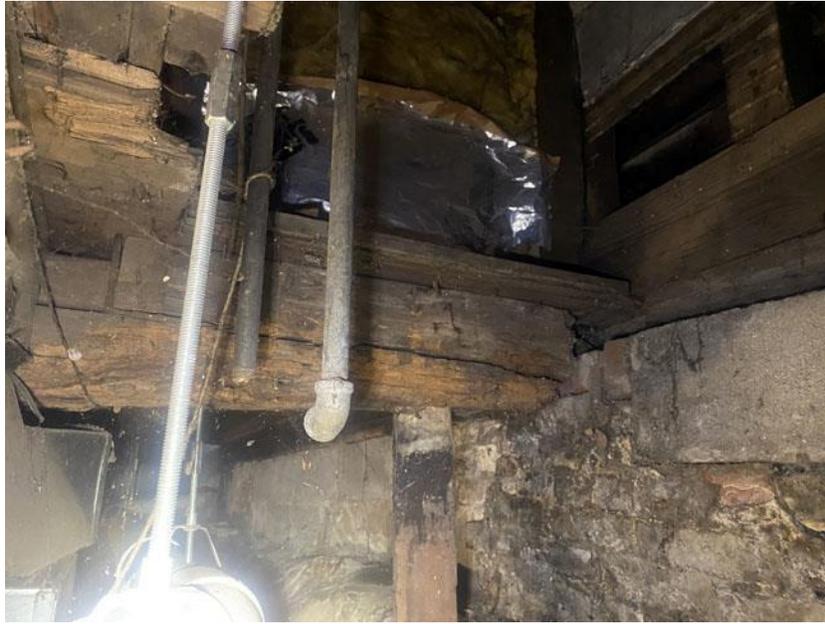
Dry-rotted timber

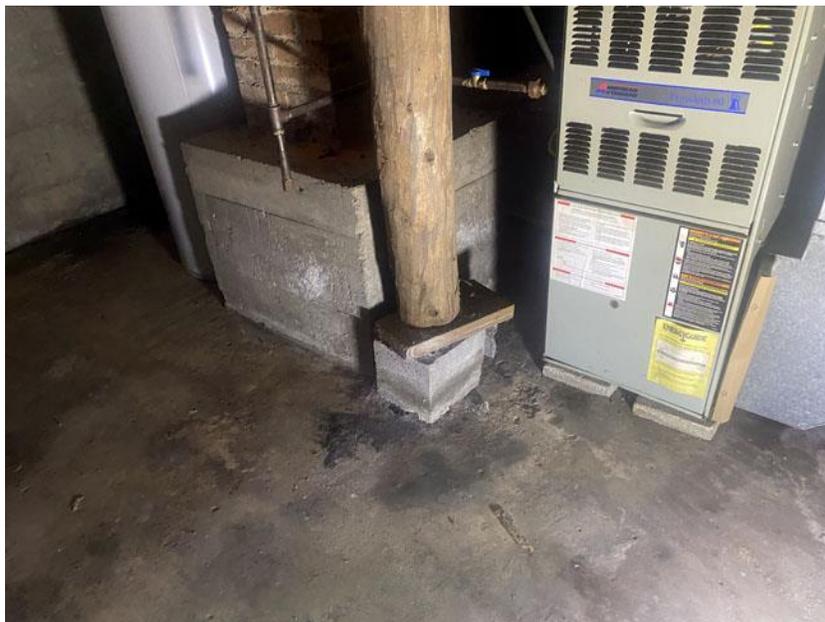
Timber post on wood shim and concrete masonry on floor

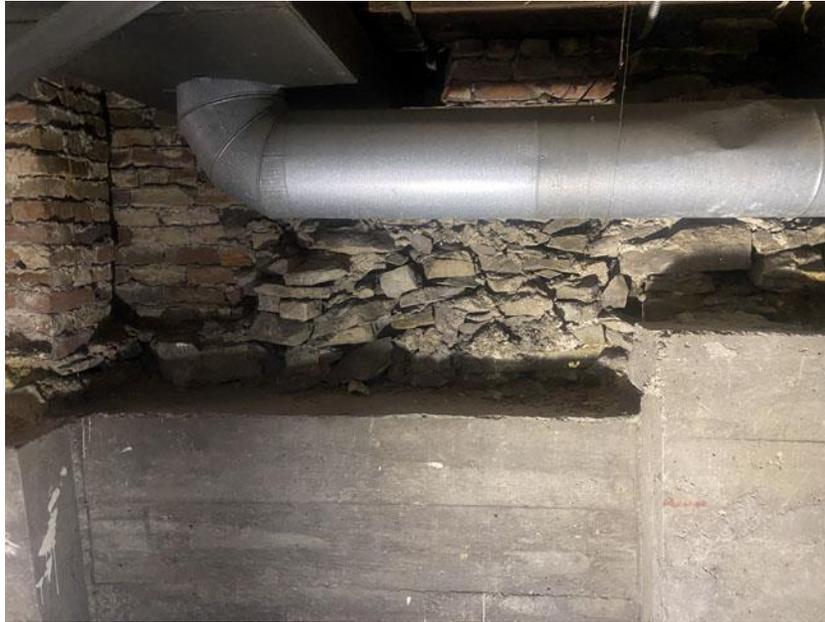
Central wall with stone needing tuckpointing

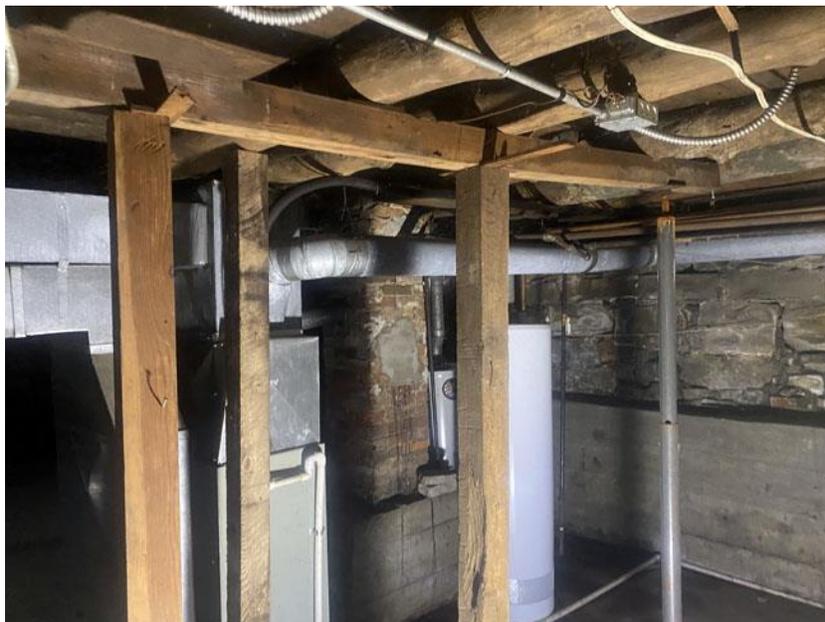
Multiple posts with shims

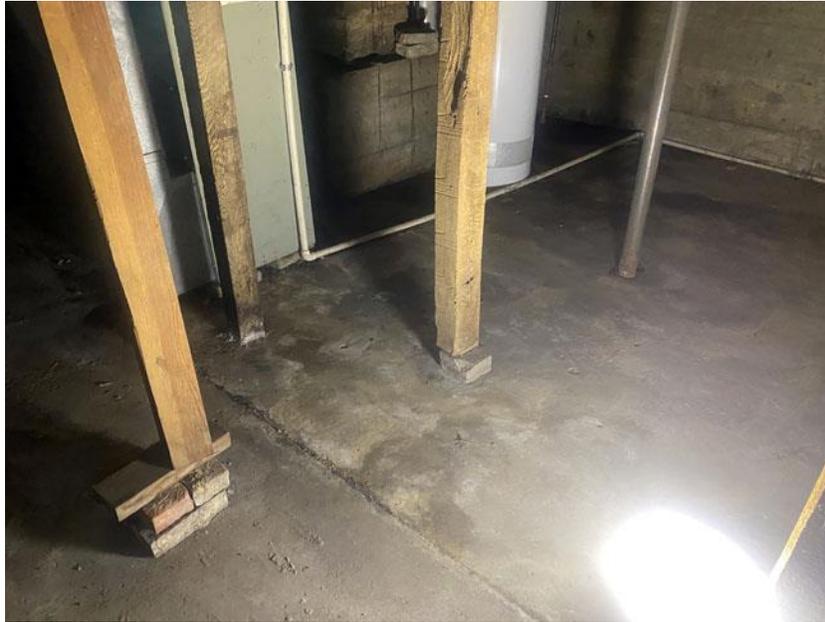
Posts improperly supported

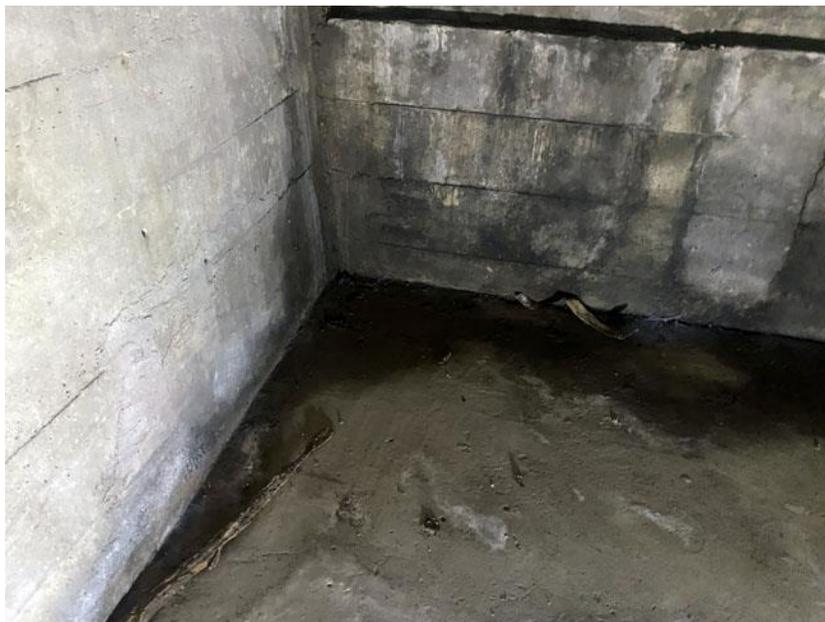
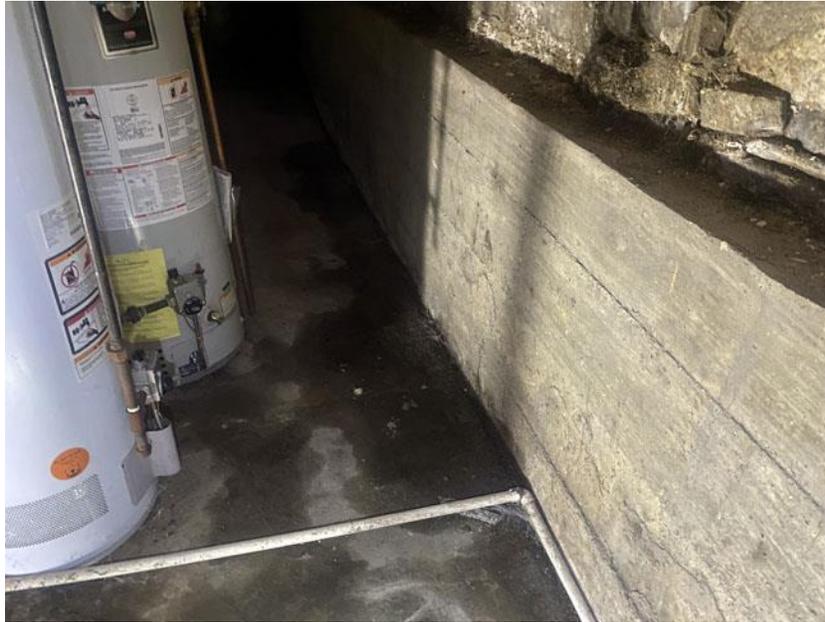
7. The basement walls show signs of significant moisture seepage into the basement. This includes water stains indicating there has been standing water.

Water stains on floor

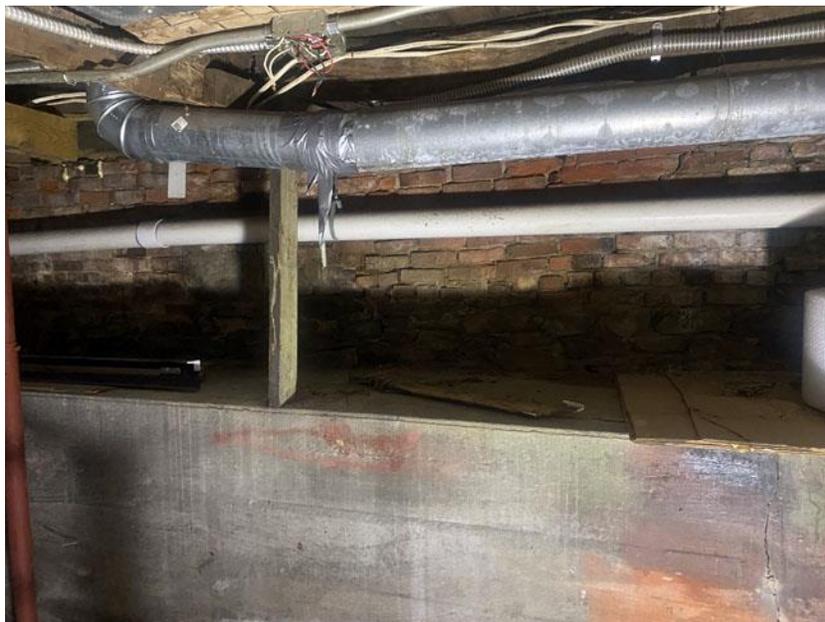
Concrete foundation wall with brick and 2x4 joist post

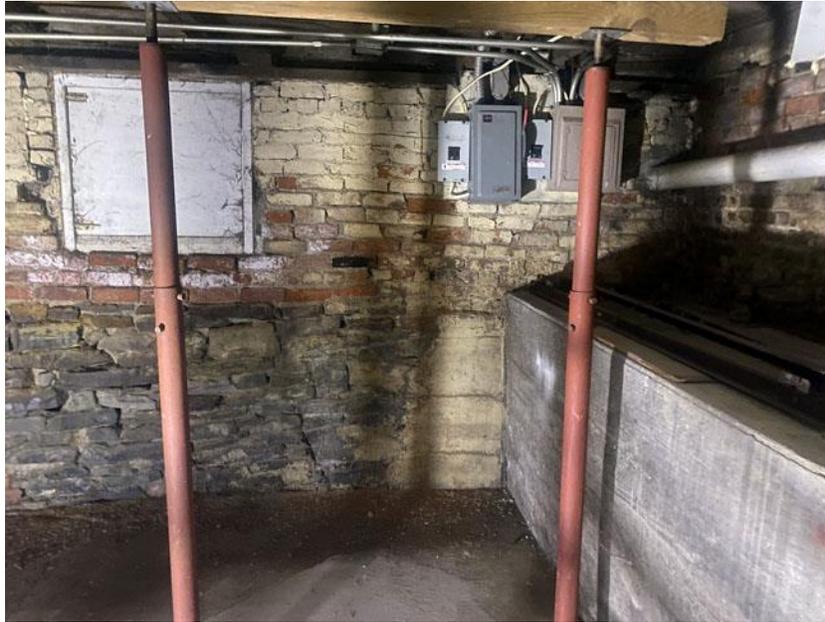
Water seepage in west (rear) wall

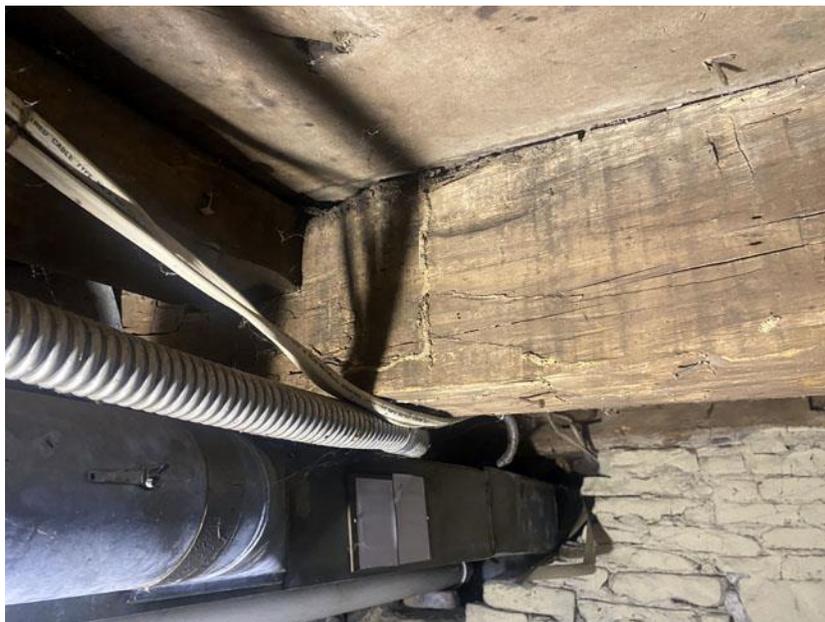
Termite tracks

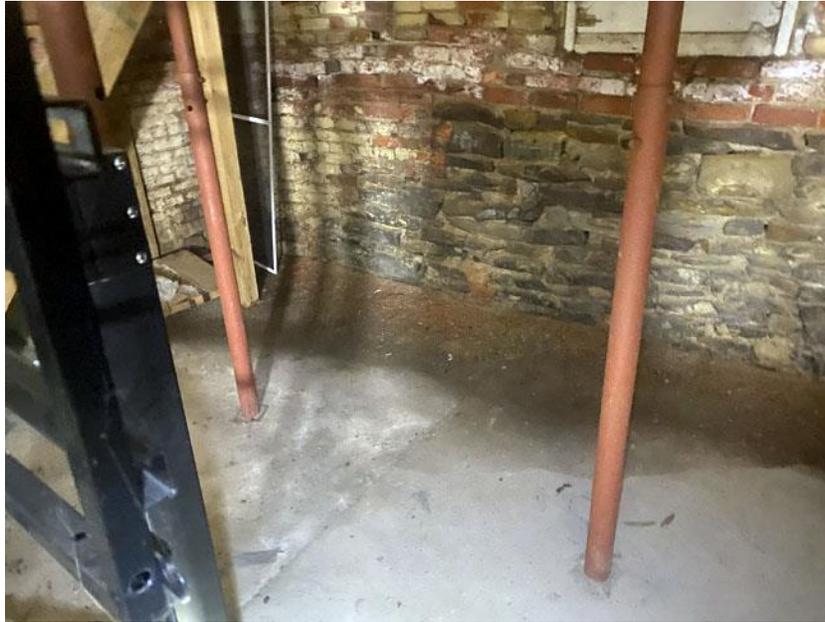
Water seepage in west basement

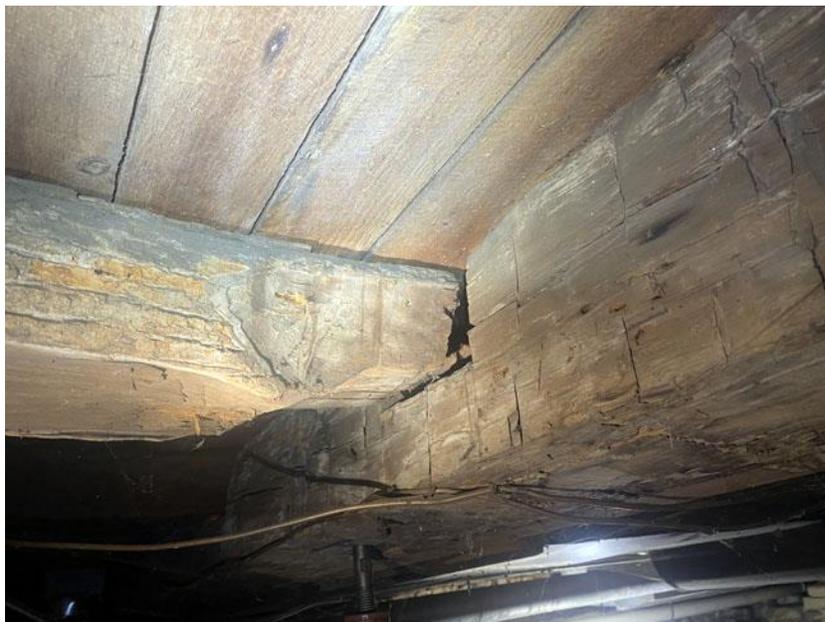
Joist tenon slipping out of beam

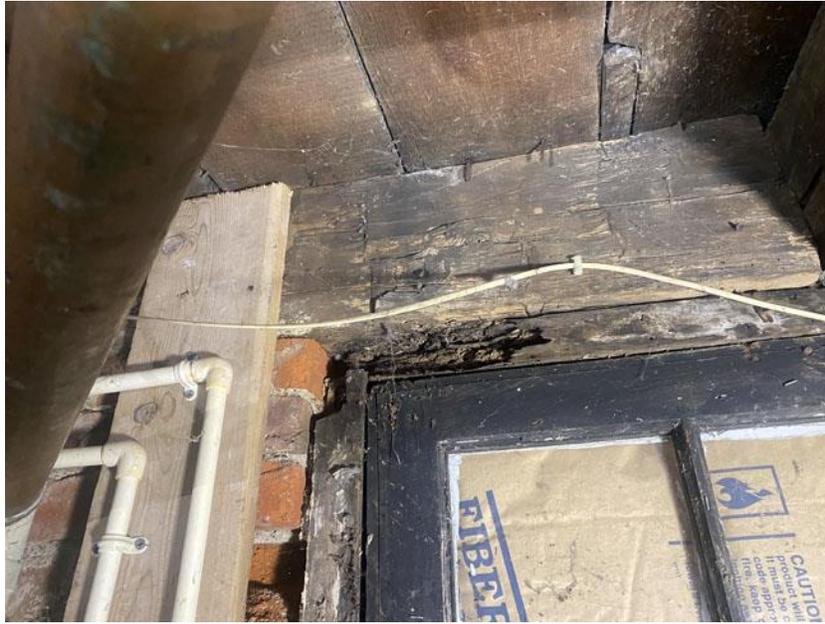
Dry rotted window frame

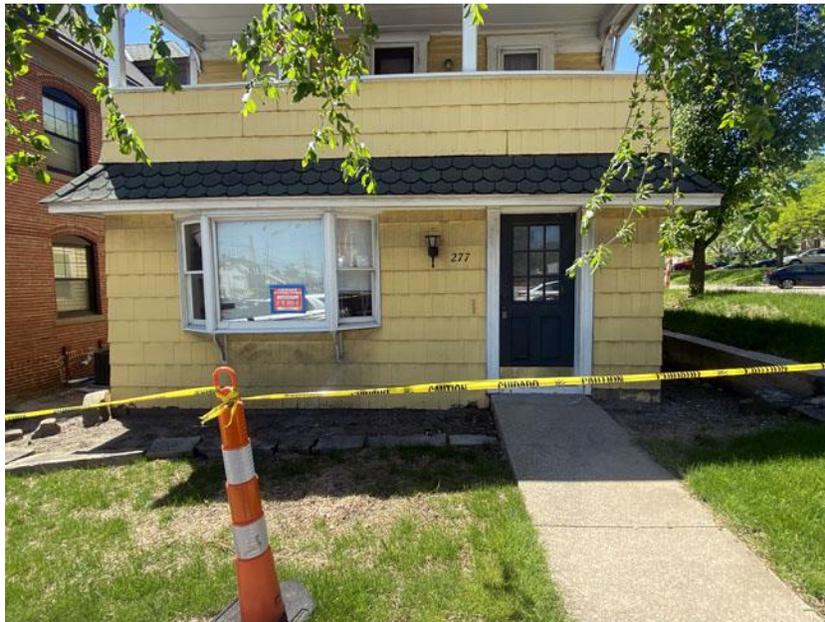
Front elevation with sag to the north

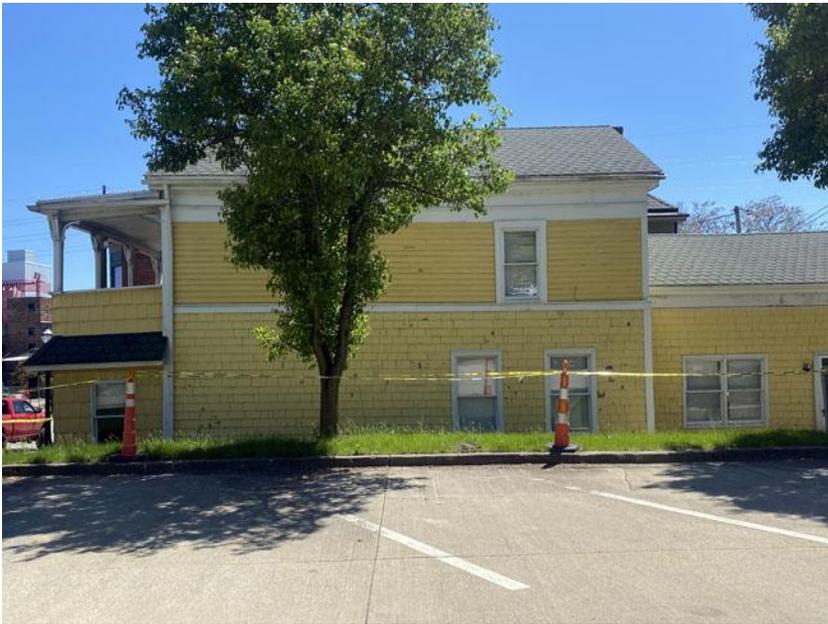
North elevation

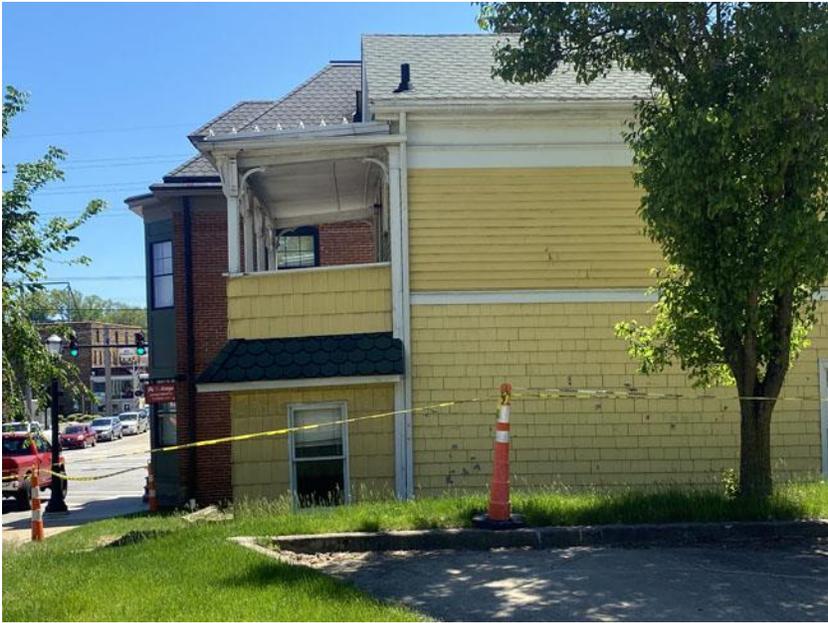
Sagged porch along north elevation

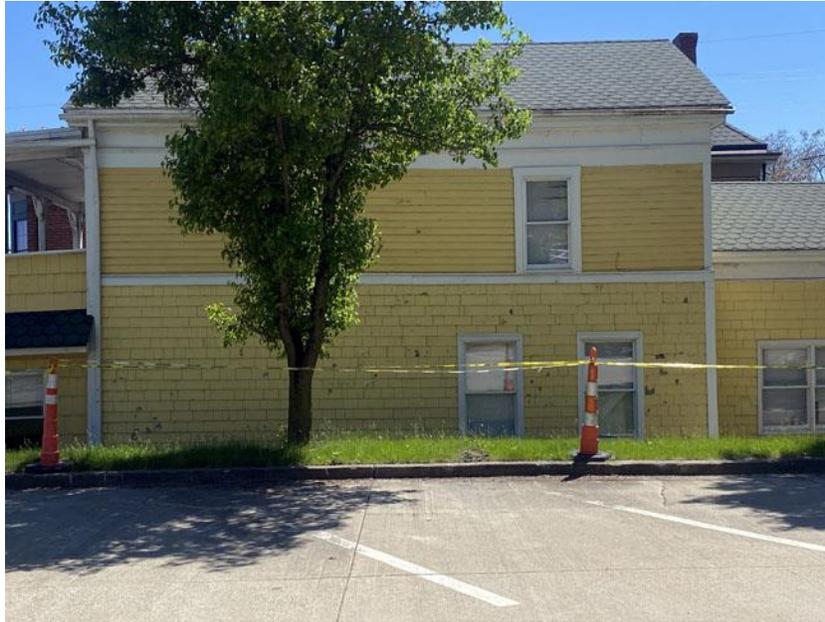
Uneven trim along north elevation

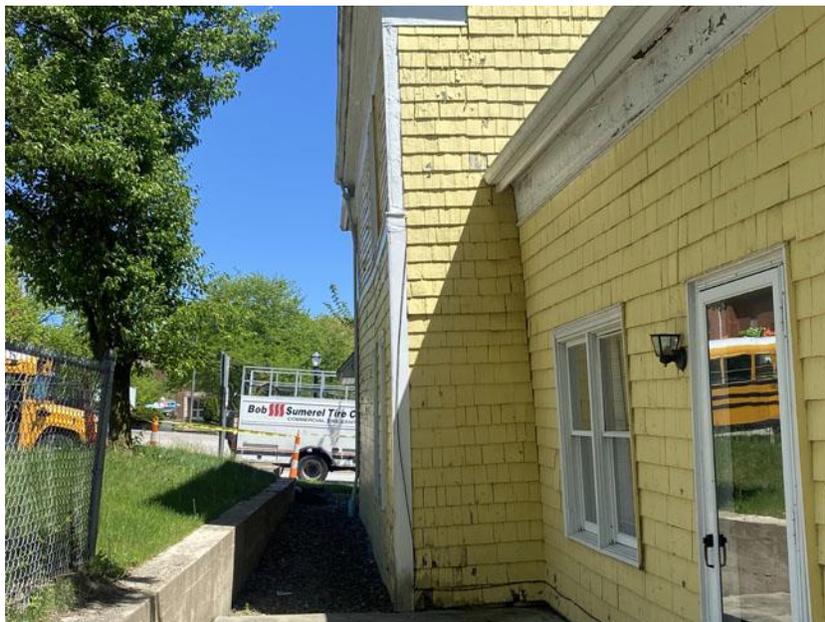
Bowing, non-plumb north wall

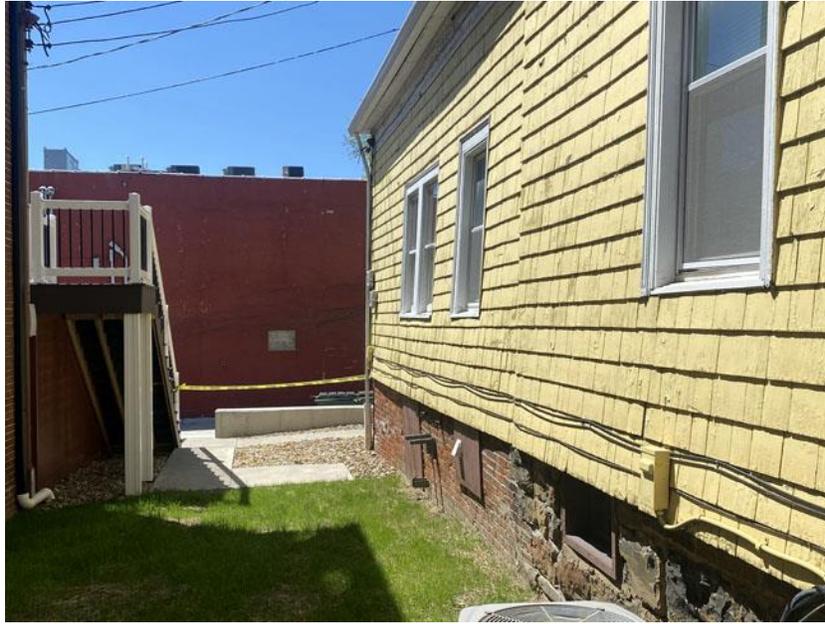
Non-plumb, undulating south wall
