HISTORIC PRESERVATION BOARD

Case No. H22-045

Building Demolition at 277 South Court Street

March 2, 2022

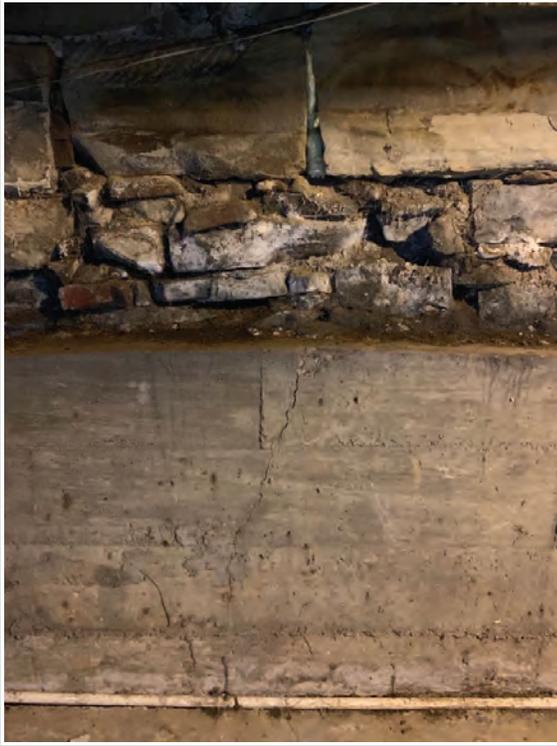
Item 7:	Crack forming in the south foundation wall indicates settlement in the foundation.

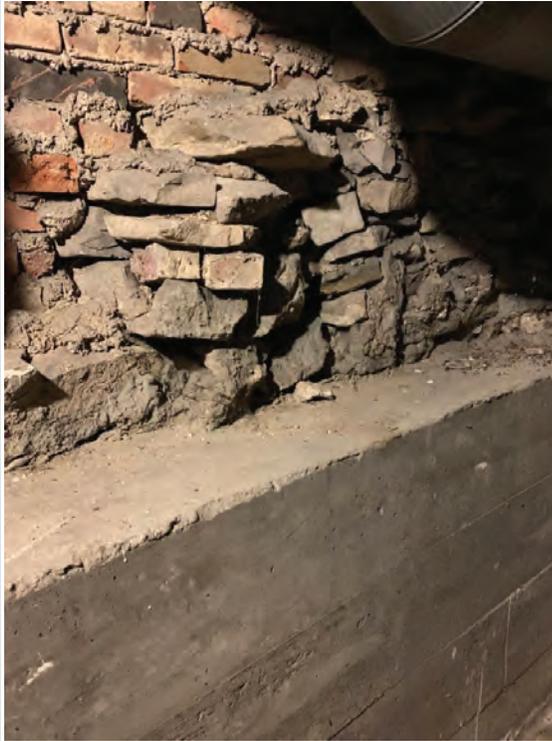
Item 8:

Loose stone foundation in the west wall of the east half of the basement.

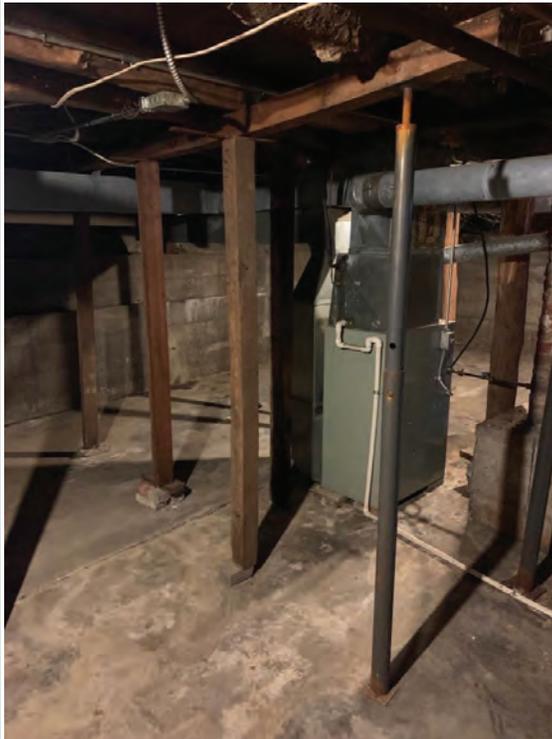
Item 9:

Temporary support posts.

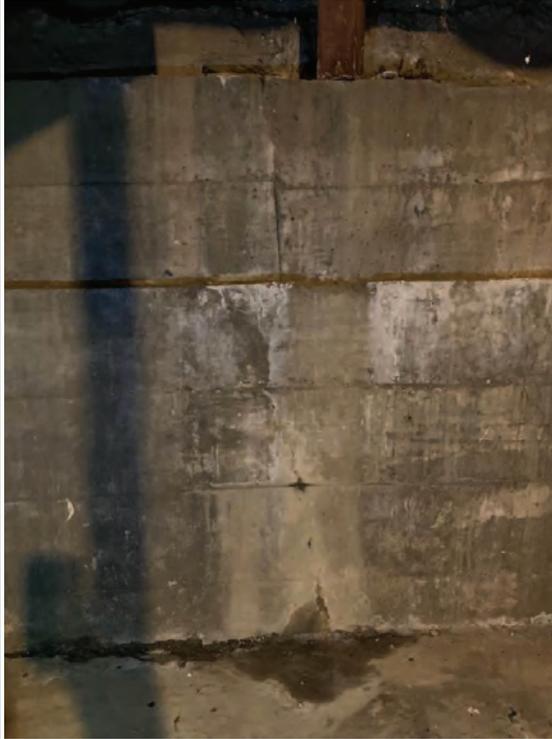
Item 10:

Crack in North foundation wall is also allowing water into the basement.

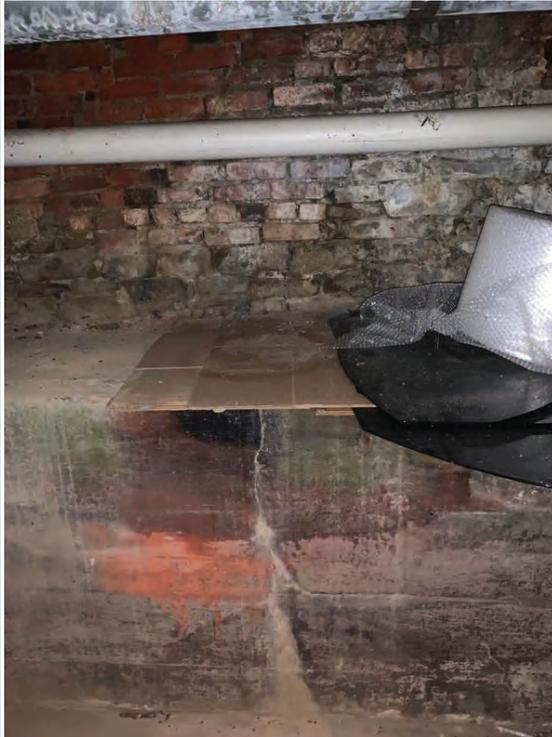
Item 11:

Crack in the north wall of the foundation on the west half of the basement. The crack is displaced about 5/16".

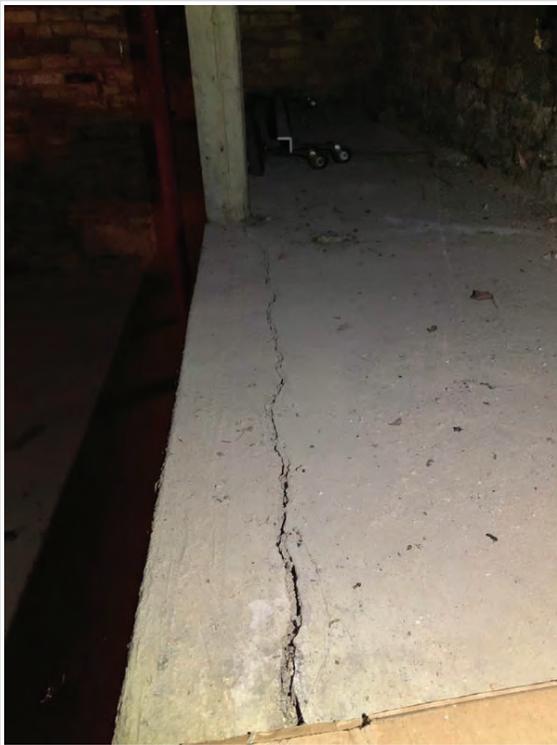
<p>Item 12:</p>	<p>Crack running through the top of the benched foundation area at the west end of the basement.</p>
<p>Single Photo</p>

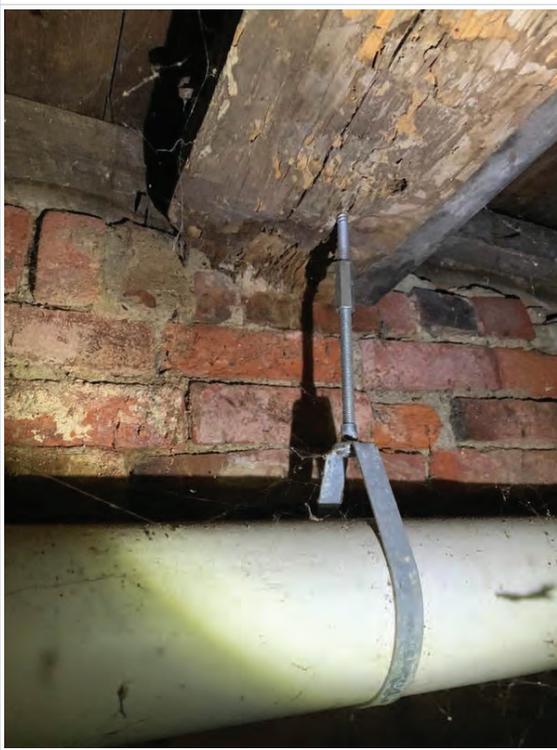
<p>Item 13:</p>	<p>North end of timber beam has been damaged by insects.</p>

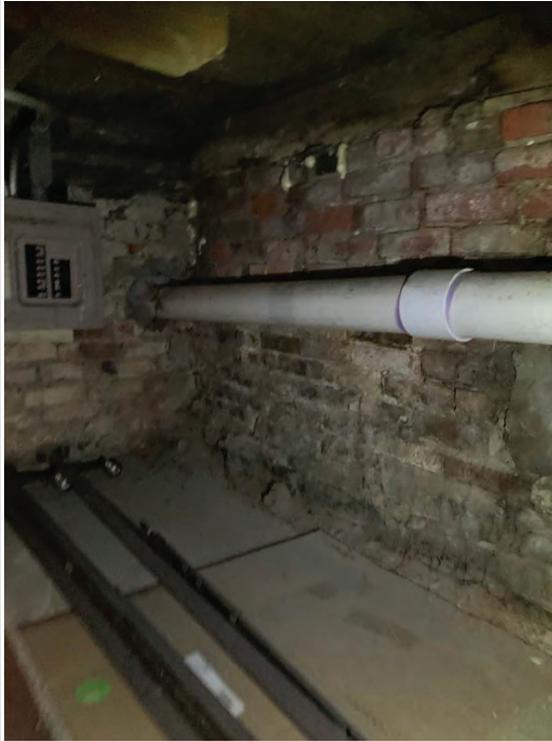
Item 14:

Shifting in the brick foundation wall at the NW corner of the basement.

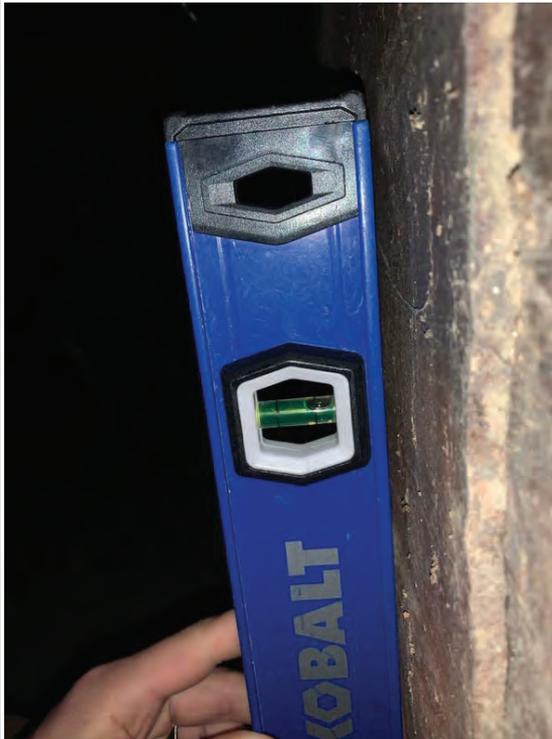
Item 15:

North foundation wall is out of plumb and has cracks indicating movement.

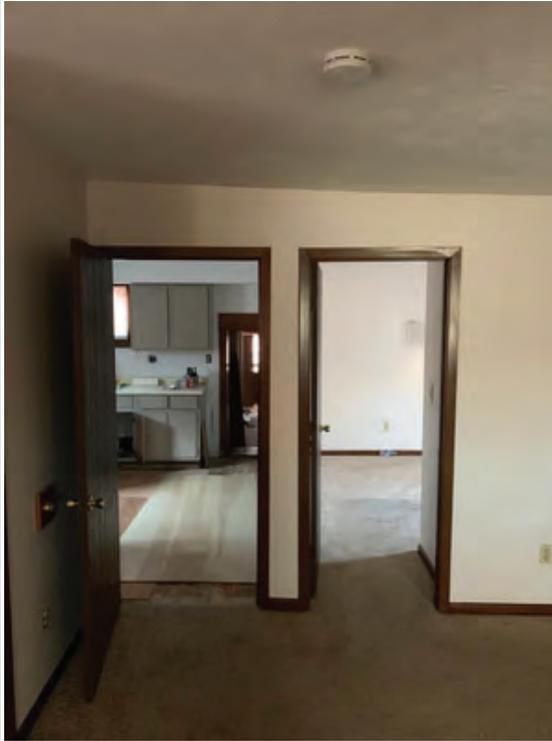
Item 22:

Floors and ceilings not level as observed above the doors.

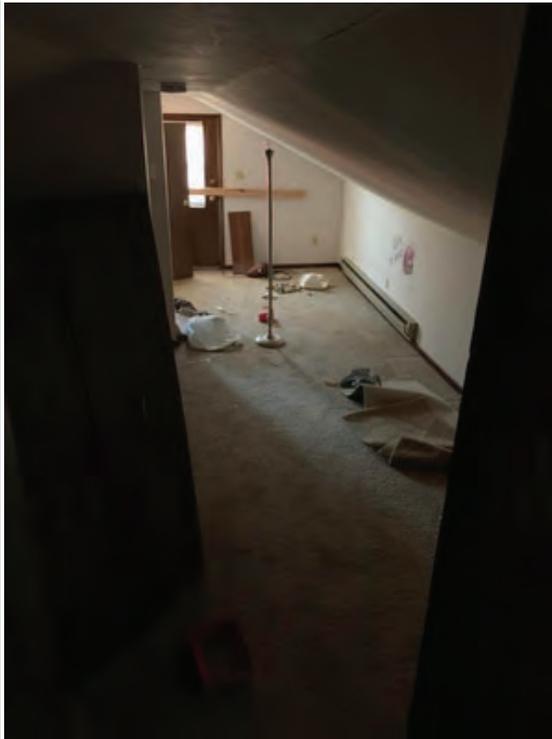
Item 23:

Floor slopes toward the middle on the 2nd floor west room.

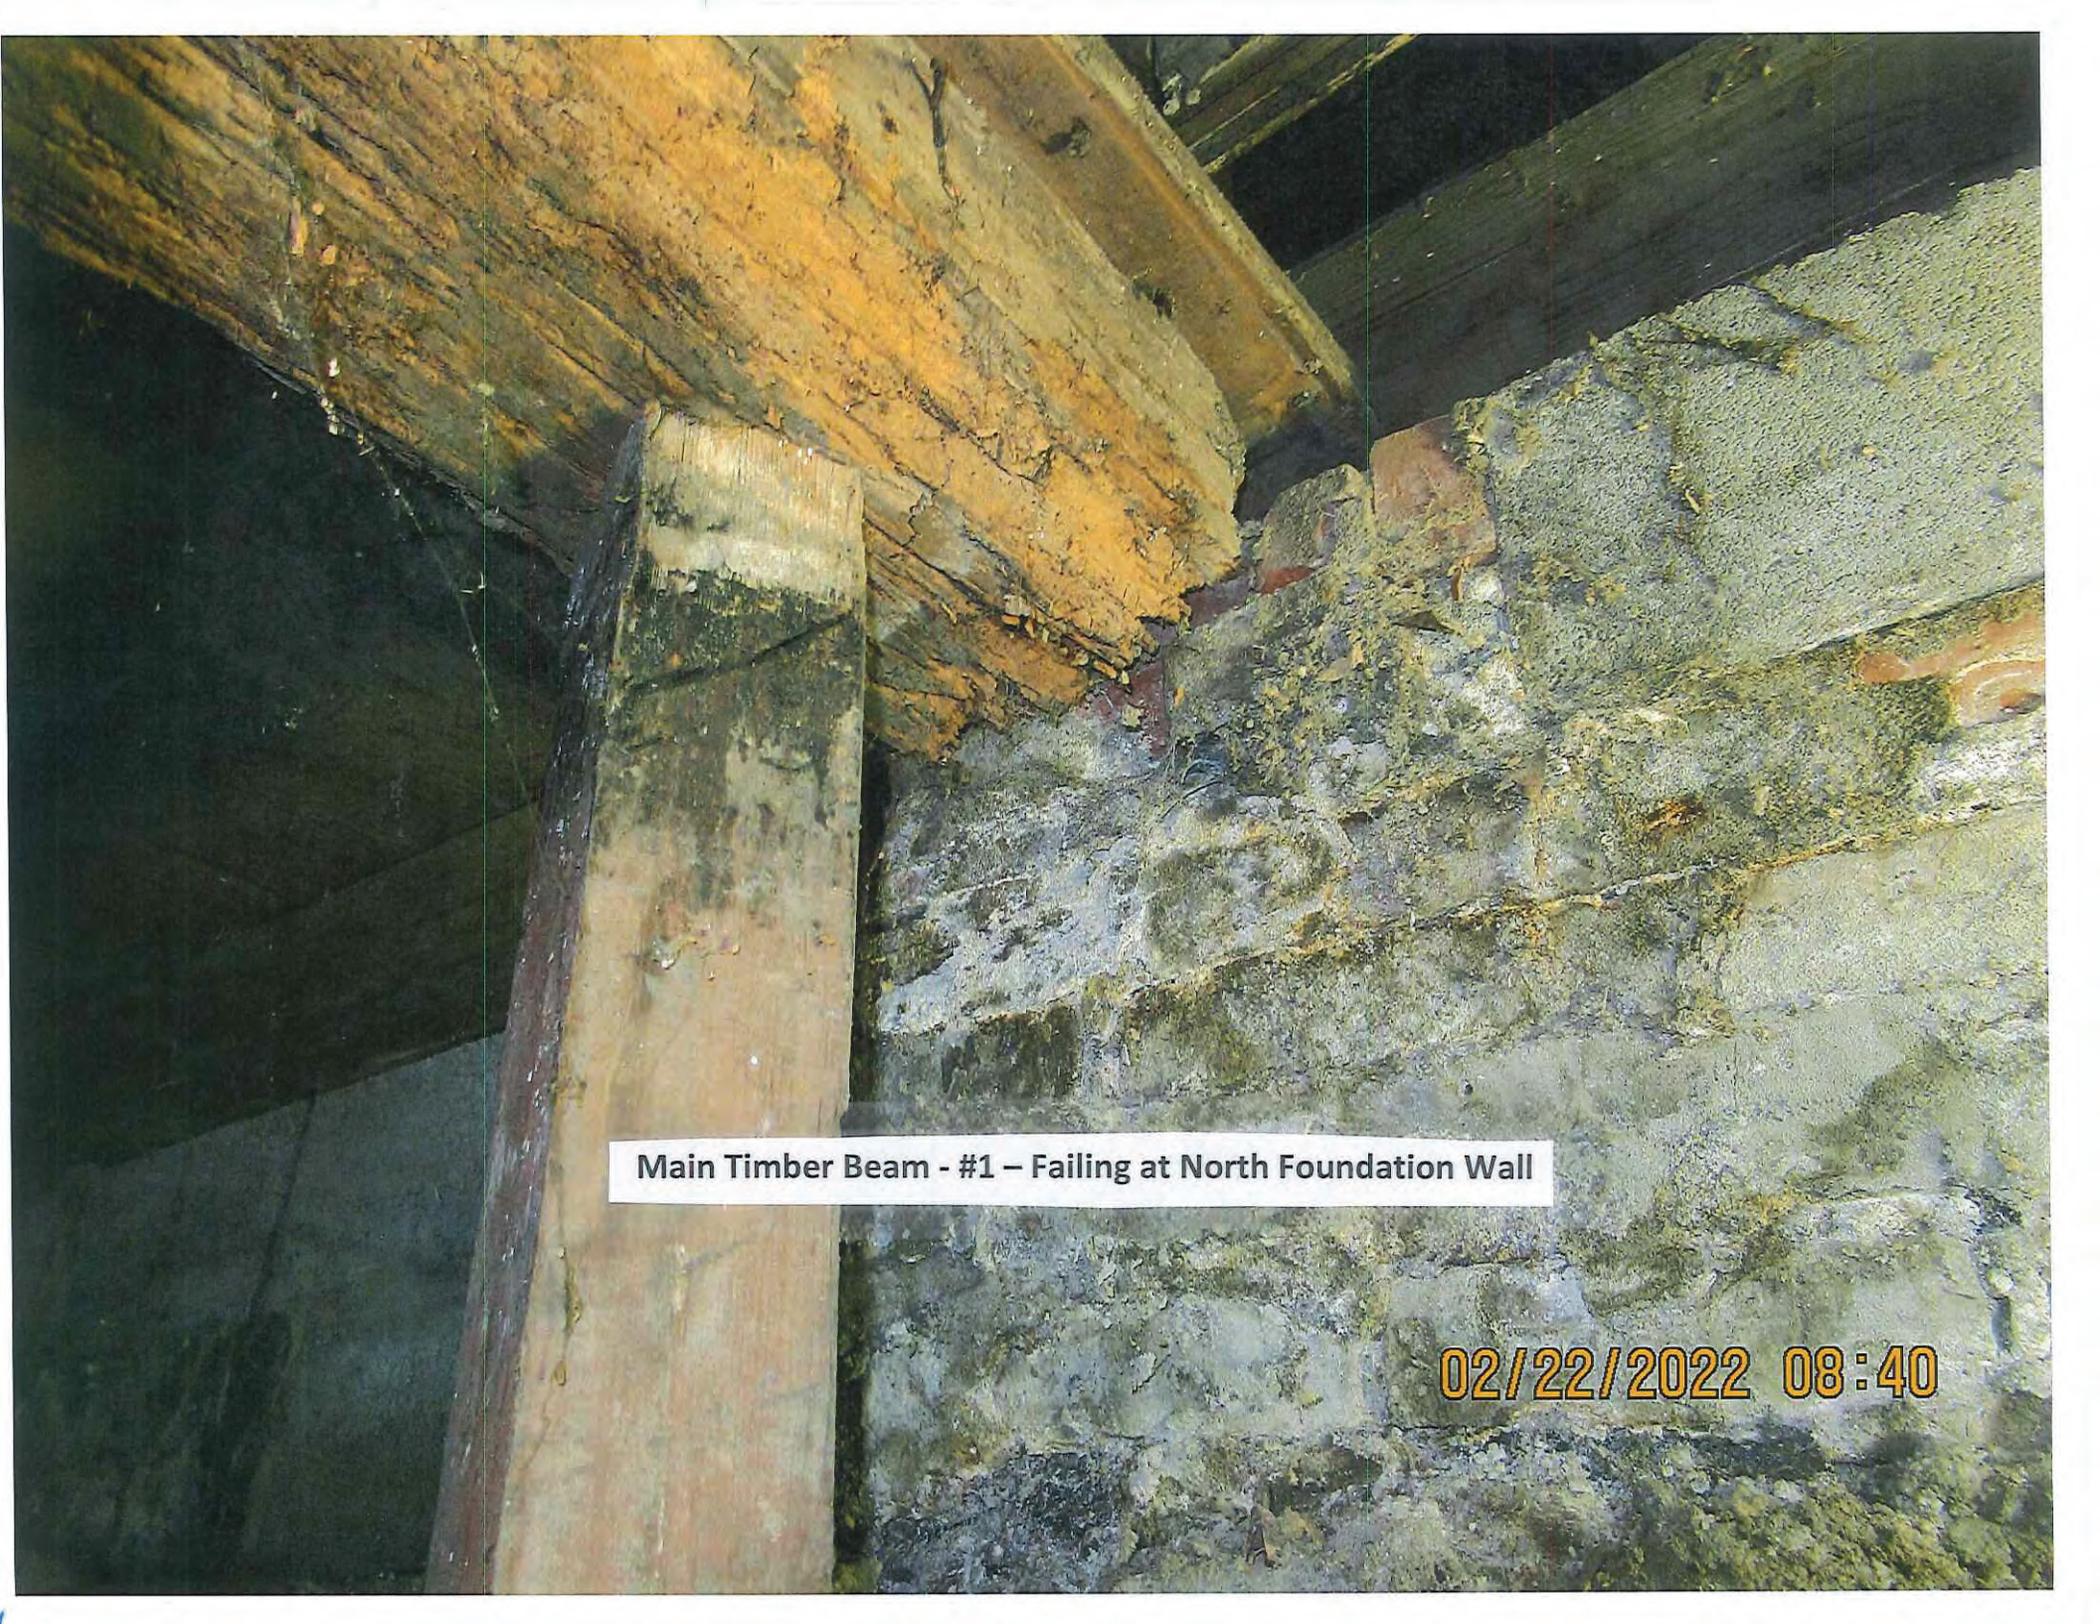
Main Timber Beam - #1 – Failing at North Foundation Wall

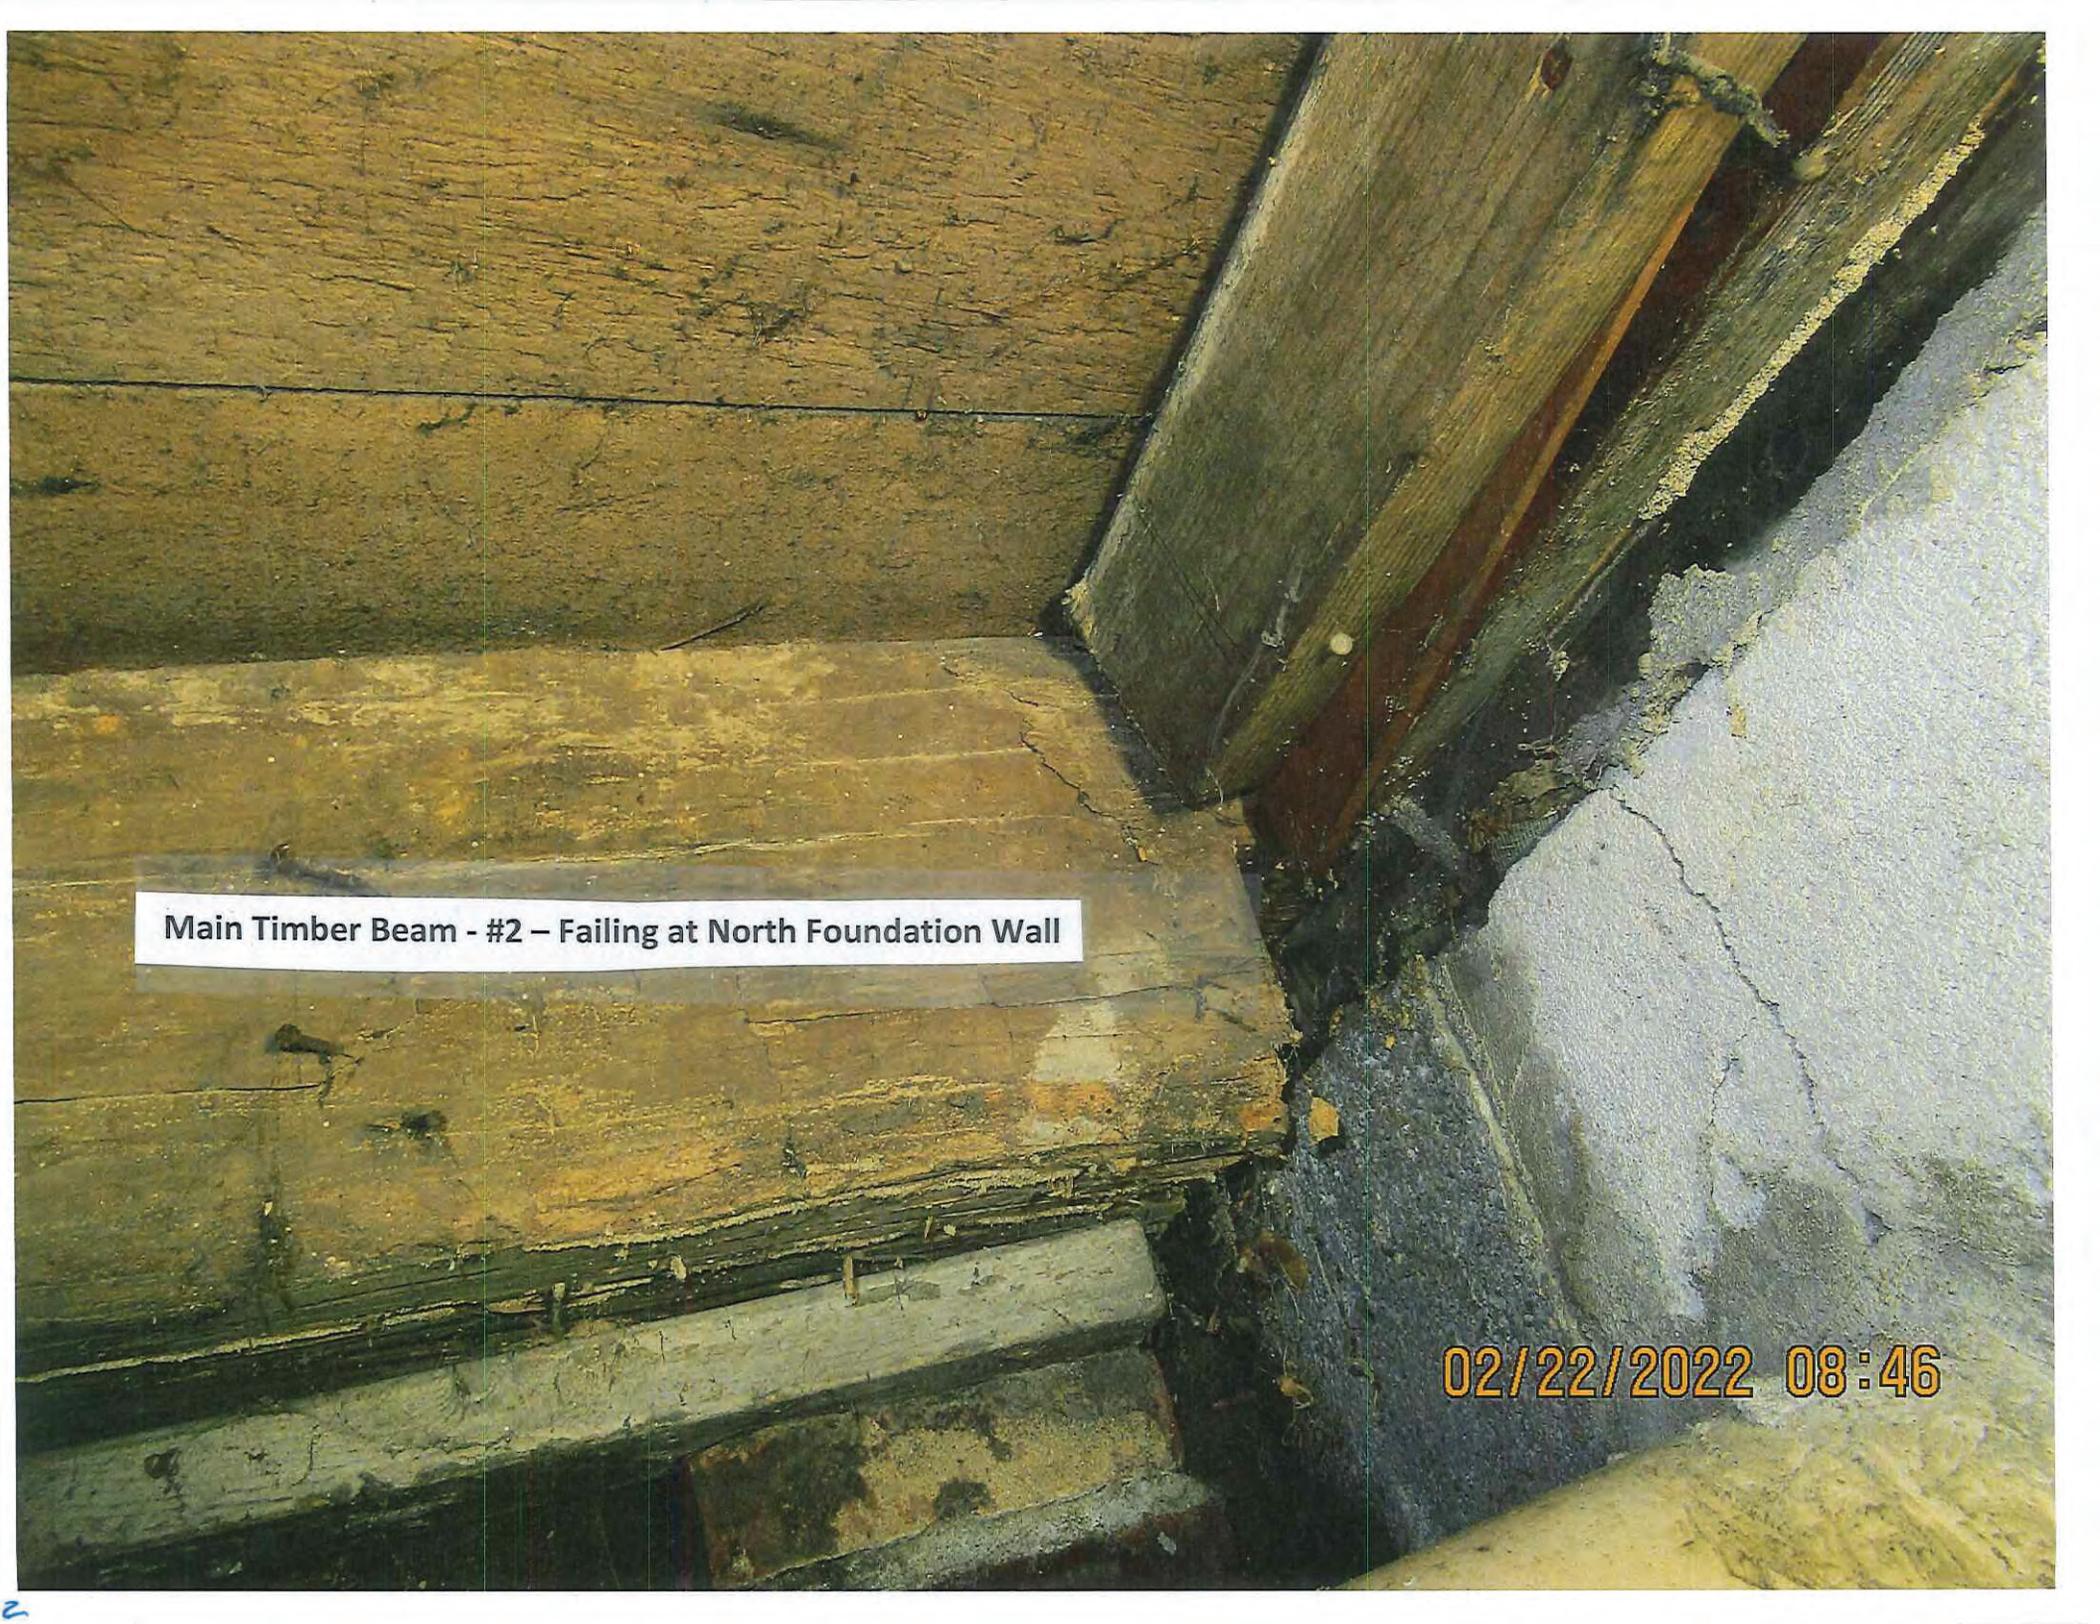
Main Timber Beam - #2 – Failing at North Foundation Wall

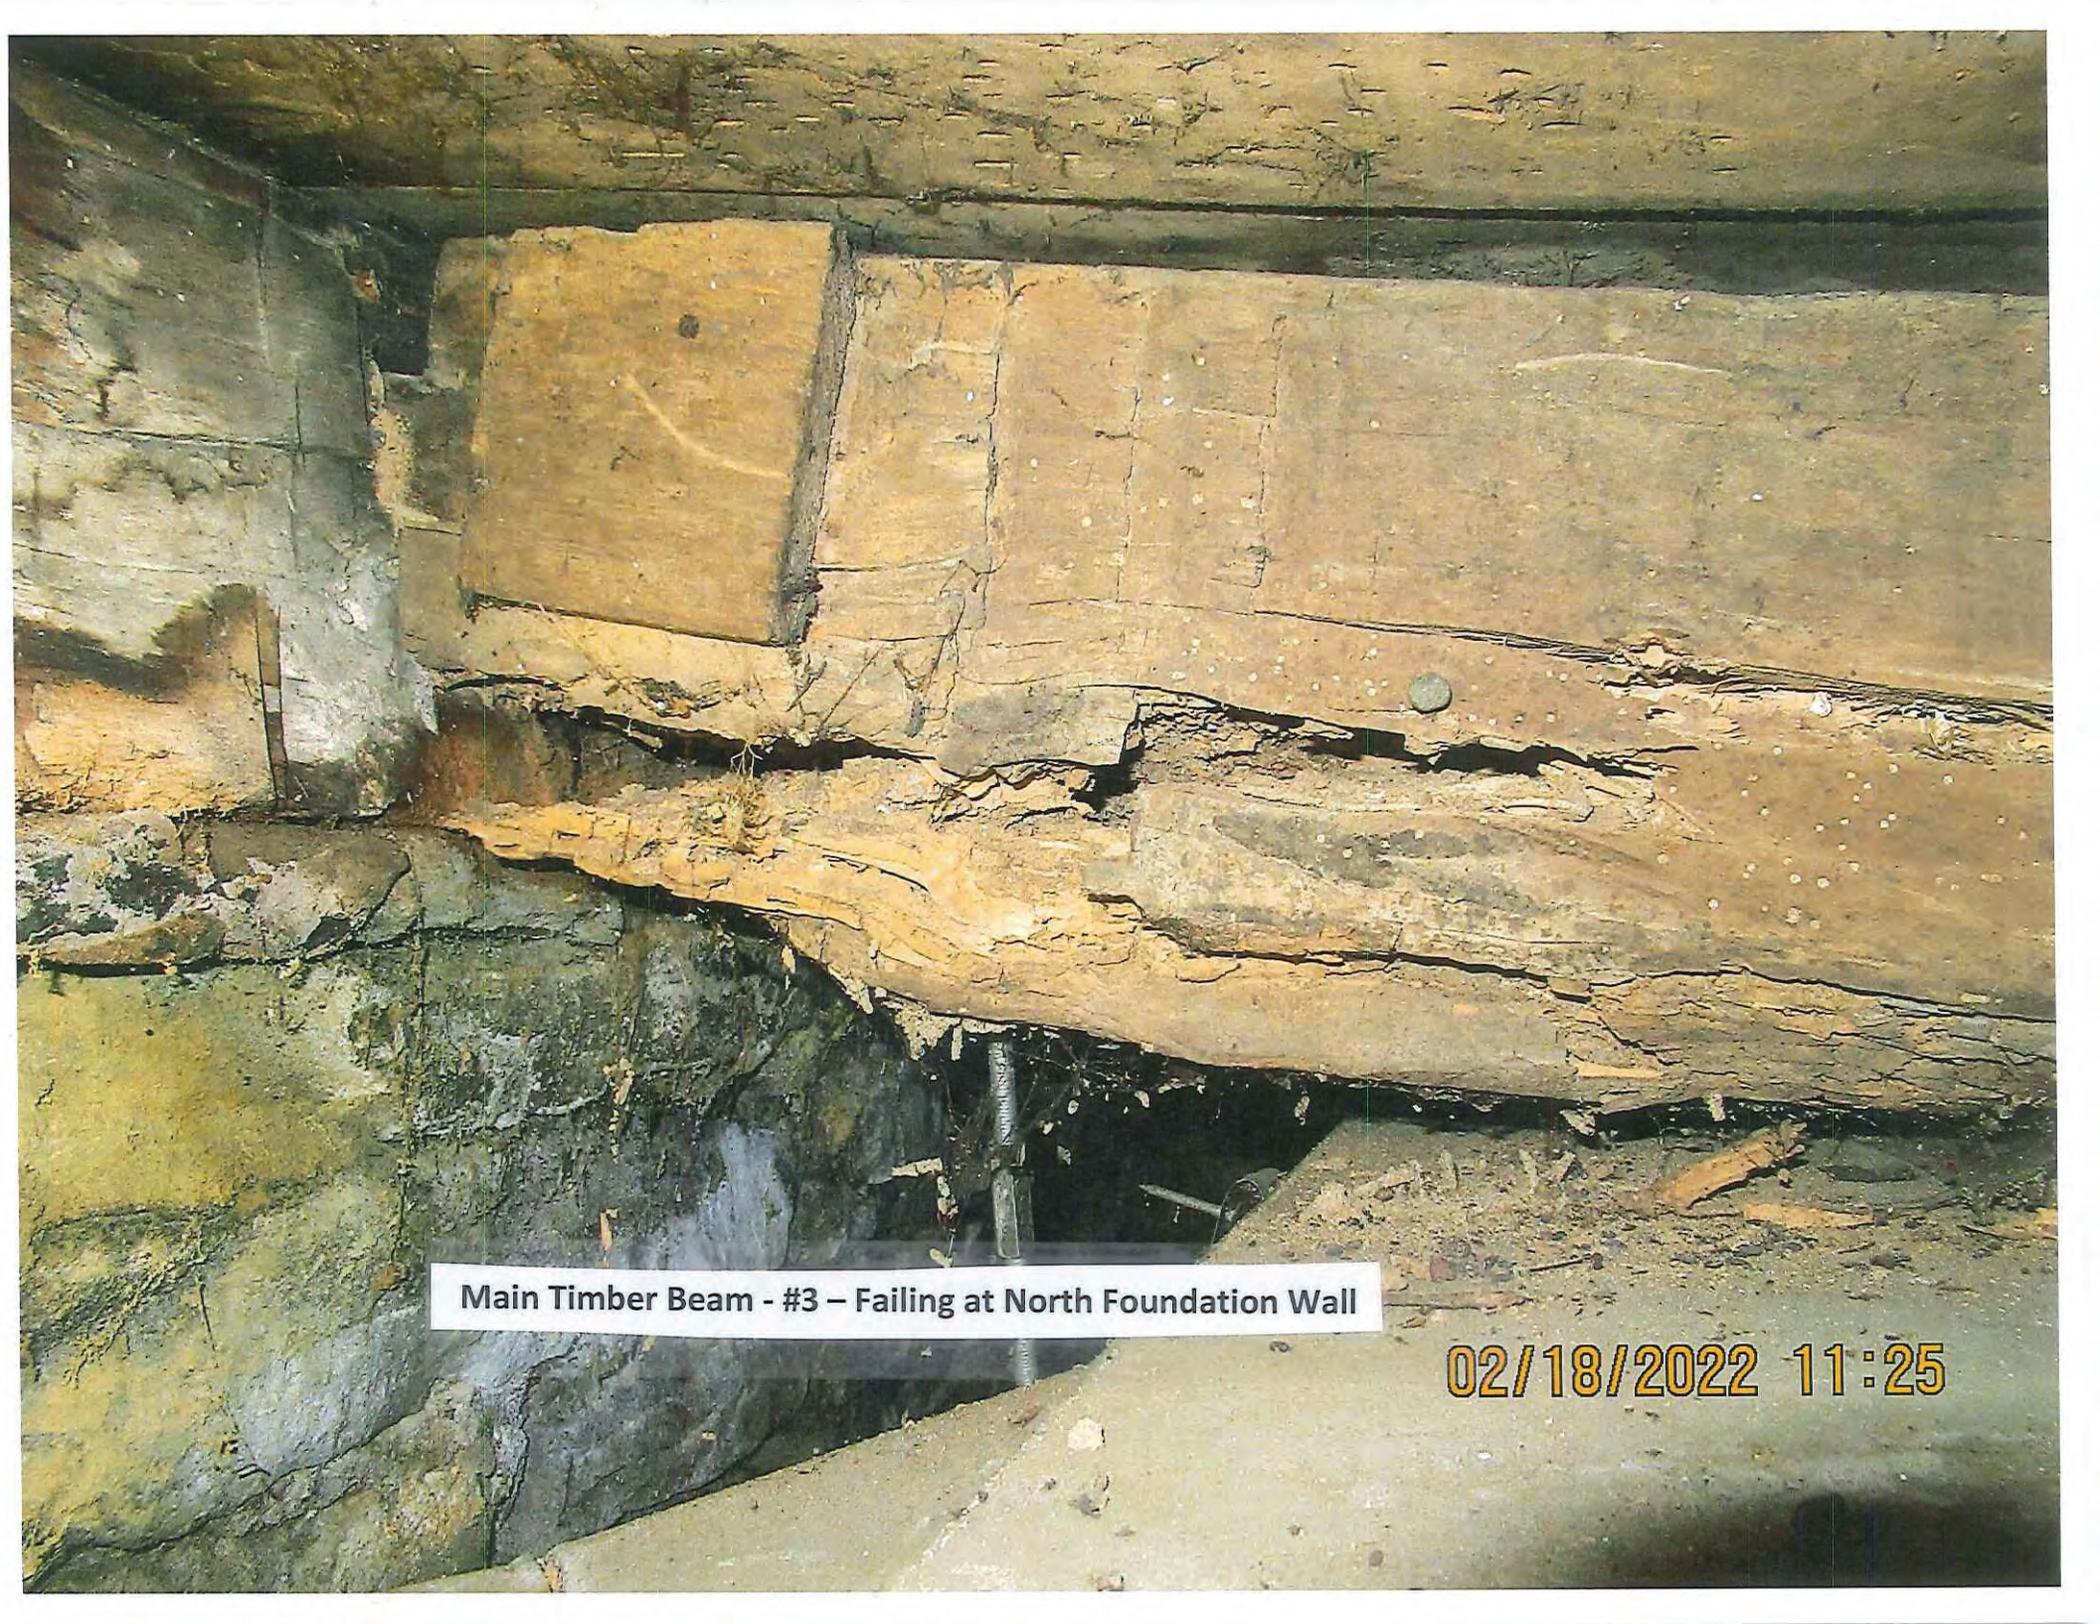
Main Timber Beam - #3 – Failing at North Foundation Wall

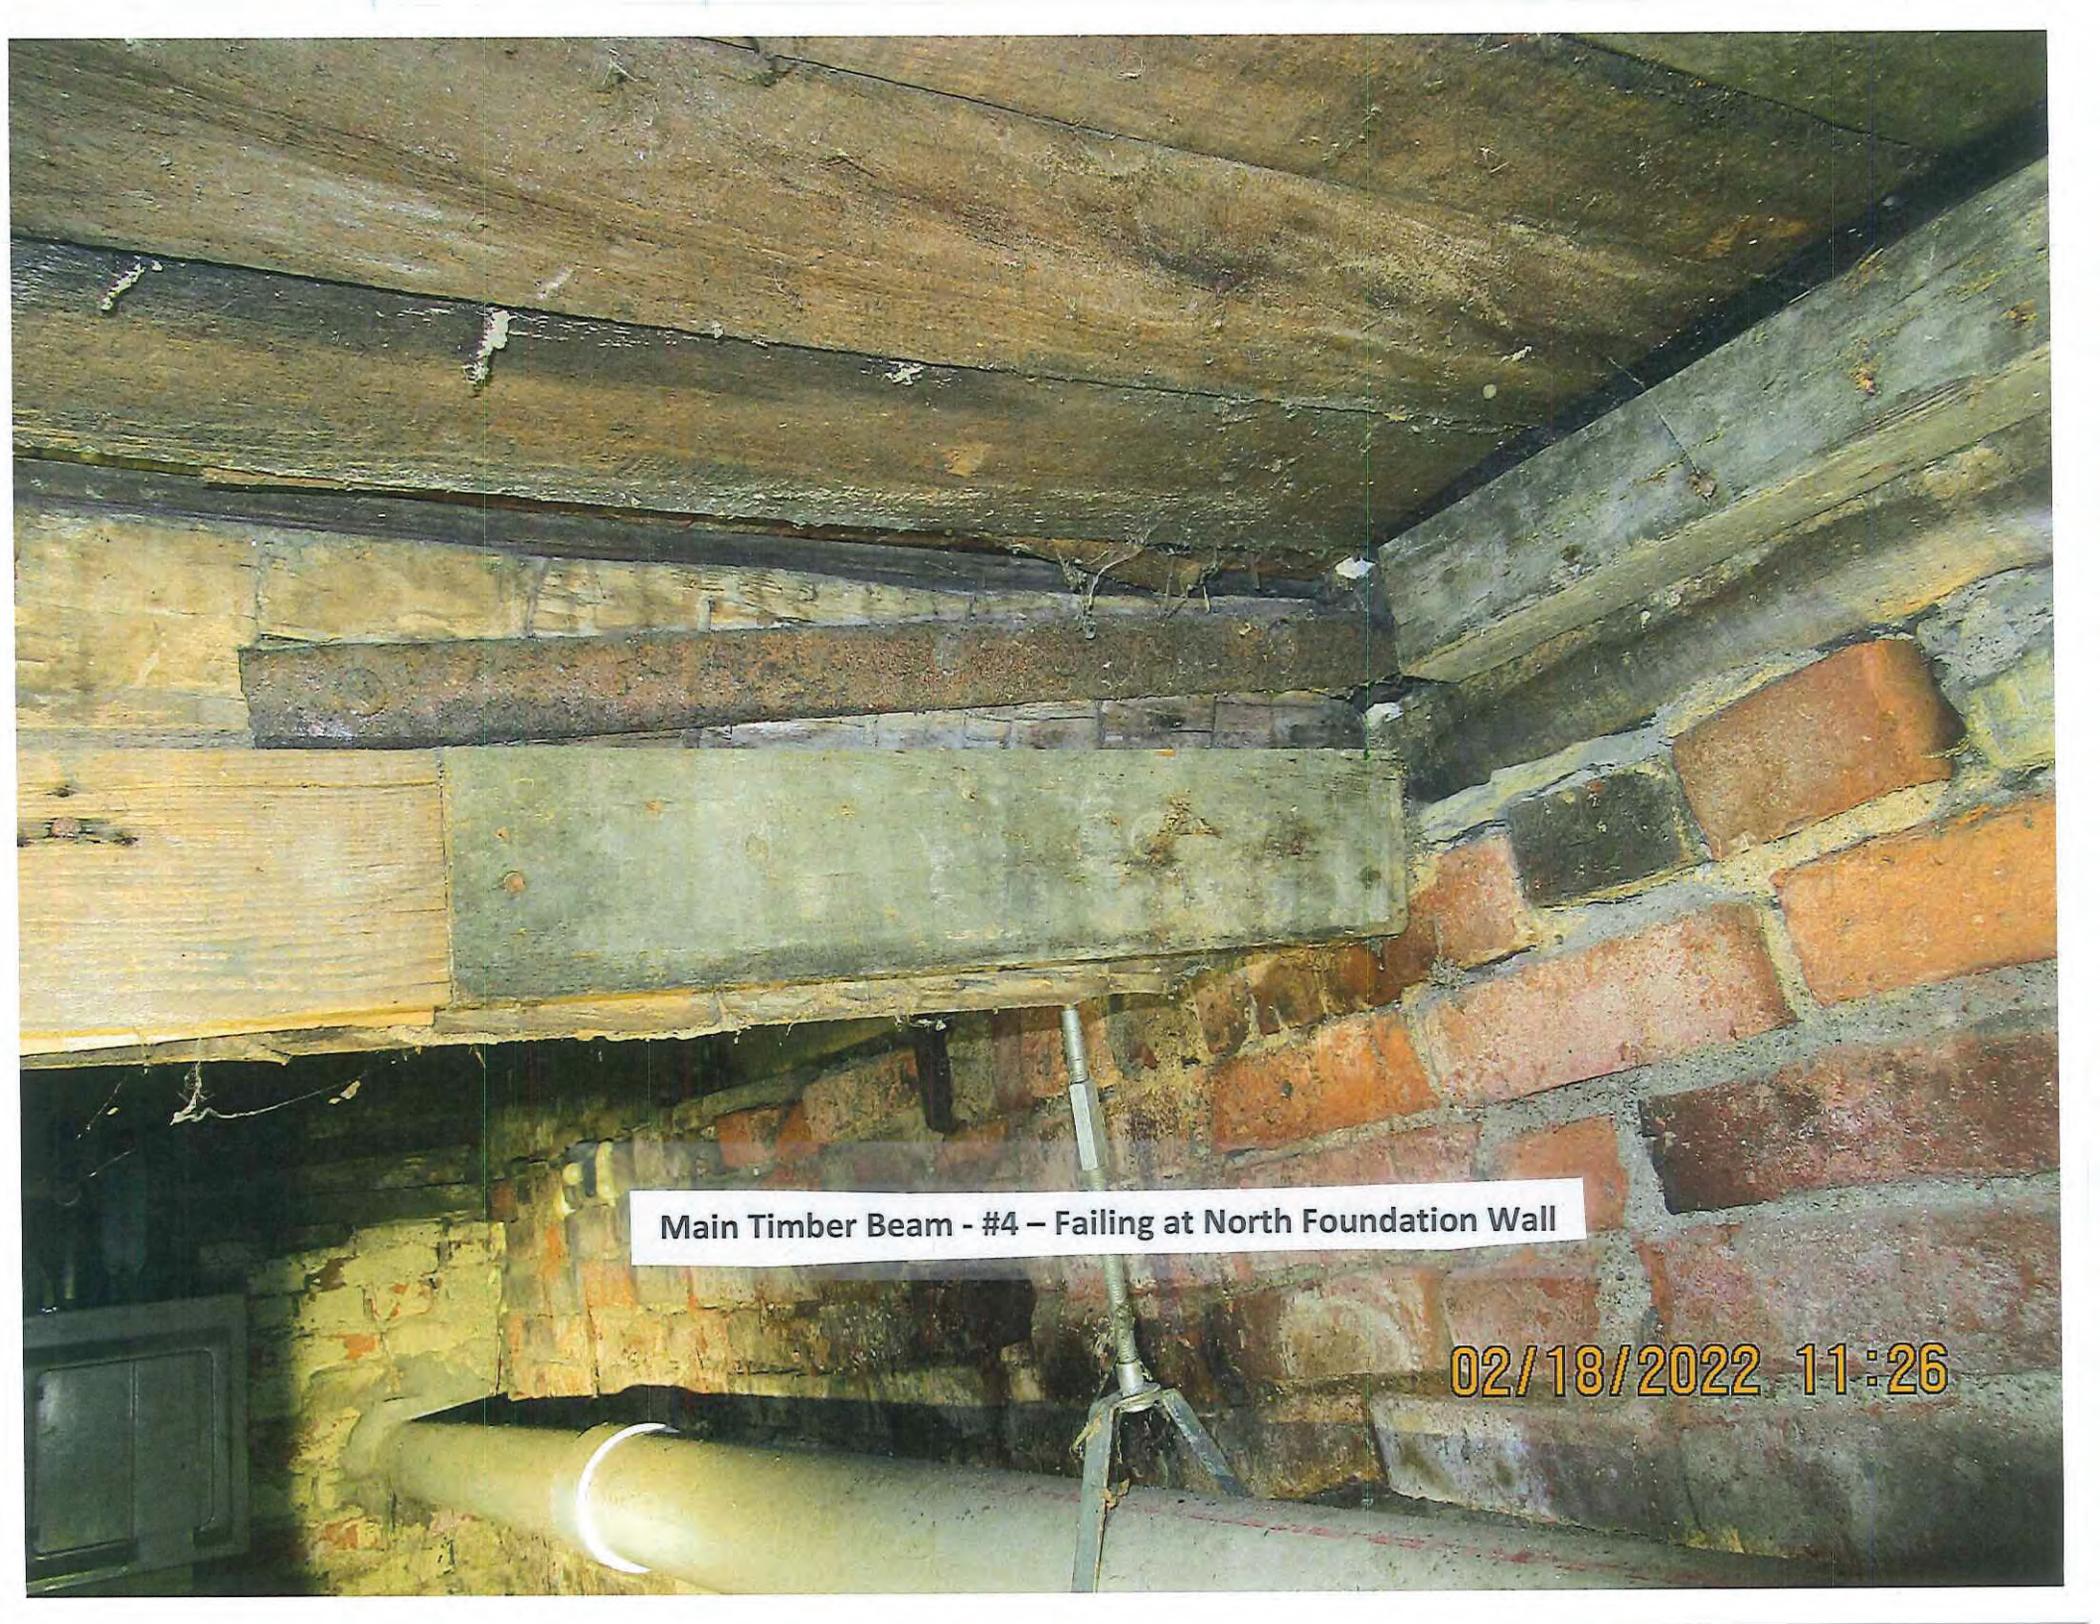
Main Timber Beam - #4 – Failing at North Foundation Wall

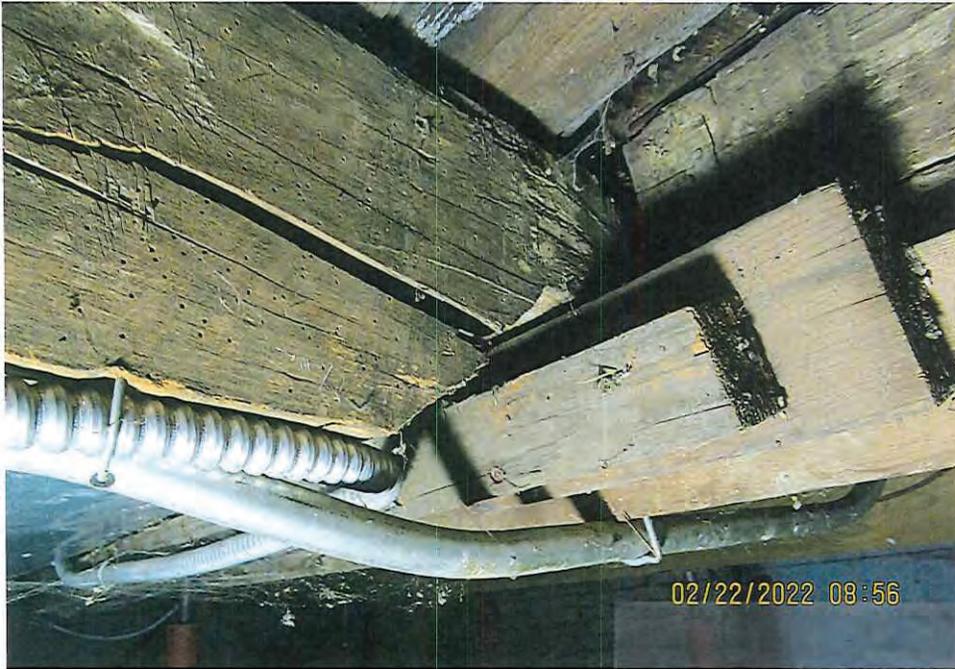
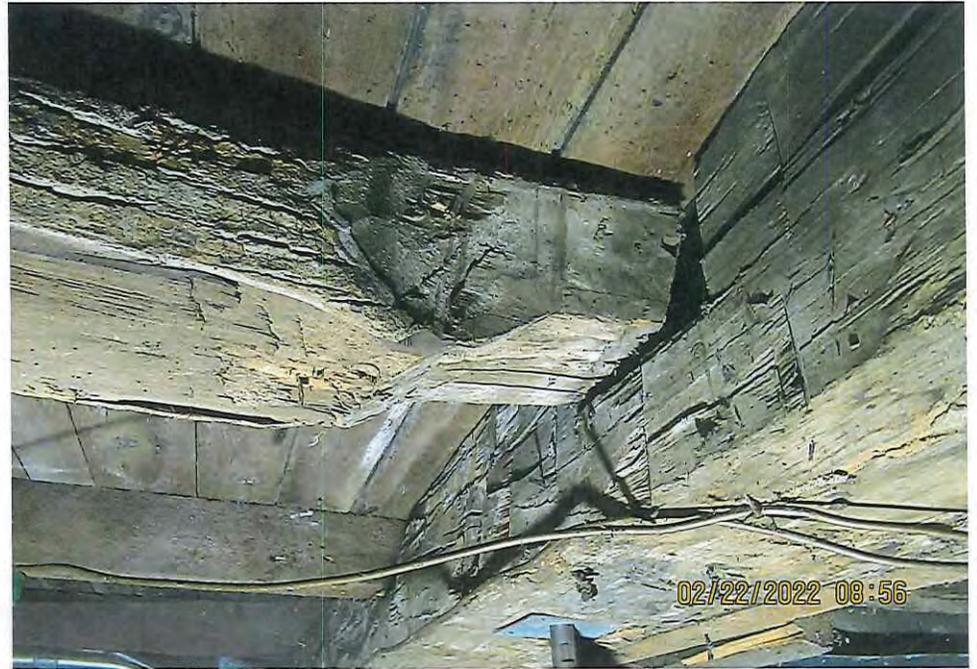
Miscellaneous ½ Sawn Tree Joists – Throughout Basement
These joists are pulling loose and not bearing on beams

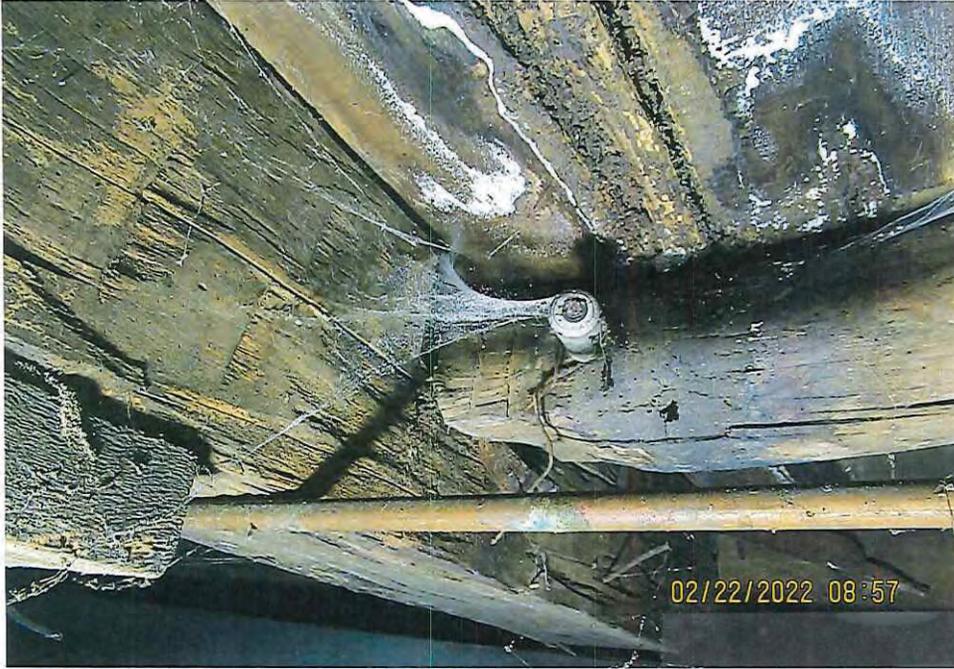
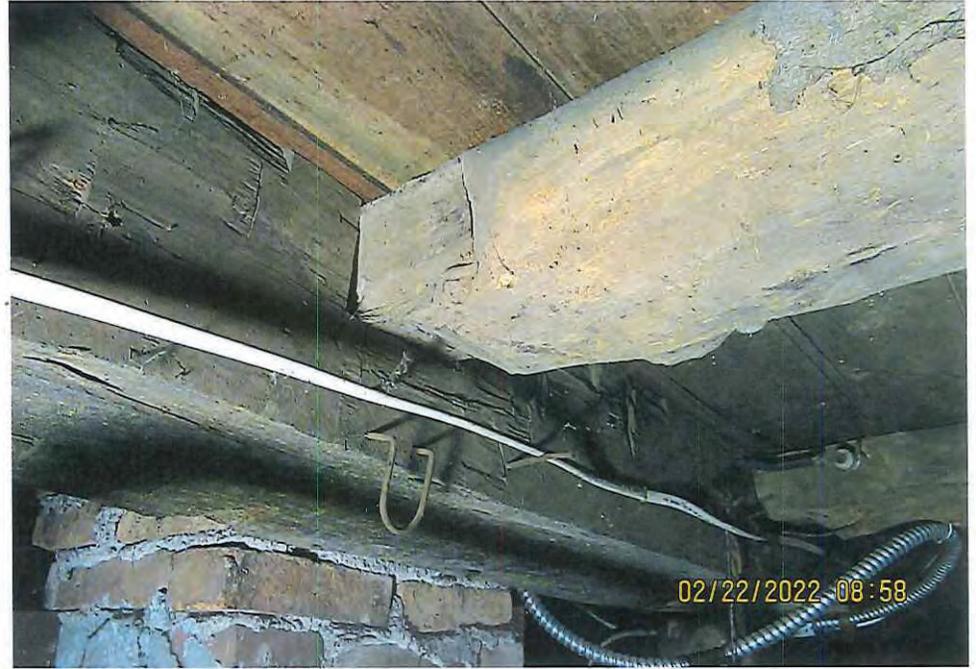
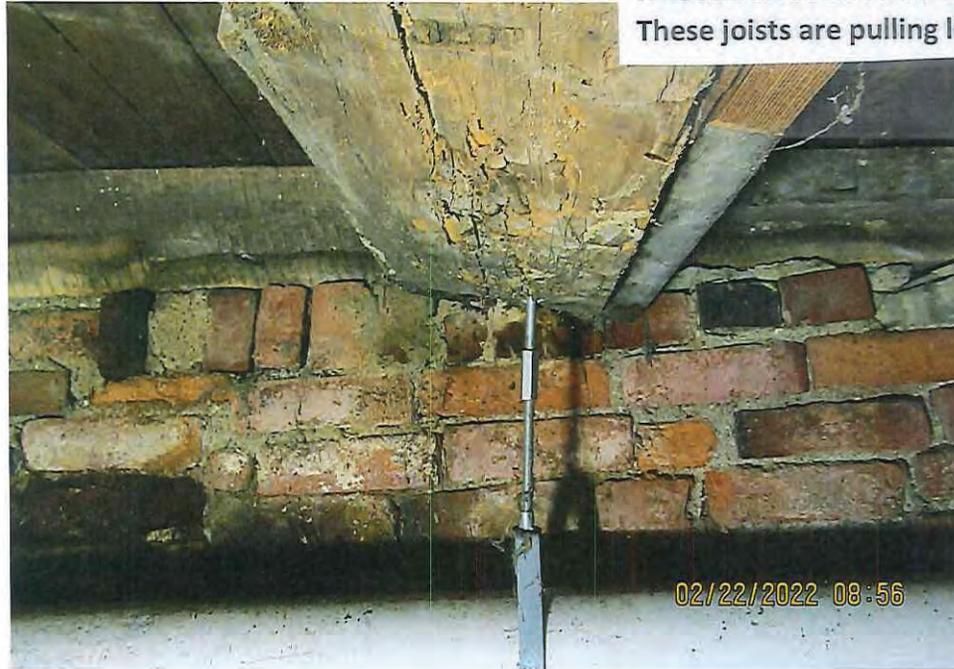
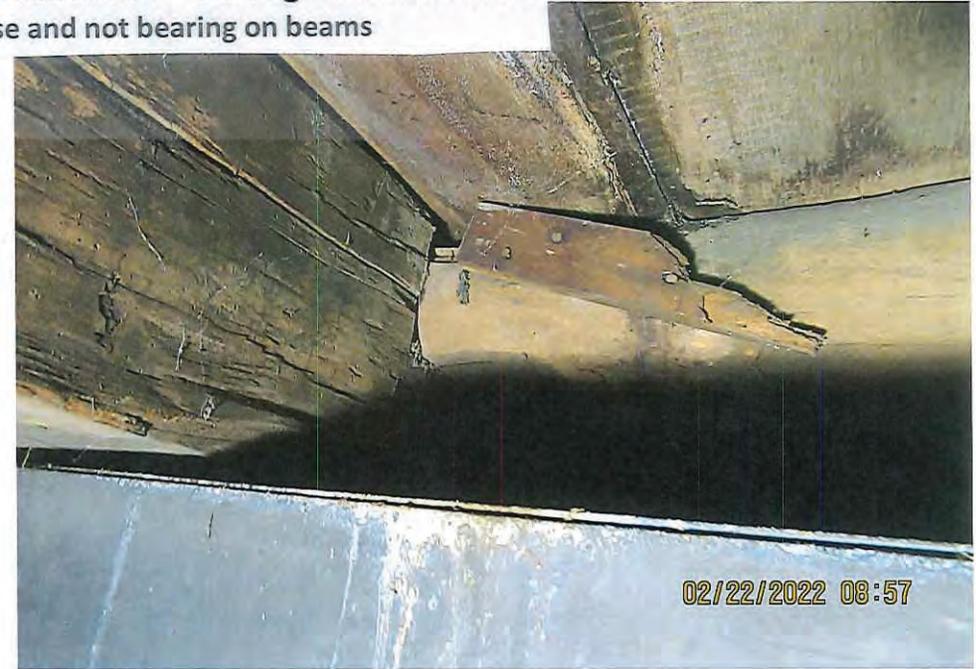
Miscellaneous ½ Sawn Tree Joists – Throughout Basement
These joists are pulling loose and not bearing on beams
