HISTORIC PRESERVATION BOARD

Case No. H22-045

Building Demolition at 277 South Court Street

March 2, 2022

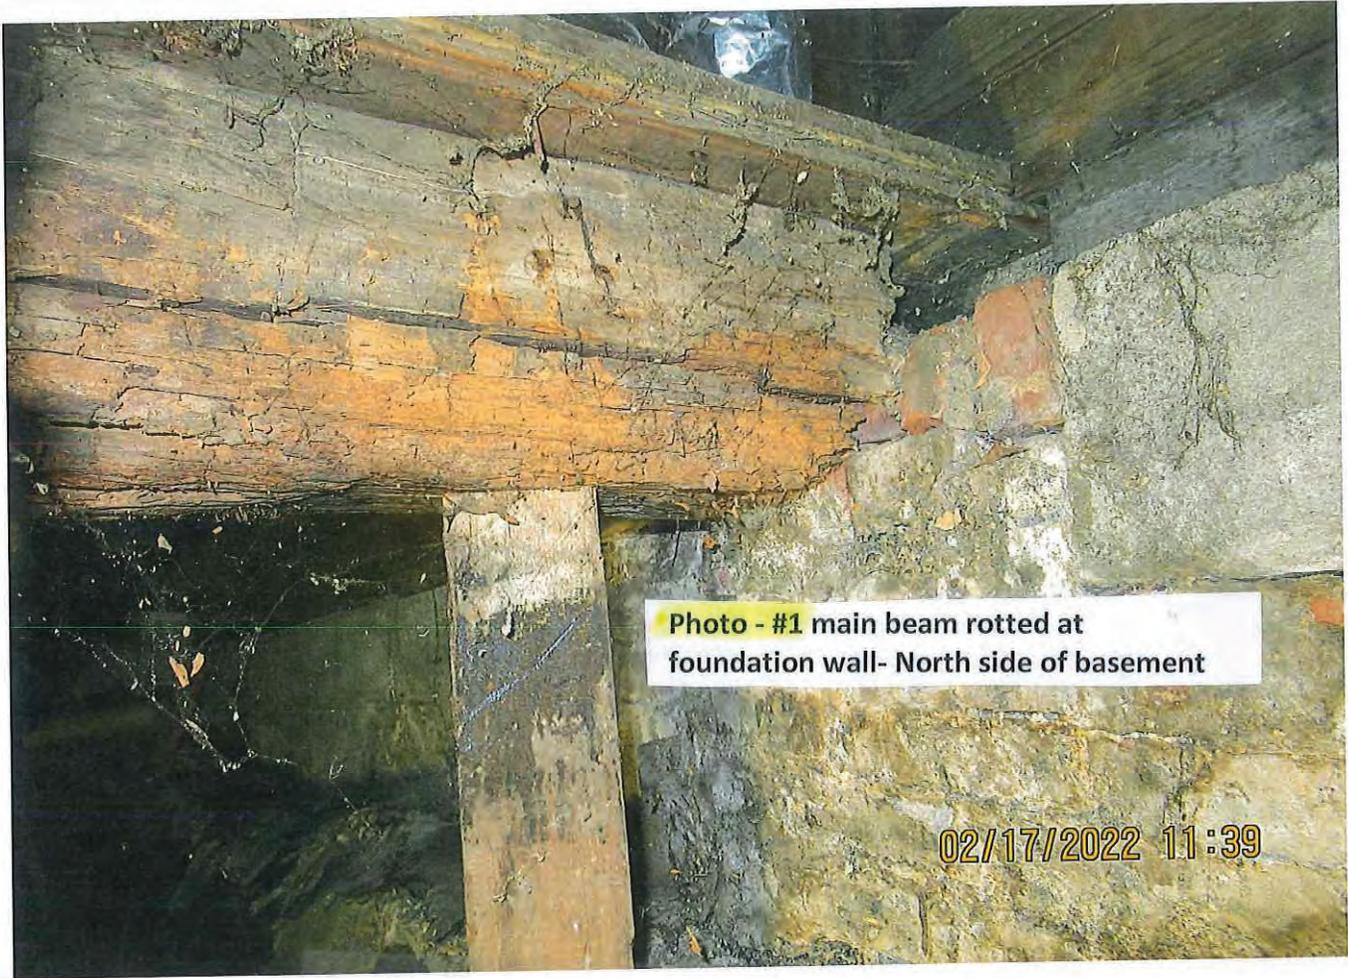
Photo - #1 main beam rotted at foundation wall- North side of basement

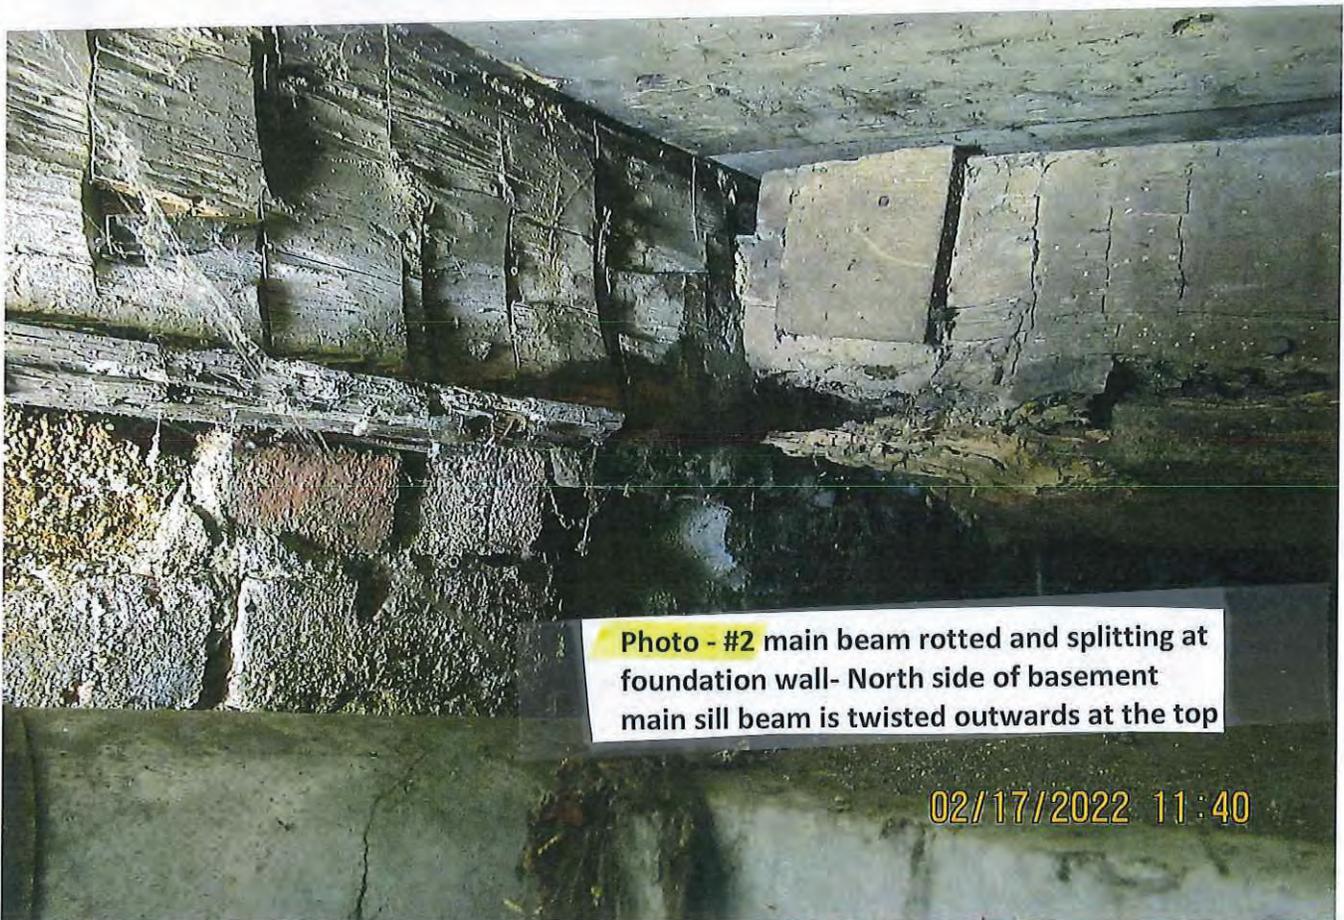
Photo - #2 main beam rotted and splitting at foundation wall- North side of basement
main sill beam is twisted outwards at the top

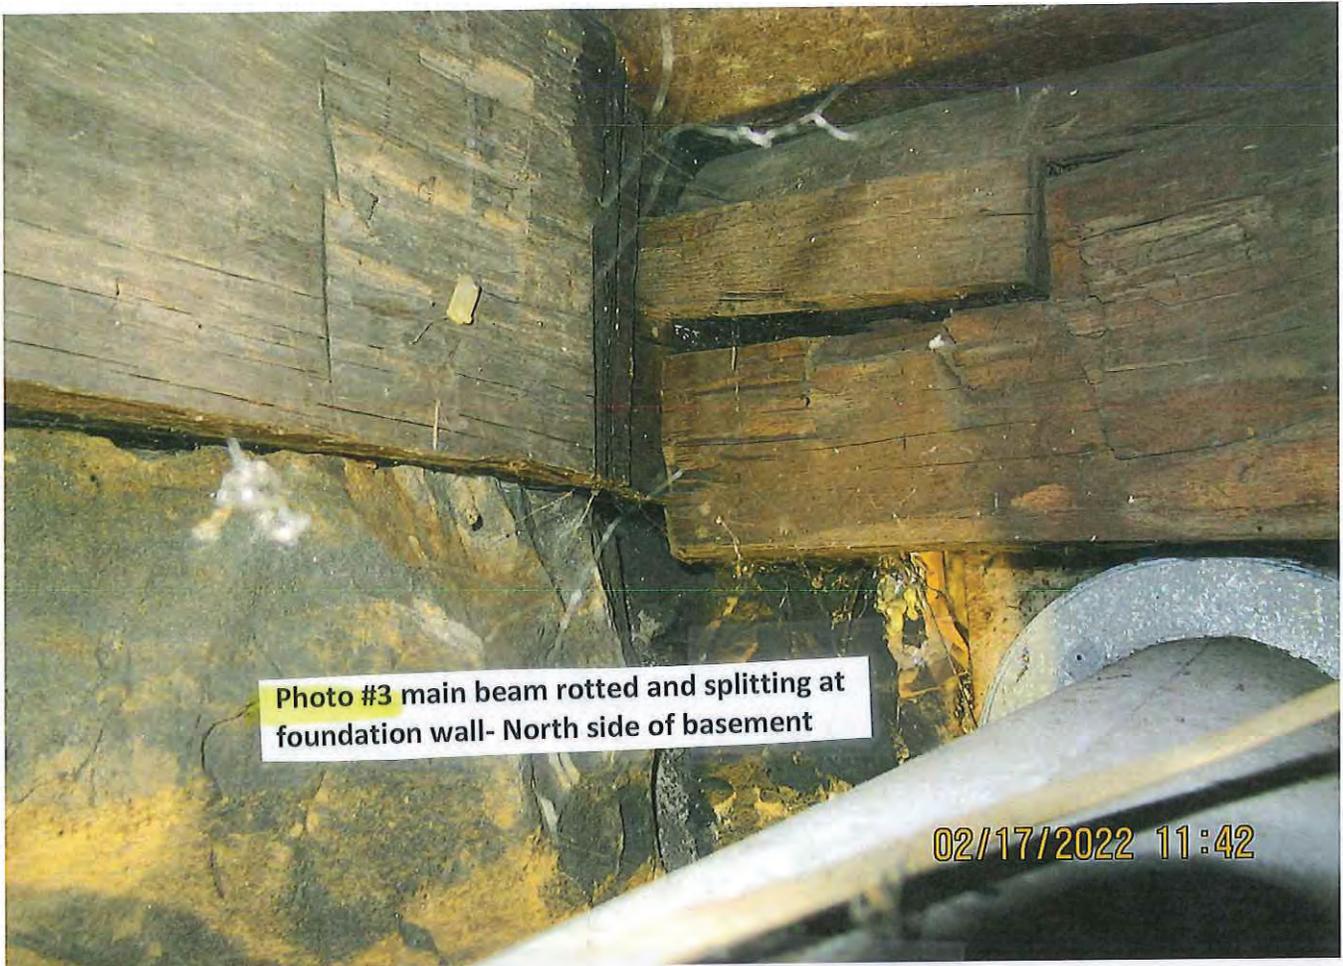
Photo #3 main beam rotted and splitting at foundation wall- North side of basement

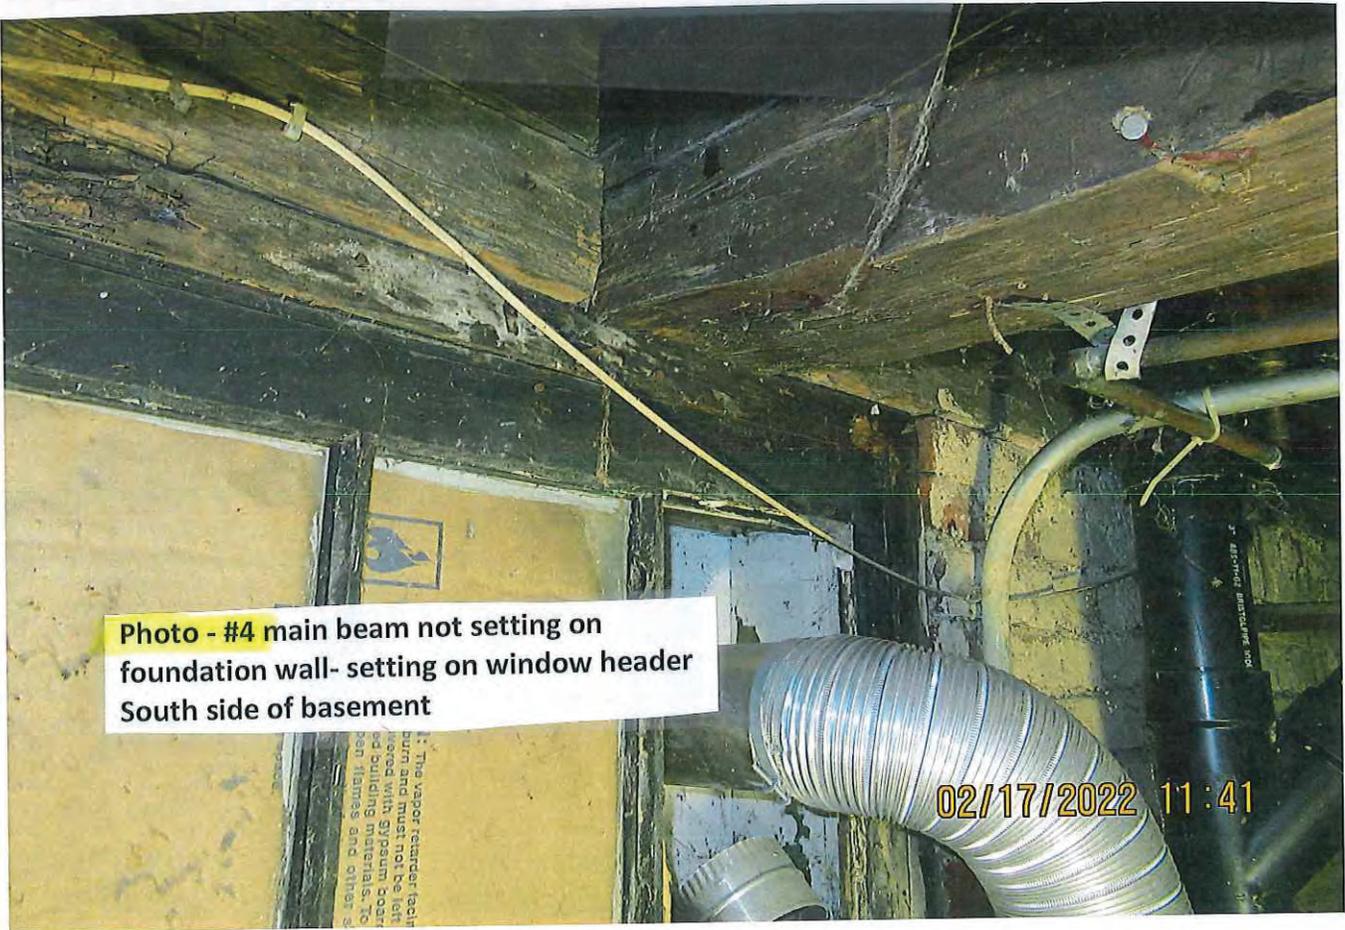
Photo - #4 main beam not setting on foundation wall- setting on window header South side of basement

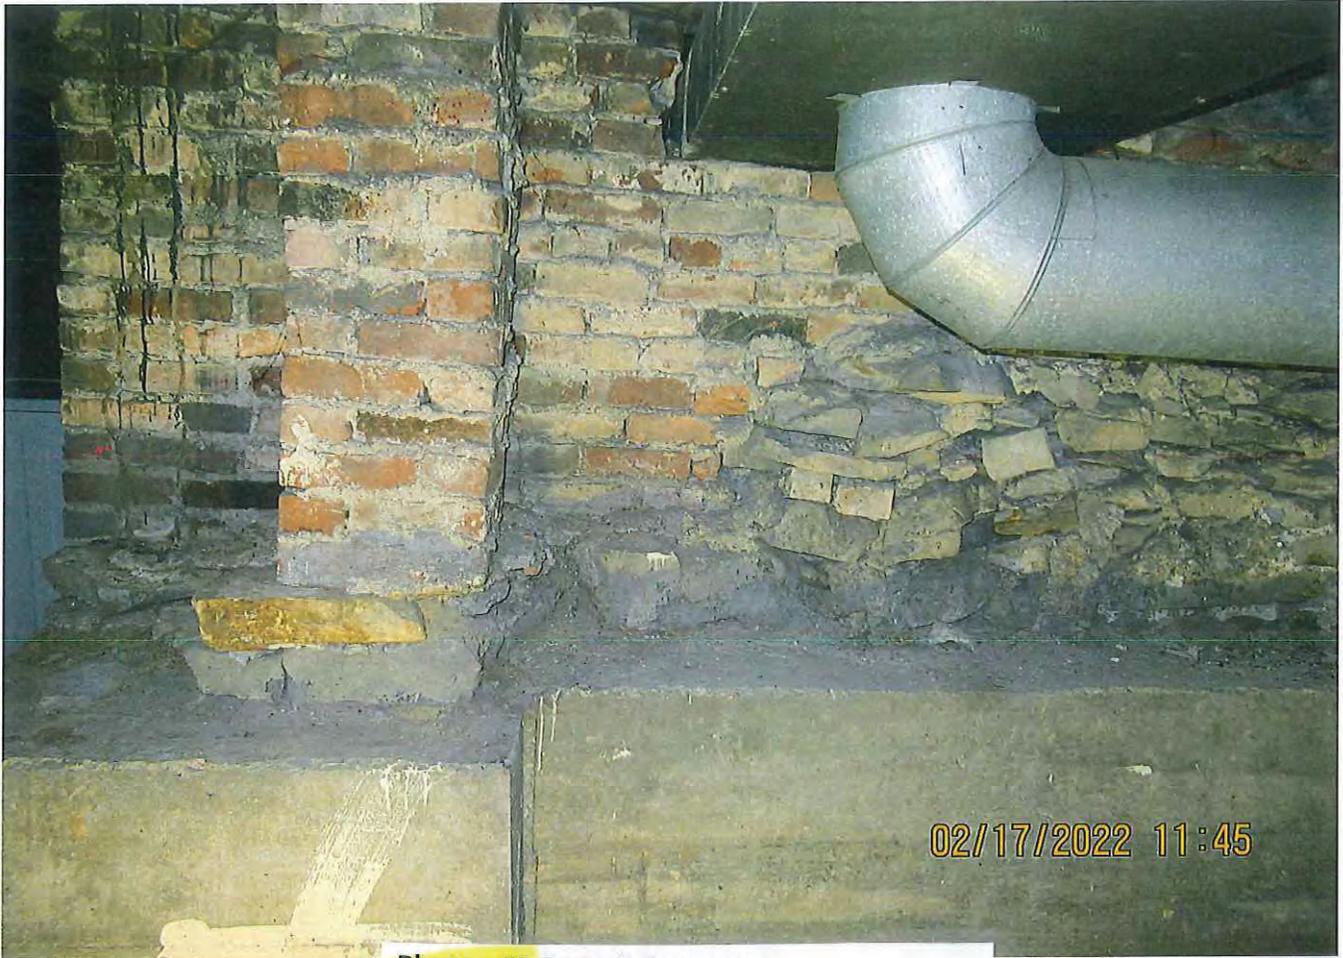
**Photo - #5 Foundation walls
Constructed of concrete, stone and bricks**

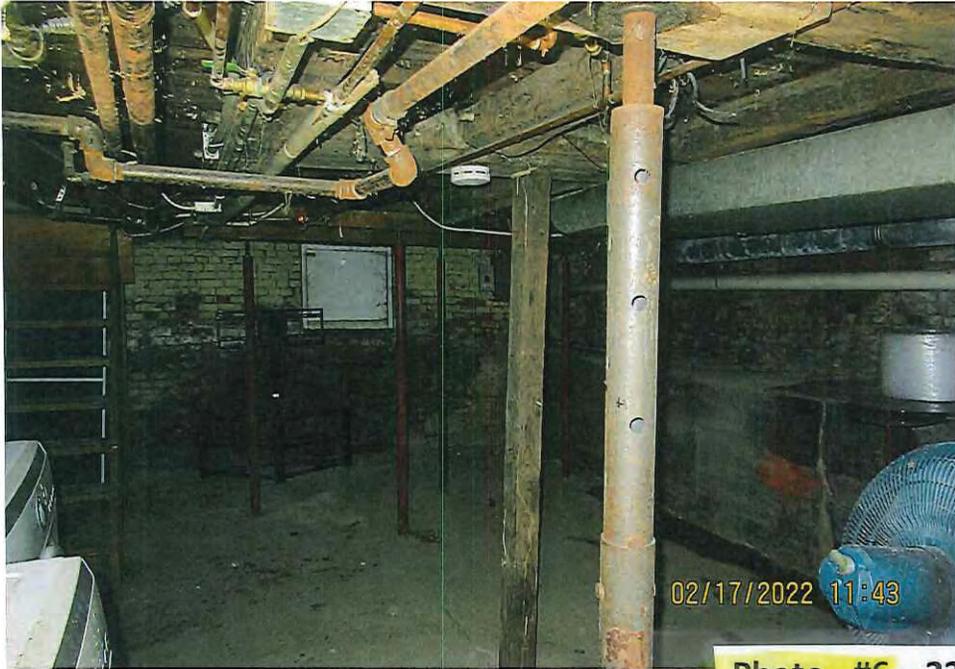
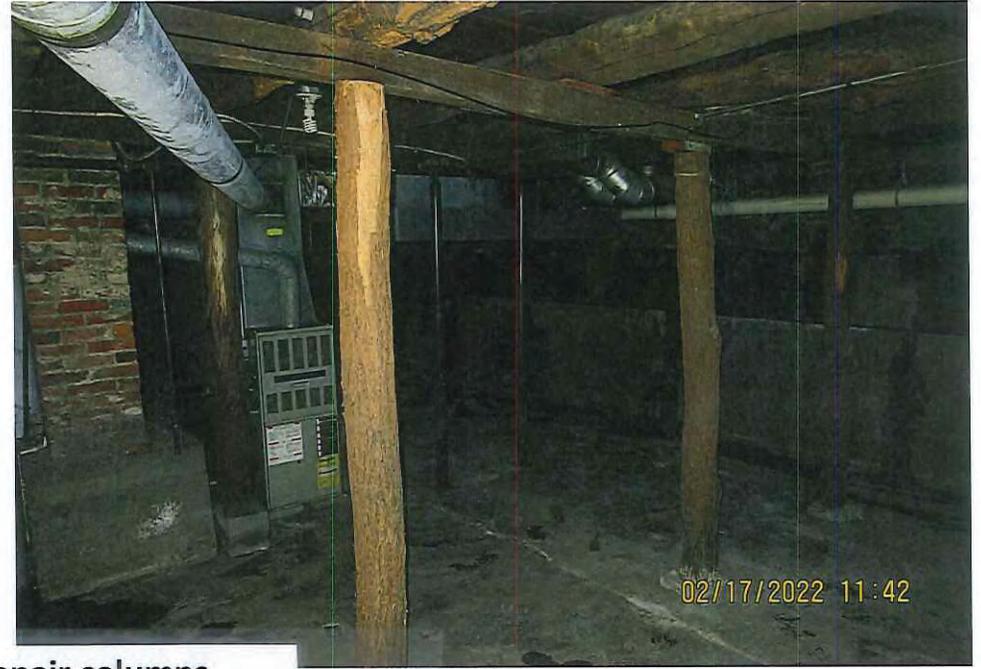
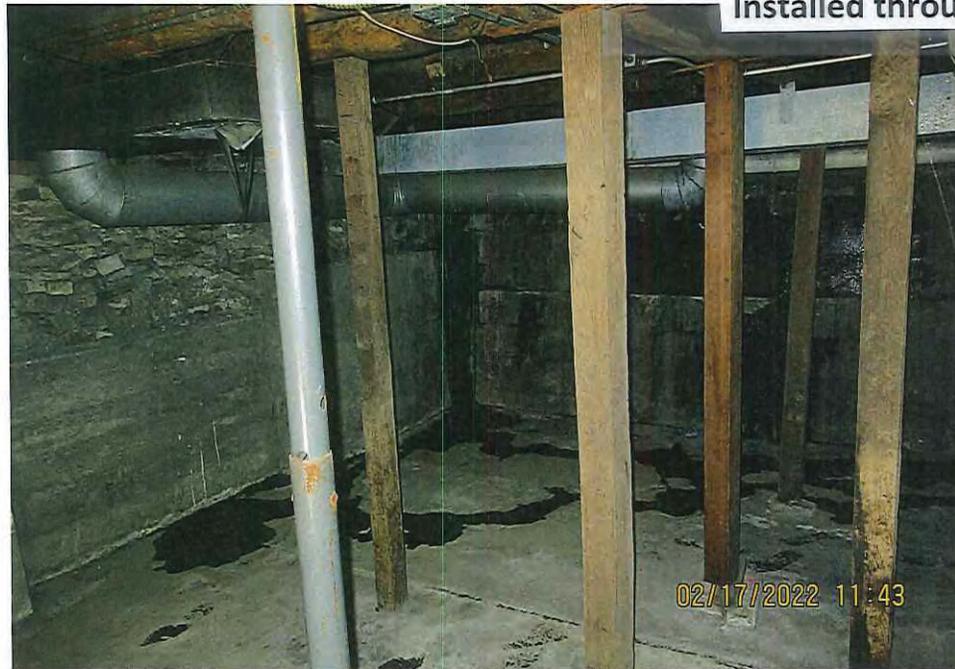
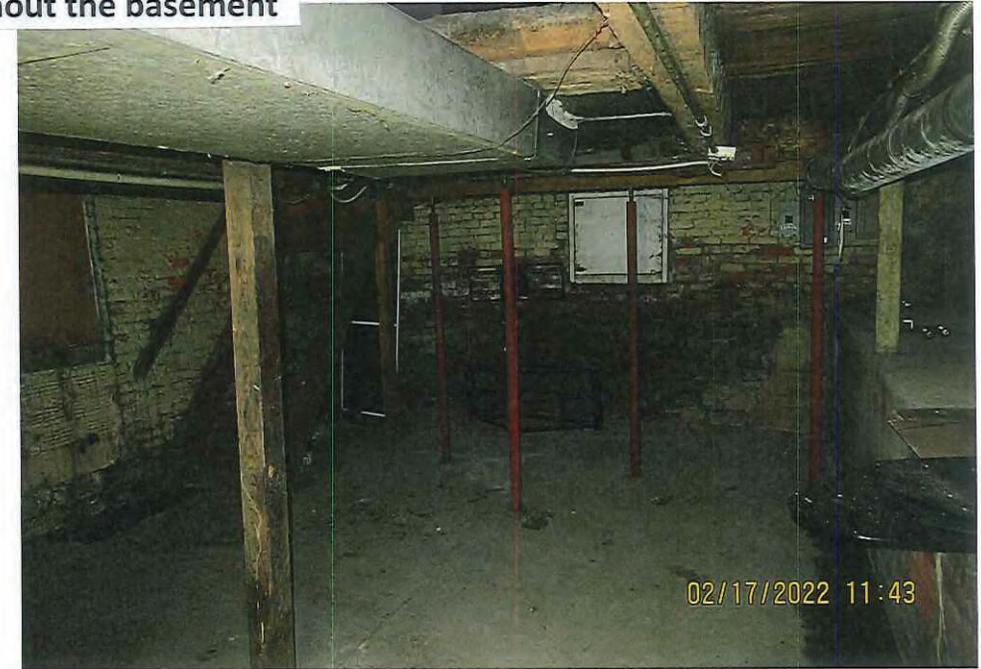
**Photo - #6 – 22 repair columns
Installed throughout the basement**

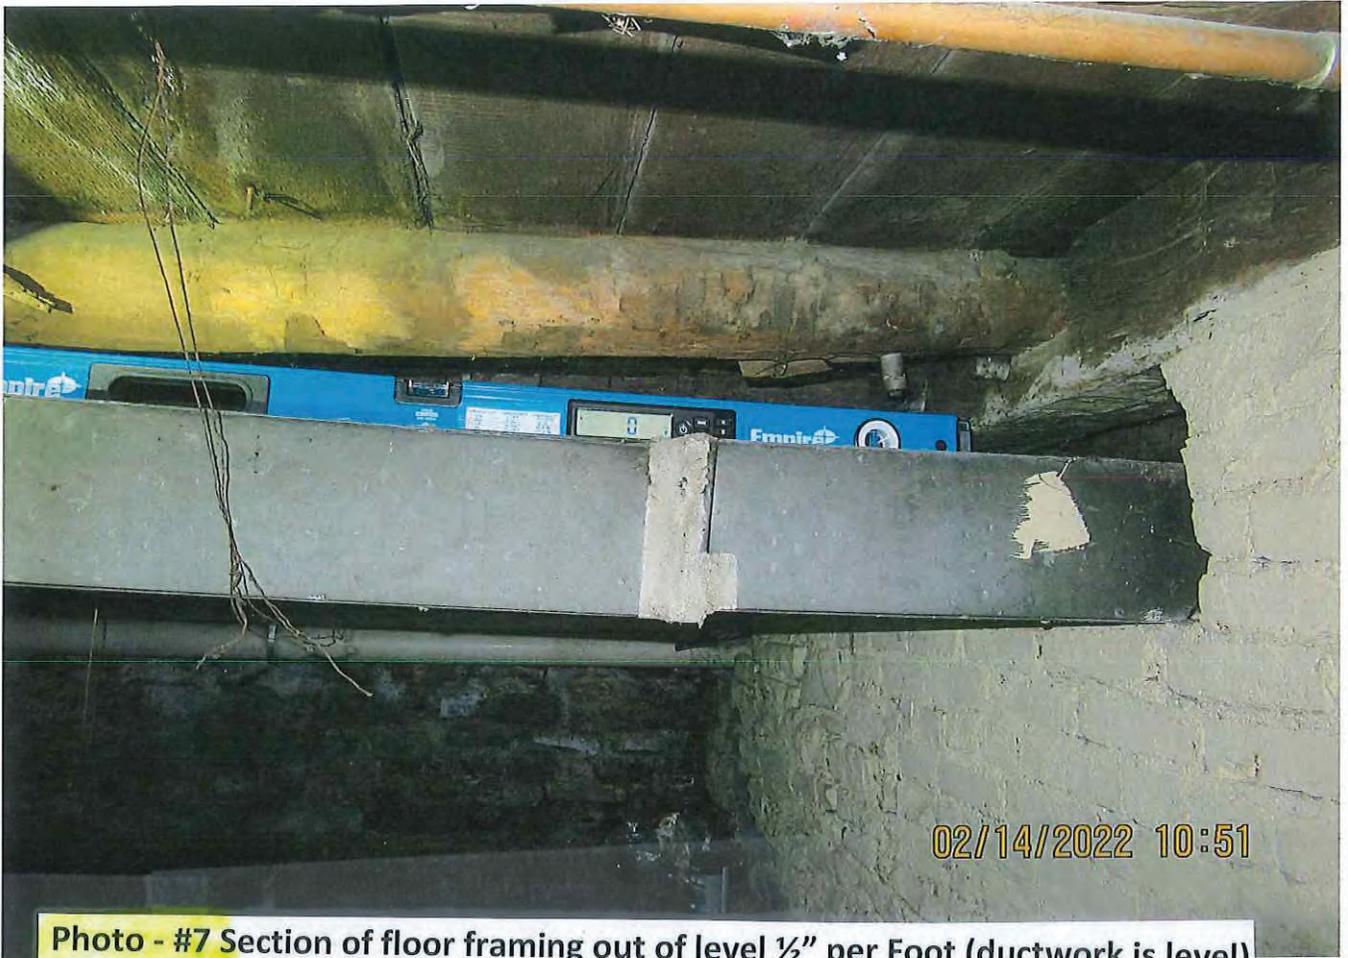
Photo - #7 Section of floor framing out of level $\frac{1}{2}$ " per Foot (ductwork is level)
This is a section between the brick wall and one of the main beams.
Located midway between the front and rear walls

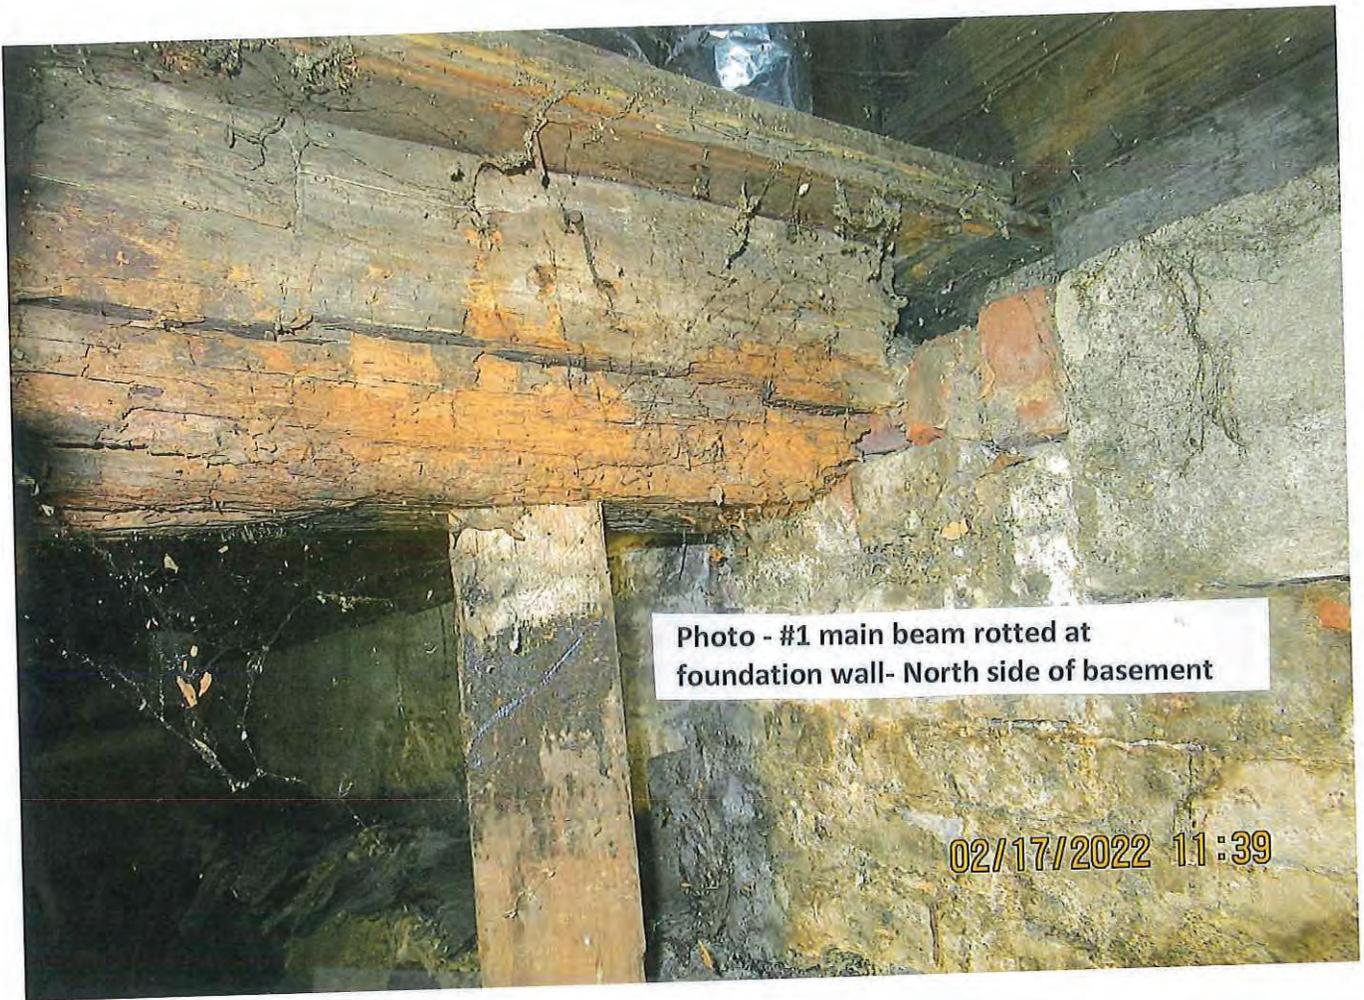
Photo - #1 main beam rotted at foundation wall- North side of basement

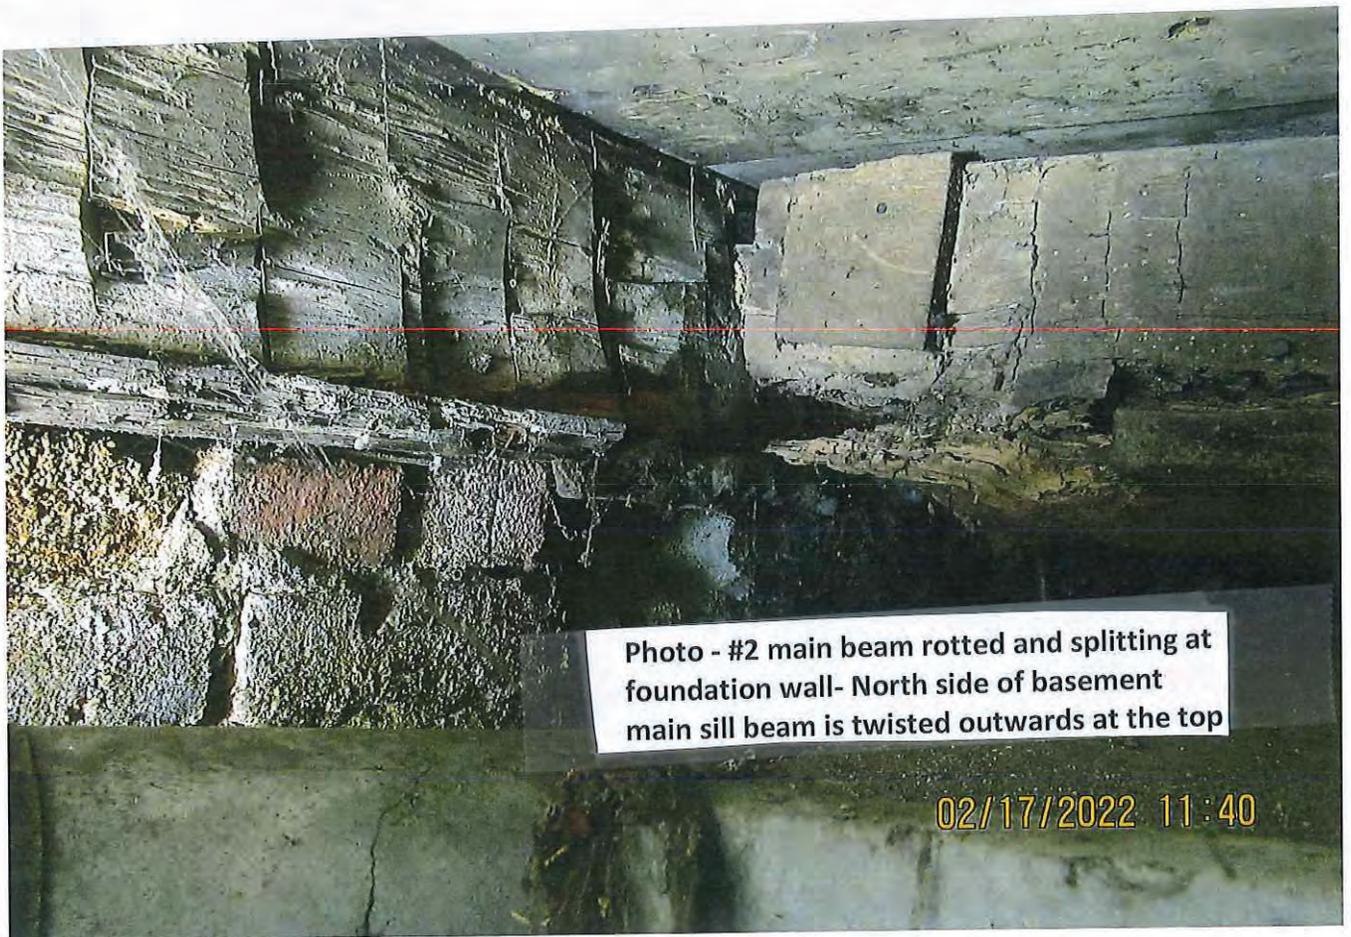
Photo - #2 main beam rotted and splitting at foundation wall- North side of basement main sill beam is twisted outwards at the top

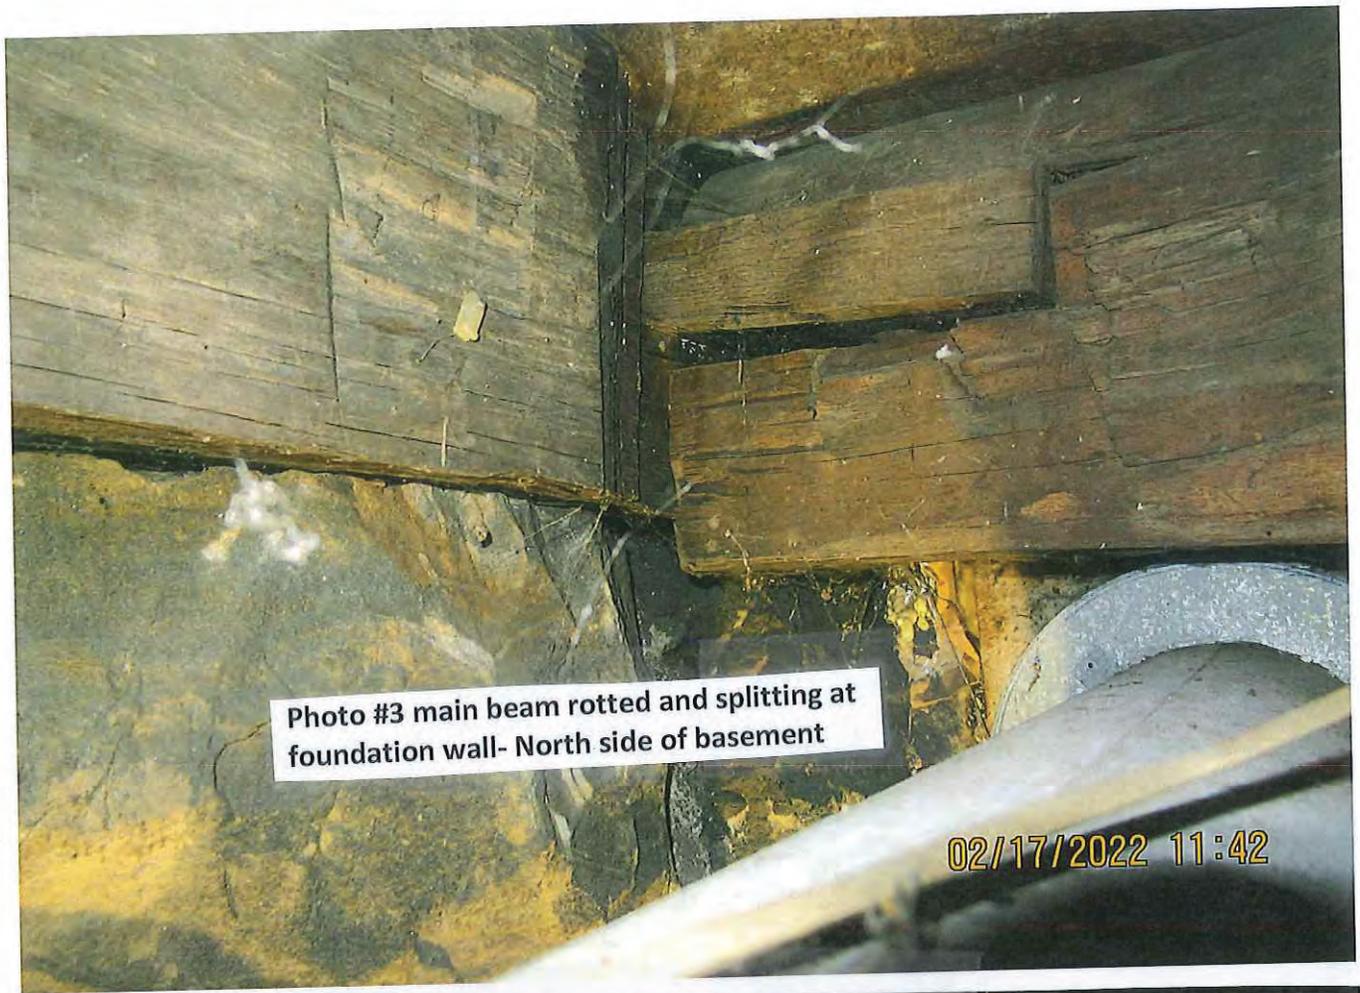
Photo #3 main beam rotted and splitting at foundation wall- North side of basement

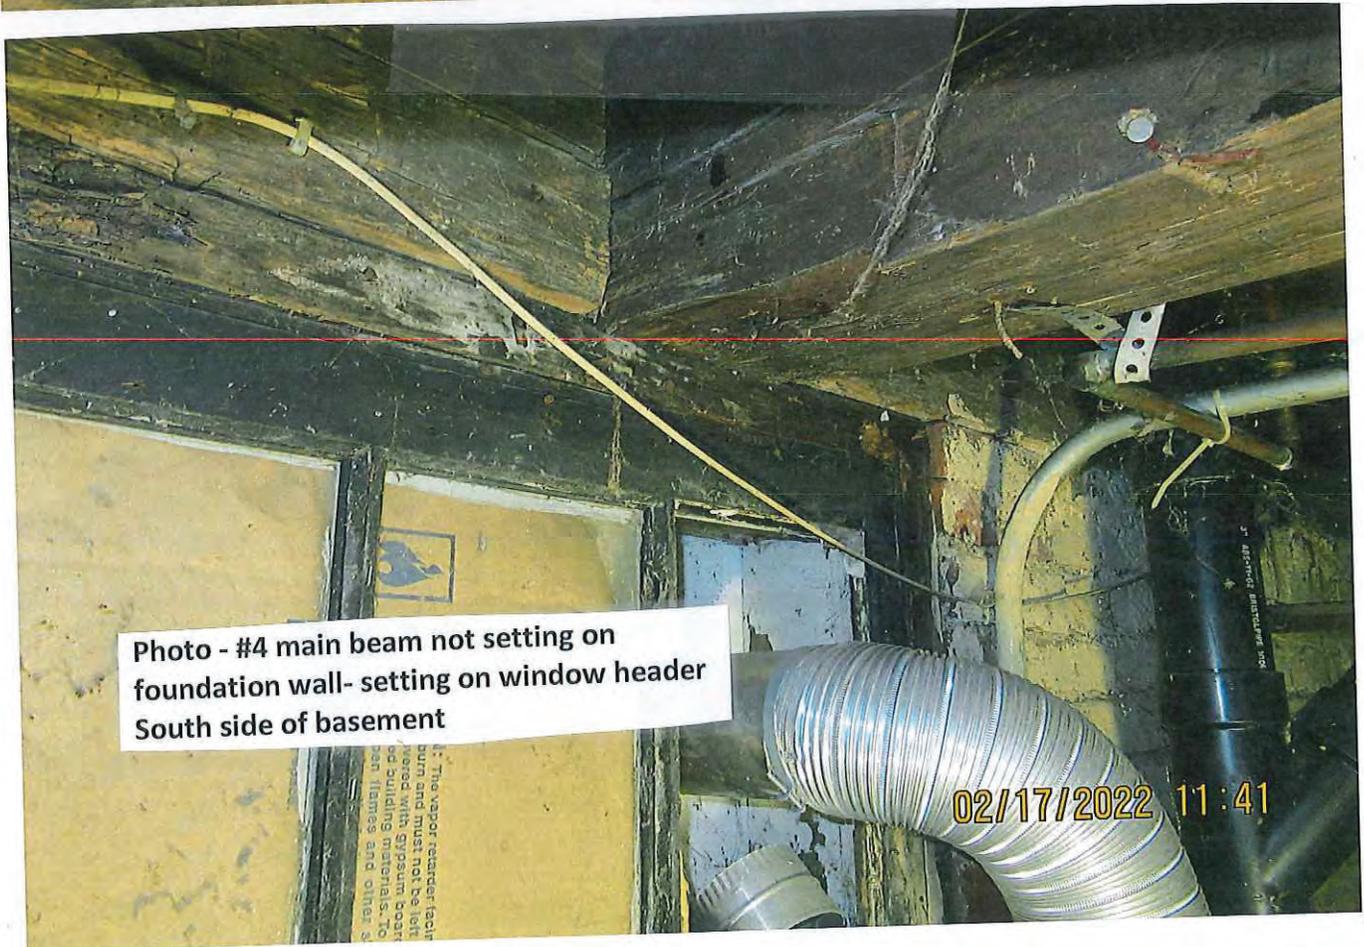
Photo - #4 main beam not setting on foundation wall- setting on window header South side of basement

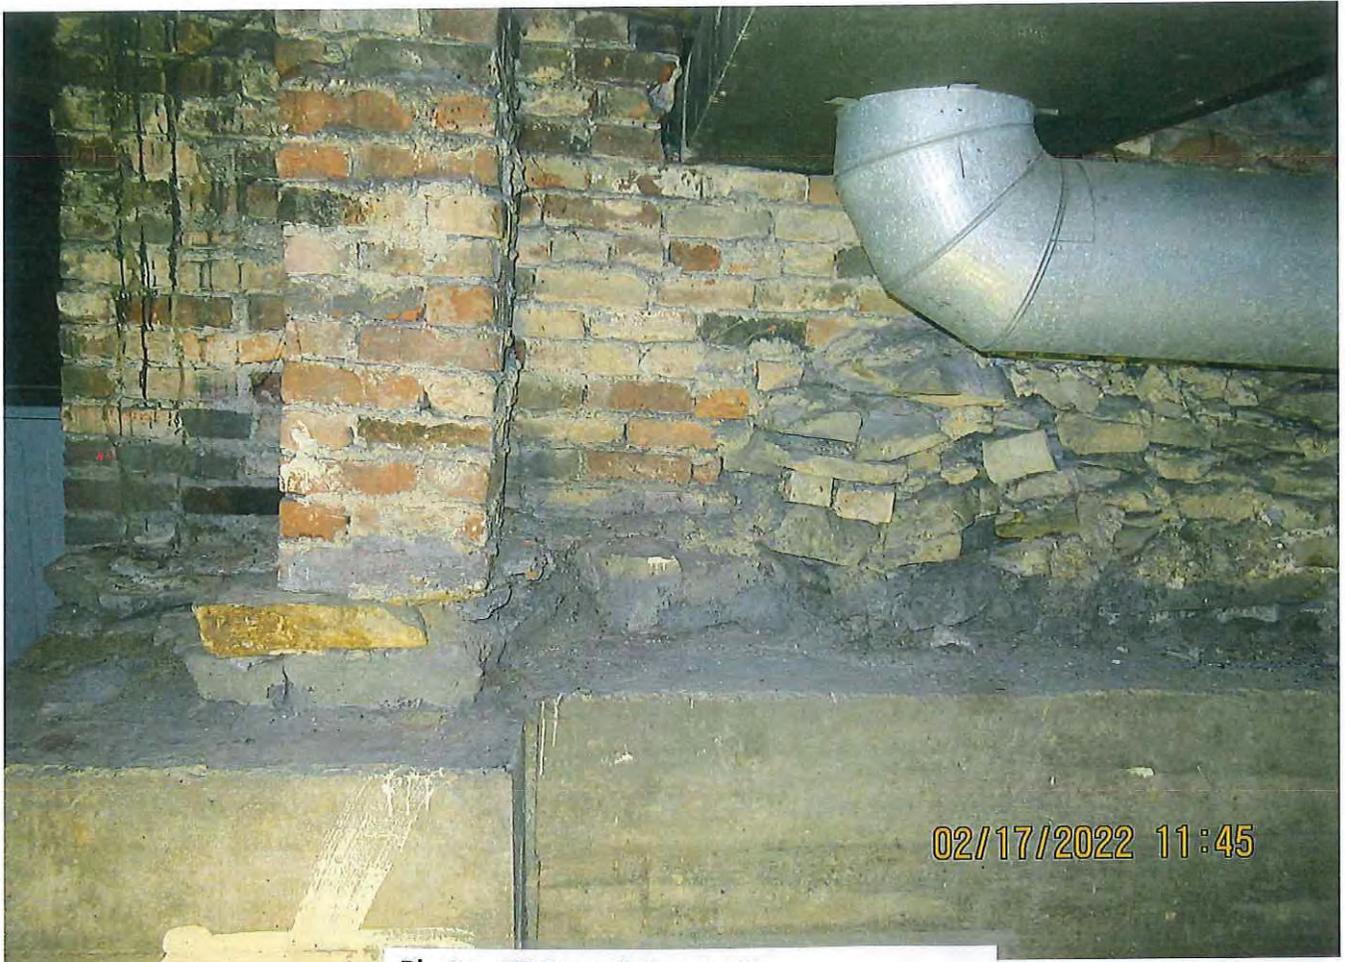
Photo - #5 Foundation walls
Constructed of concrete, stone and bricks

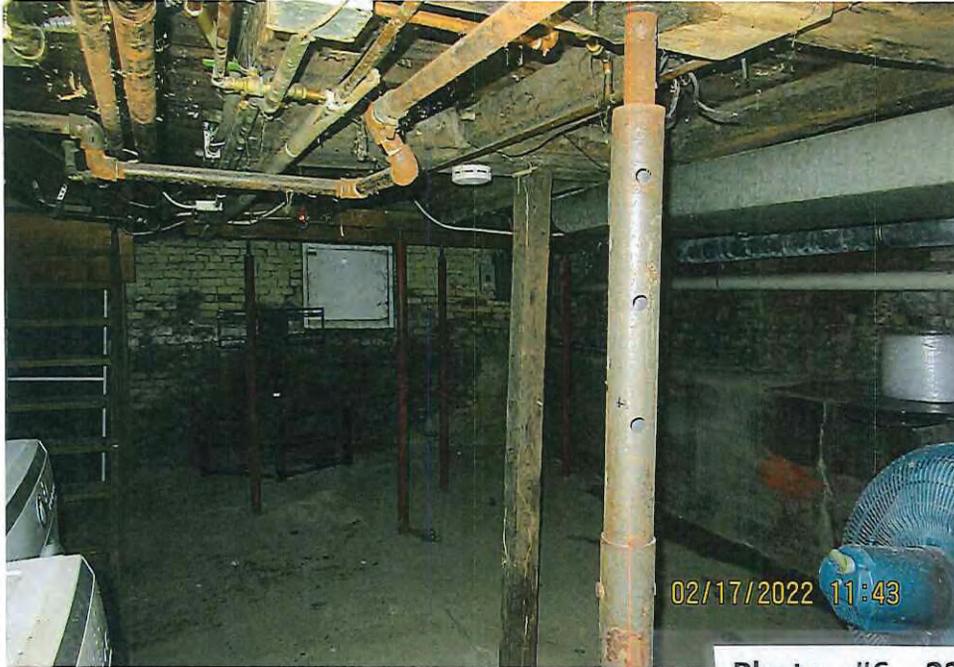
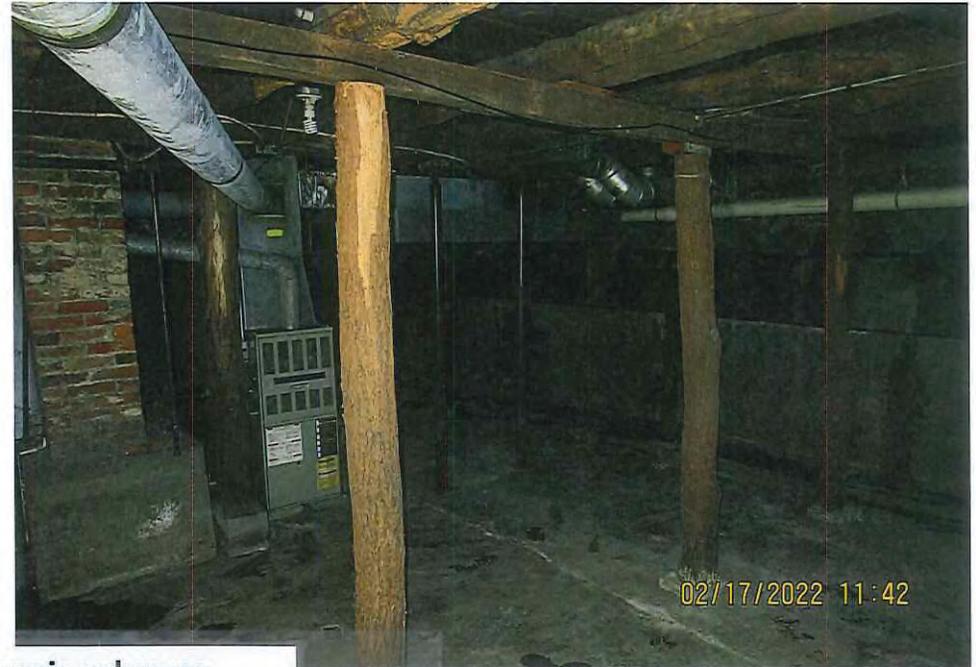
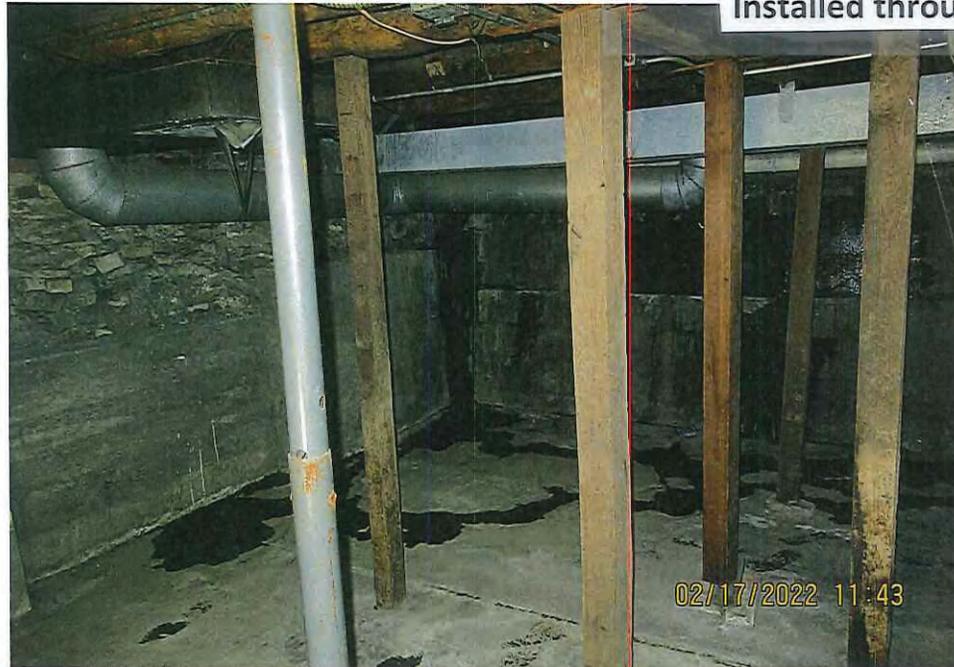
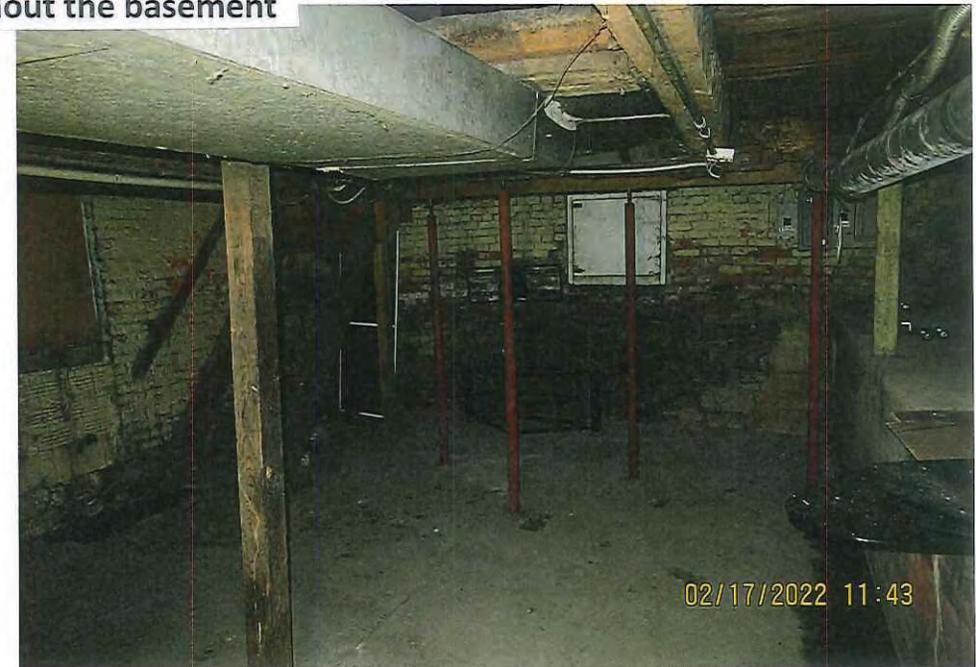
Photo - #6 – 22 repair columns
Installed throughout the basement
