**Z21-01
133 N. Court Street**

Case No: Z21-01

Subject: Appeal of November 12, 2021 Historic Preservation decision on case H20-06 (Request for demolition of 133 N. Court St.)

**Case No. H20-06
133 N. Court St.**

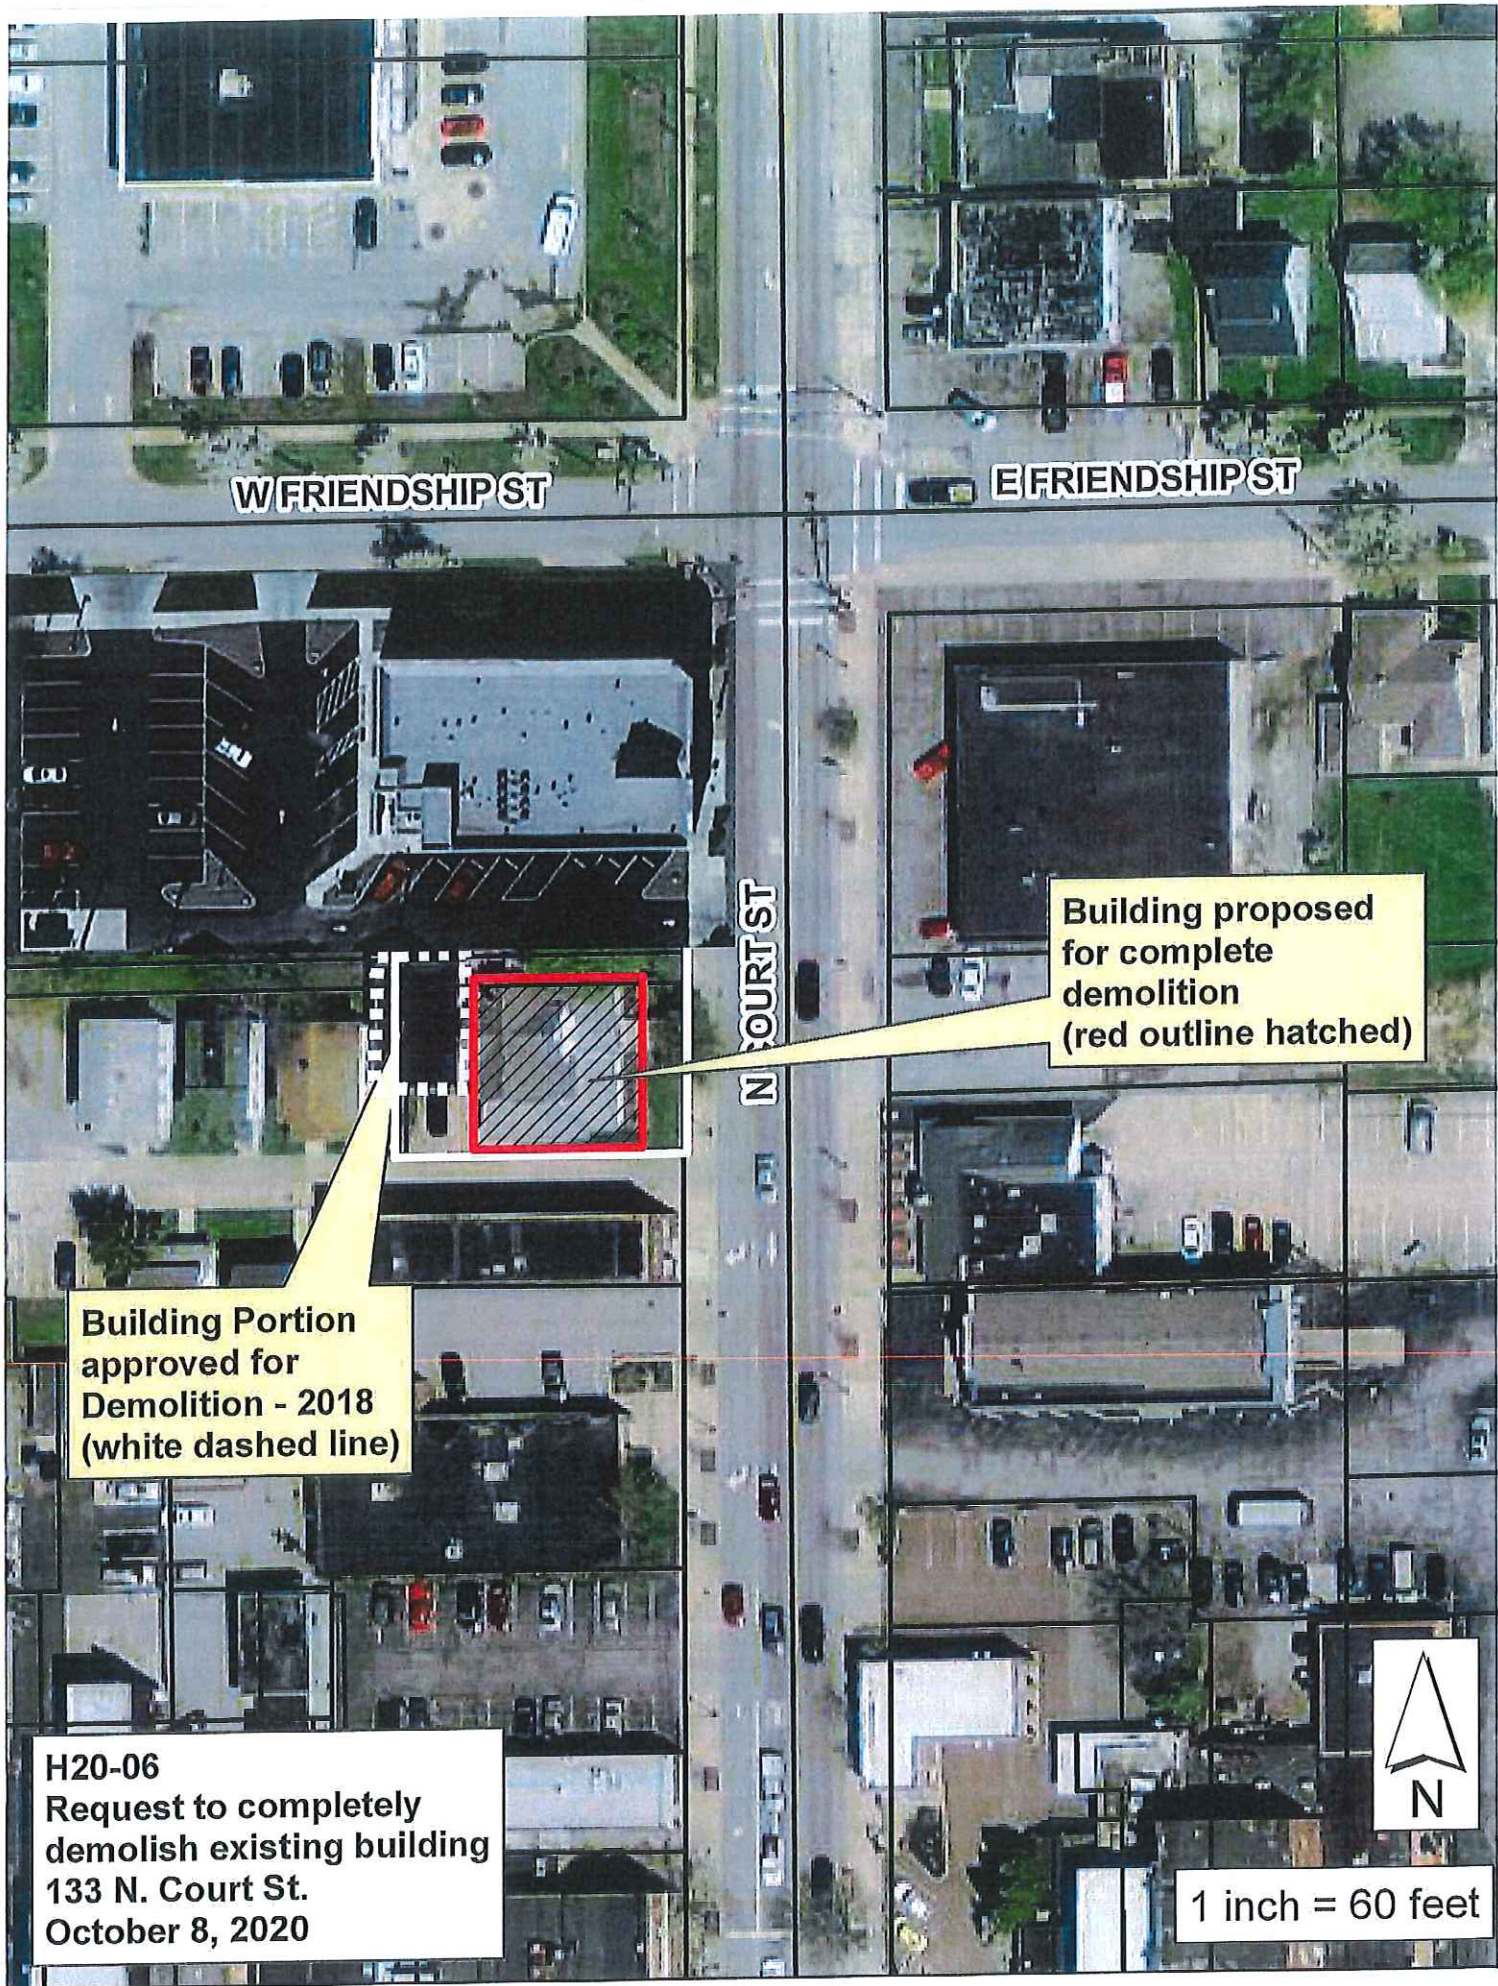
H20-06
Request to completely demolish existing building
133 N. Court St.
October 8, 2020

Building proposed for complete demolition (red outline hatched)

Building Portion approved for Demolition - 2018 (white dashed line)

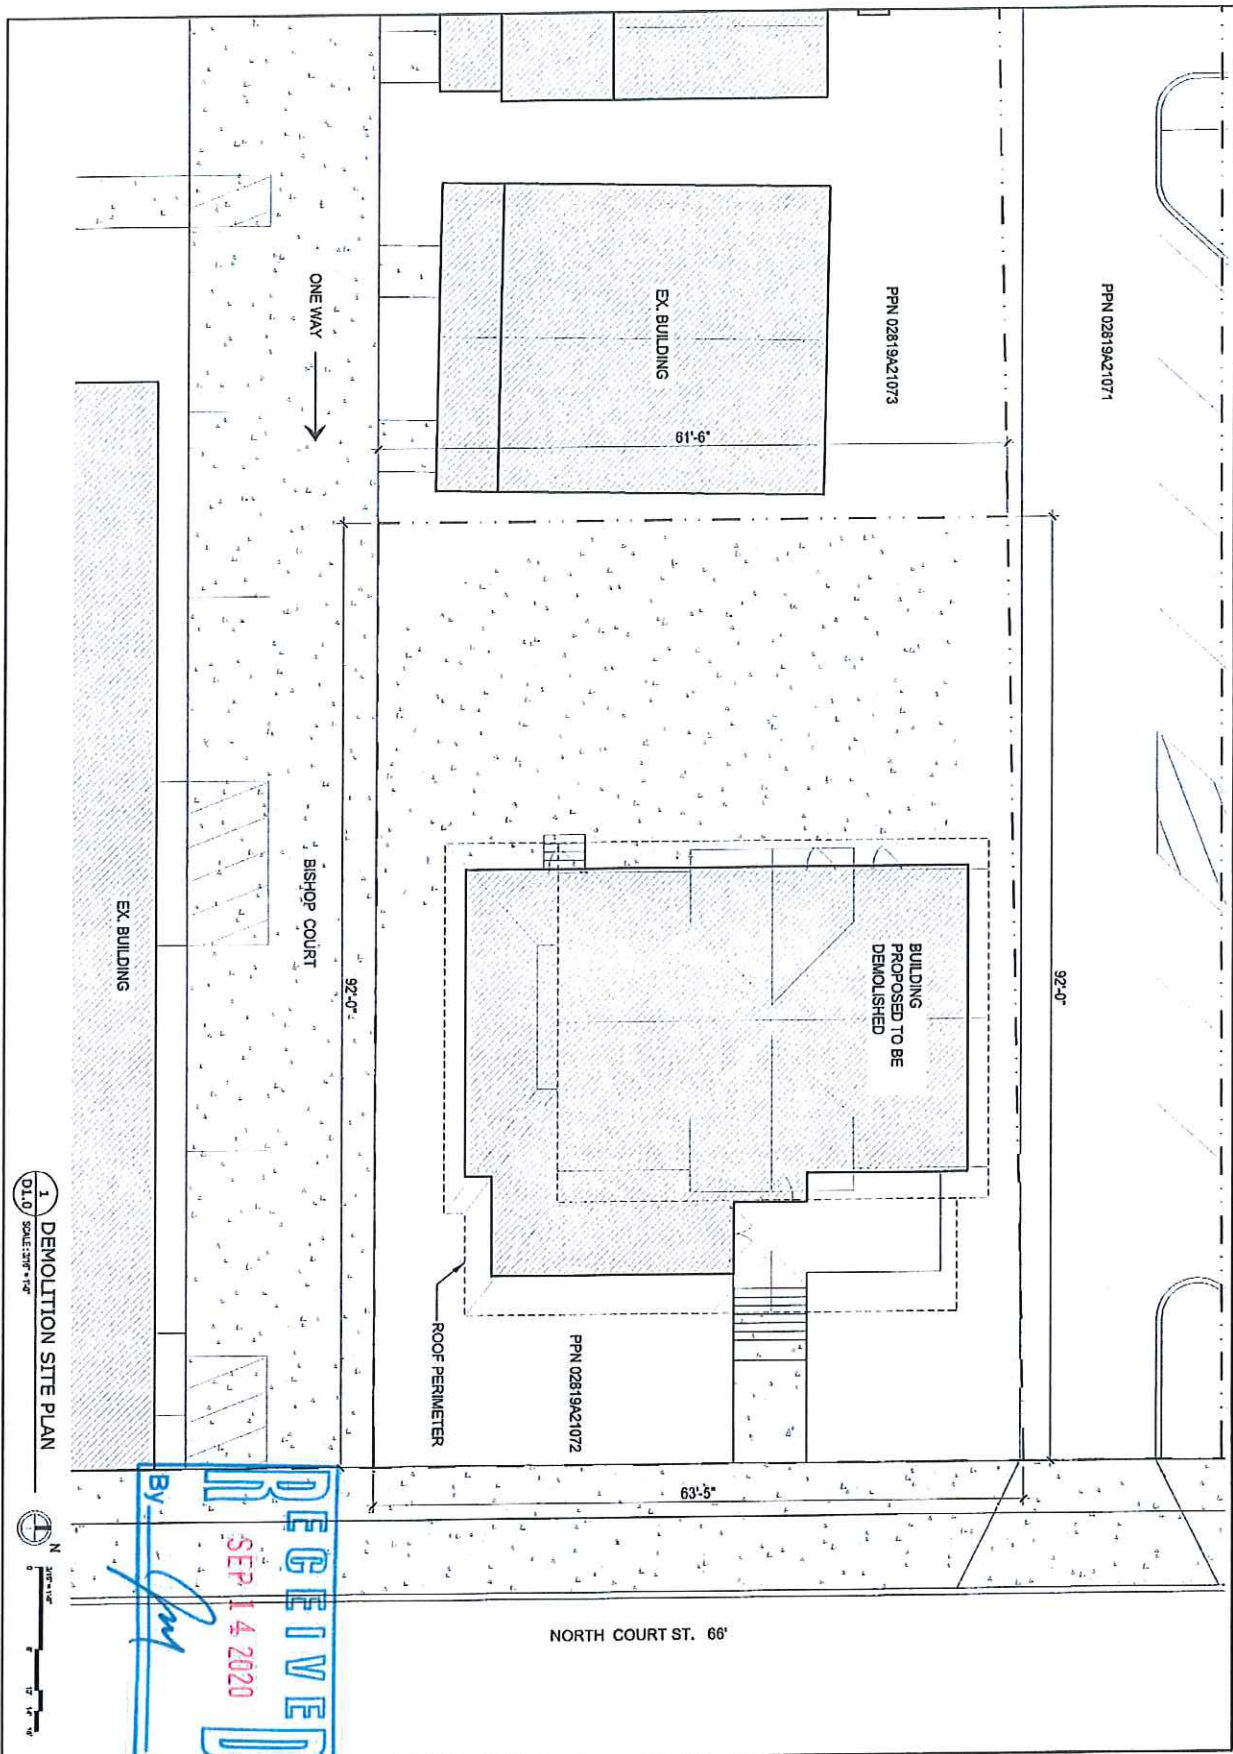
D1.0
1 OF 1

DEMOLITION SITE PLAN
PROJECT #: 21420 DATE: SEPTEMBER 4, 2020
FORMER FUNERAL HOME
133 NORTH COURT
MEDINA, OHIO 44256
