**DATE:** January 4, 2024  
**TO:** Historic Preservation Board  
**FROM:** Andrew Dutton, Community Development Director  
**SUBJECT:** Demolition Request – 129 North Broadway Street

129 North Broadway Street

### **I. Introduction**

### **III. Current Condition of the Building**

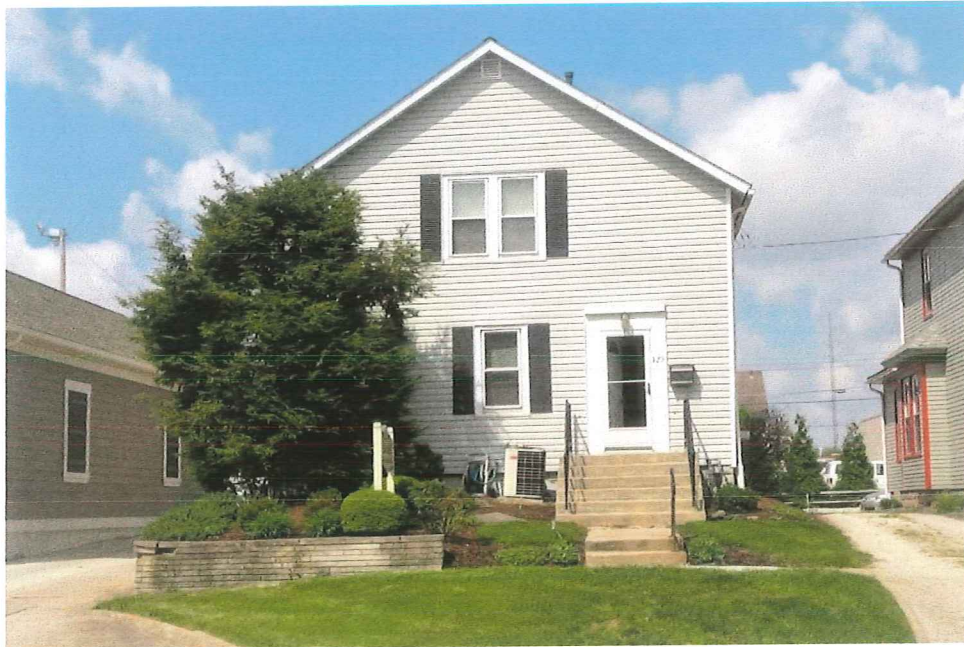
The home is clad in vinyl siding with a mixture of wooden and aluminum framed windows throughout. The framing of the home is a mixture of original hand-hewn log floor joists, rough sawn lumber, rough sawn and dimensional lumber roofing joists and rough sawn balloon framed walls. Below is a photo of the façade that has been in place since approximately 2005.

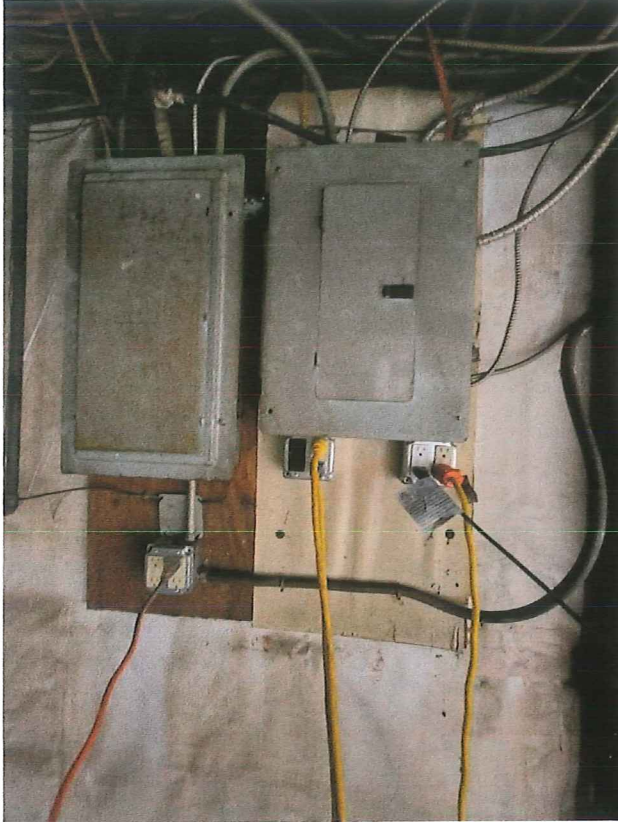
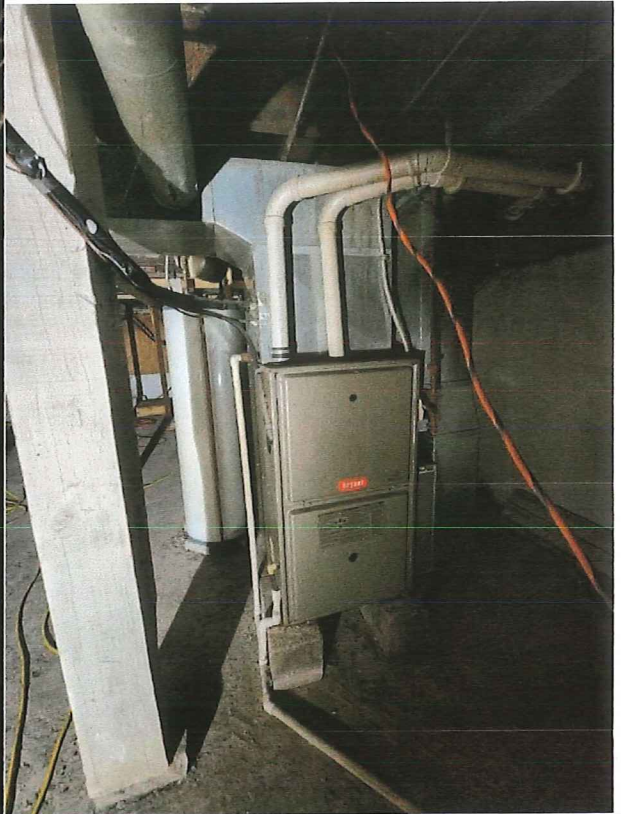
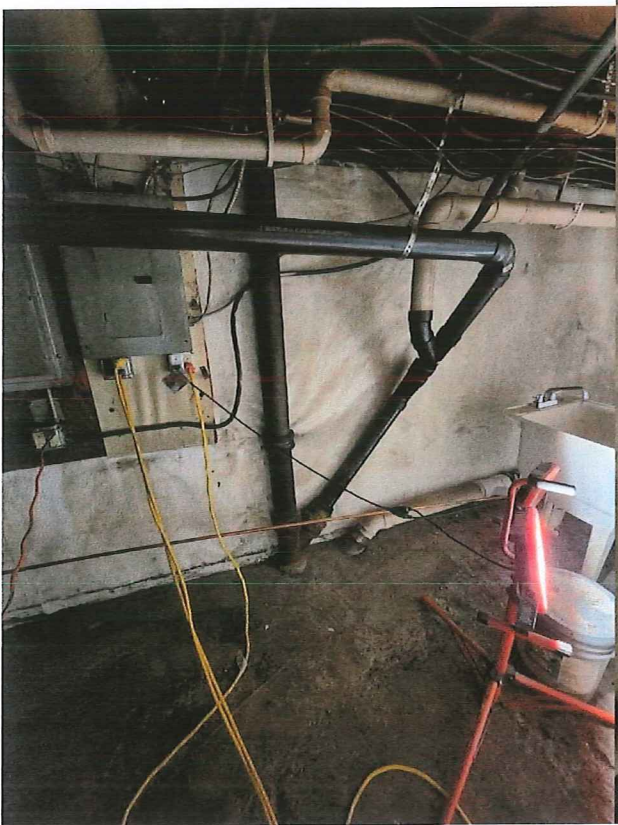
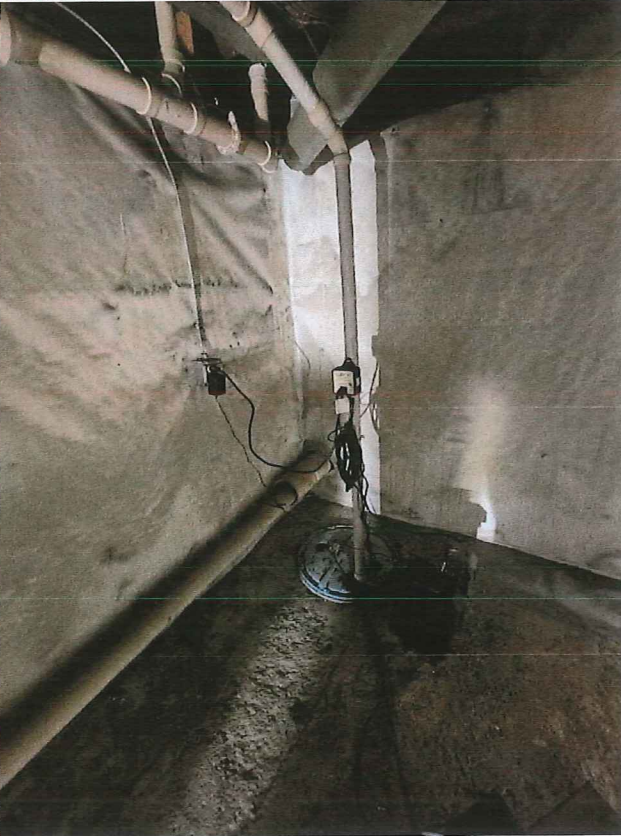
**Basement (Electric panel, Furnace)**

The HVAC system has been completely removed from the first and second floors. The remaining tin and furnace in the basement are intact but have significant smoke and fire damage. In current condition are unusable and must be removed and replaced.

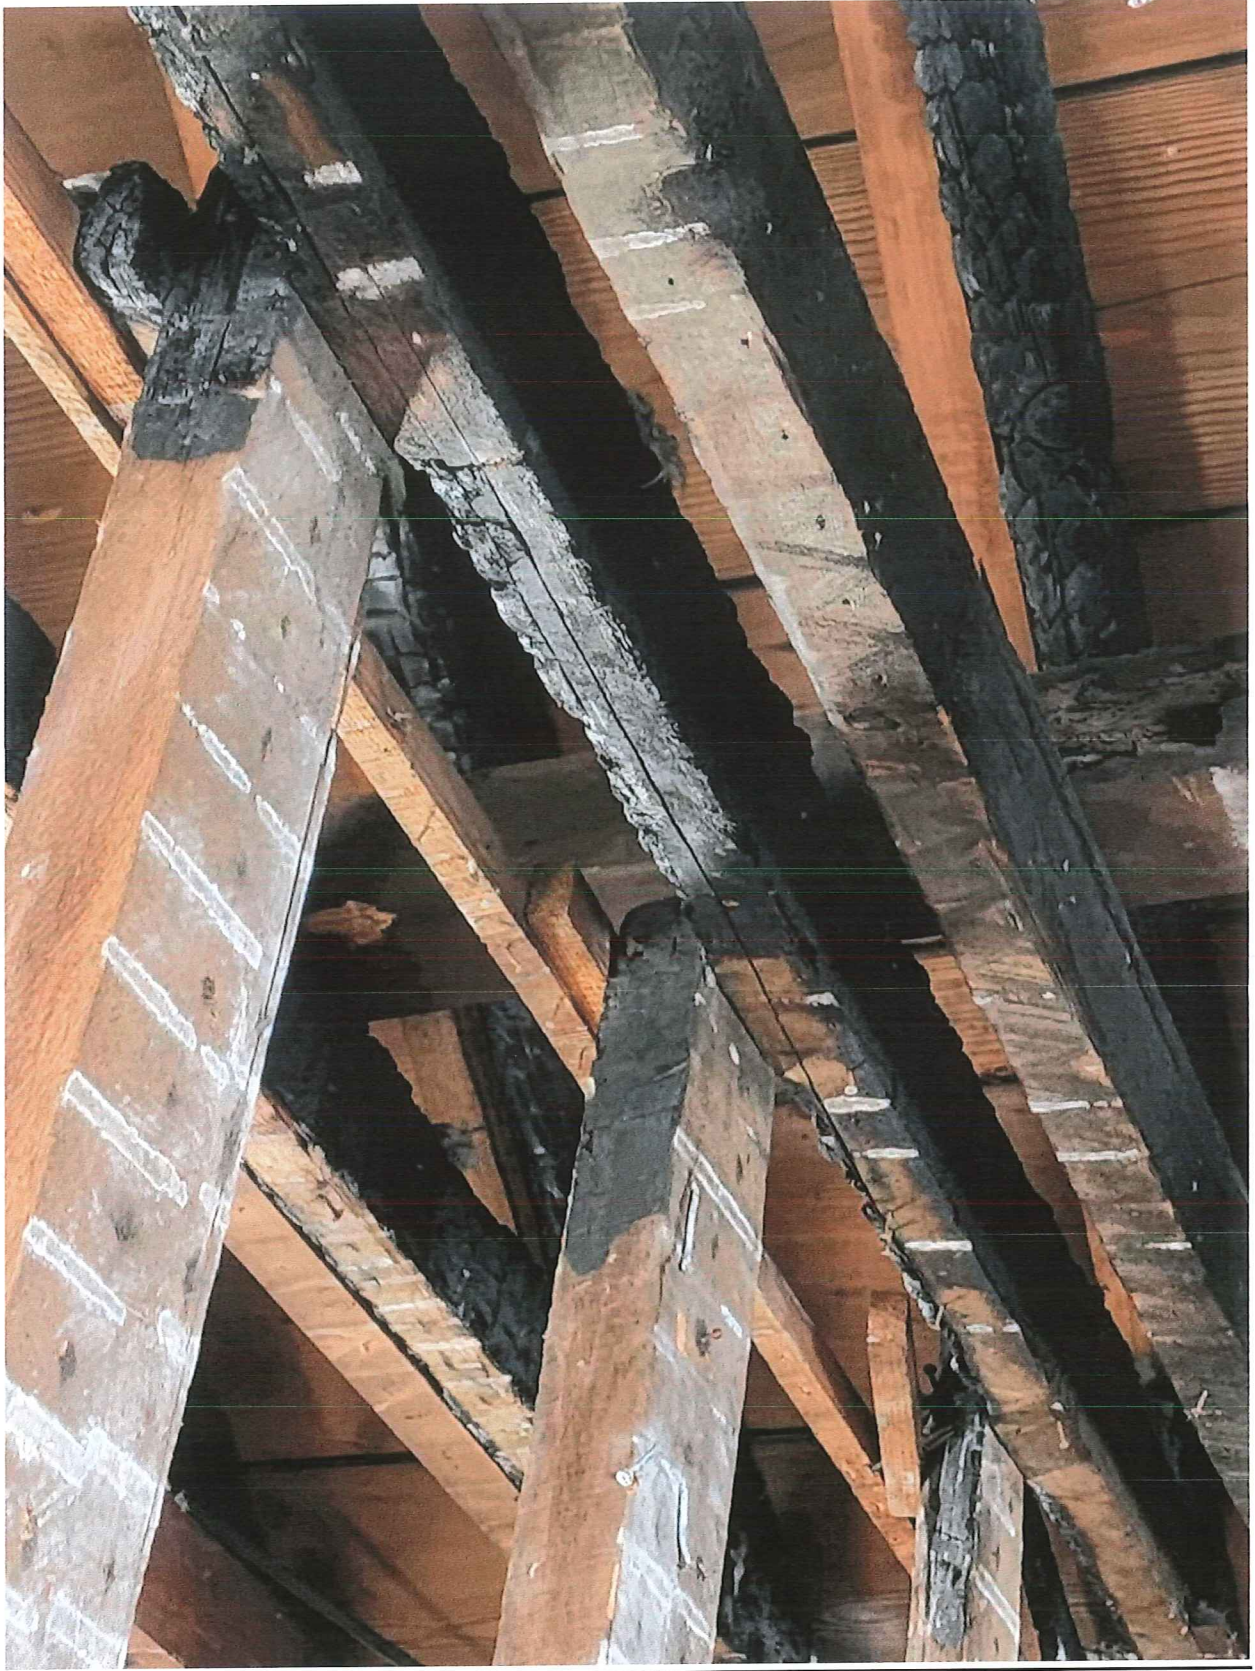
**Kitchen**

First Floor Framing – the center portion of the home between the dining room and kitchen is where the fire was prominent. The floor framing in that area is mostly gone due to the fire. Temporary bracing has been installed but would need to be replaced with conventional lumber. There is a significant amount of ‘shoring’ that has been installed as temporary bracing and would also need to be further installed to reduce the span of structural timbers, due to a spacing that exceeds the standard for adequate support.
