HISTORIC PRESERVATION BOARD

Case No. H22-045

Building Demolition at 277 South Court Street

March 2, 2022

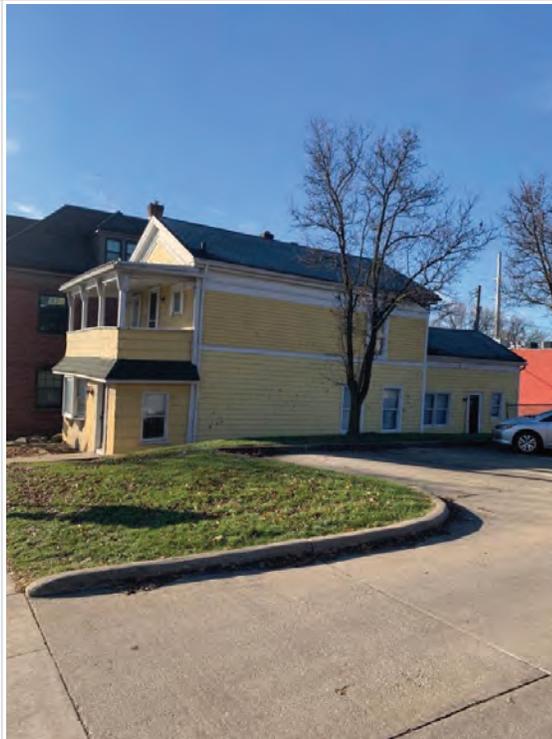
Item 1: North elevation of the home. The front porch has settled. You can see the railing and window line are sloping down to the left.

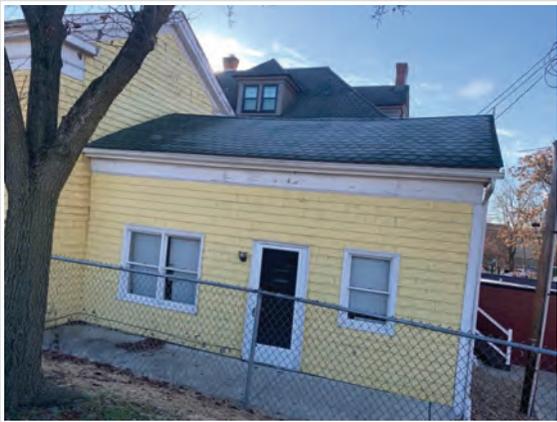
Item 2:	Deflecting roof ridge on the back of the house.
Single Photo

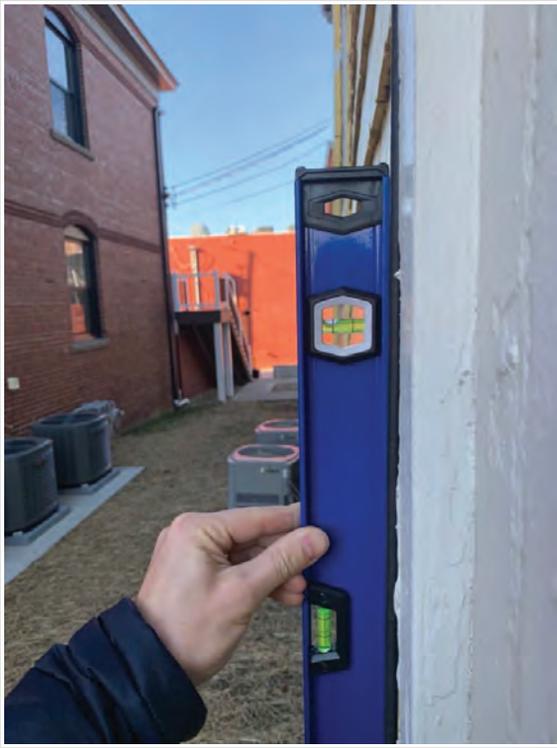
Item 3:	The south wall of the house is out of plumb 5/8" over 2'.

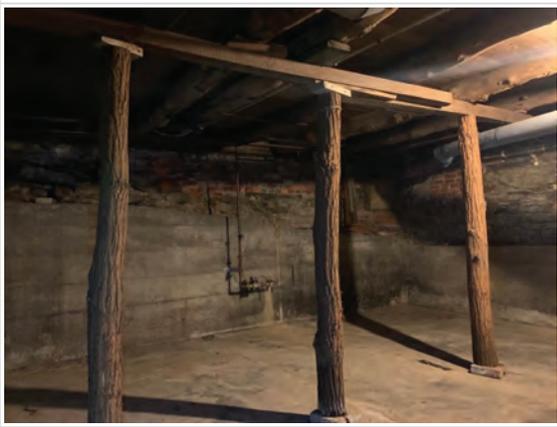
<p>Item 5:</p>	<p>Timber posts temporarily supporting timber joists. These are sitting on bricks, which is not adequate.</p>

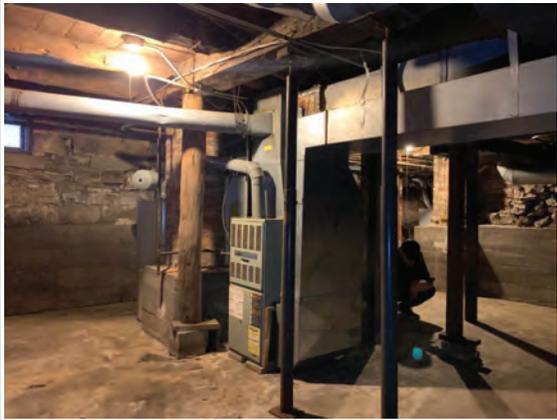
Item 6:	More support posts were installed to try and shore up a settling structure.
Single Photo

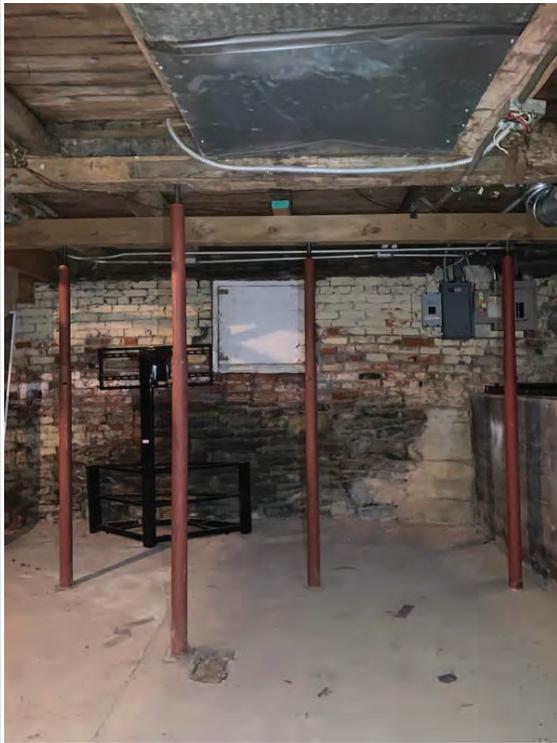
<p>Item 16:</p>	<p>Temporary support posts.</p>
<p>Single Photo</p>

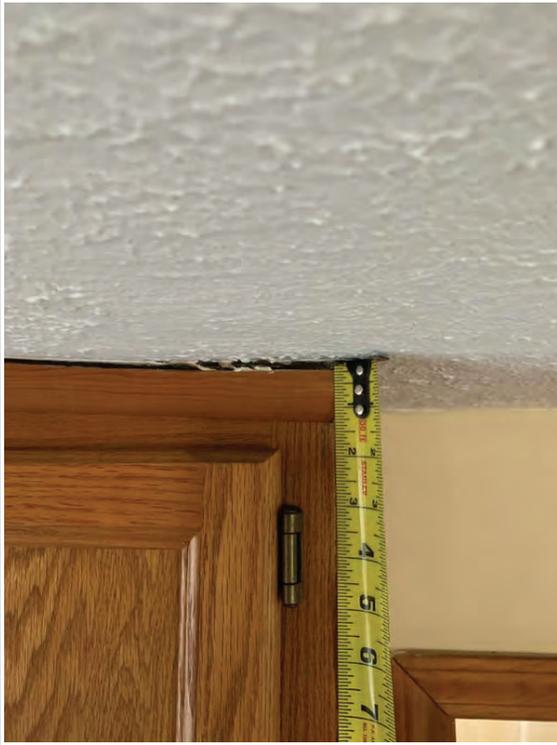
<p>Item 17:</p>	<p>The kitchen cabinets are not flush with the ceiling due to racking of the building.</p>

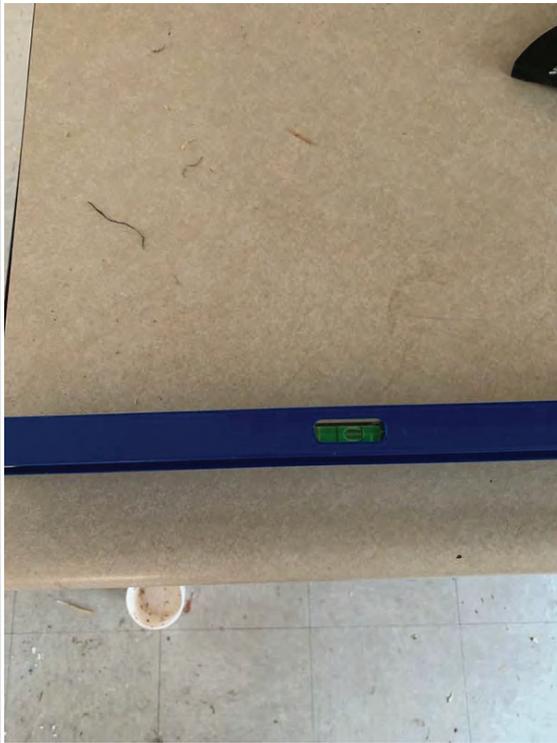
<p>Item 18:</p>	<p>Kitchen counter slopes down to the north.</p>
<p>Single Photo</p>

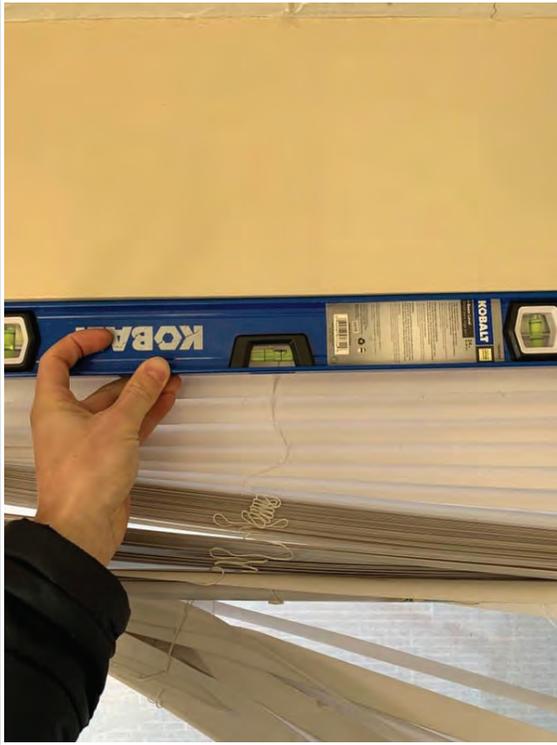
<p>Item 19:</p>	<p>SE window header out of level 3/4" over 2'.</p>

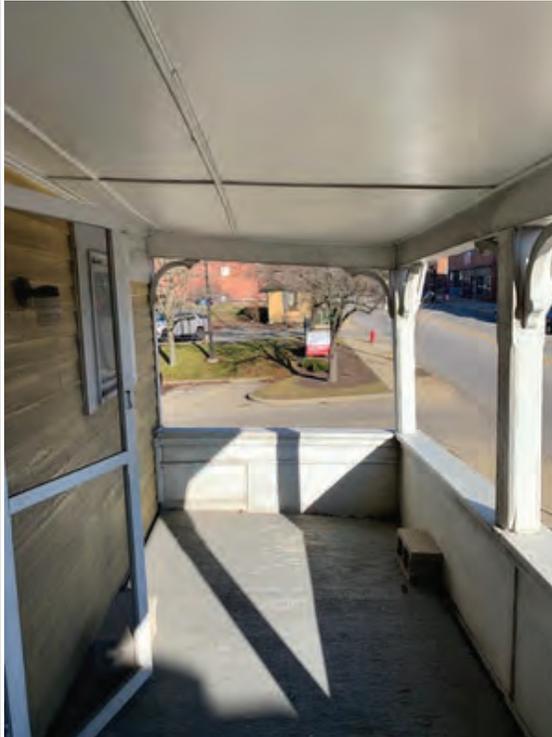
Item 21:

Significant settlement of the front porch.

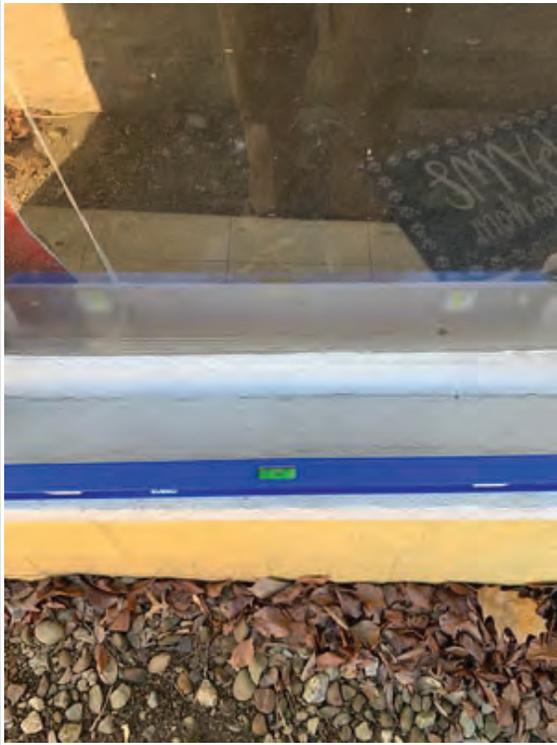
A close-up photograph of a window sill. A blue spirit level is placed horizontally across the sill. The sill is painted white and sits on a yellow-painted concrete base. Below the concrete is a layer of brown mulch. The background shows a dark, textured surface, possibly a wall or ceiling.
<p>Item 24:</p>	<p>NW window sloping down to the east.</p>
<p>Single Photo</p>

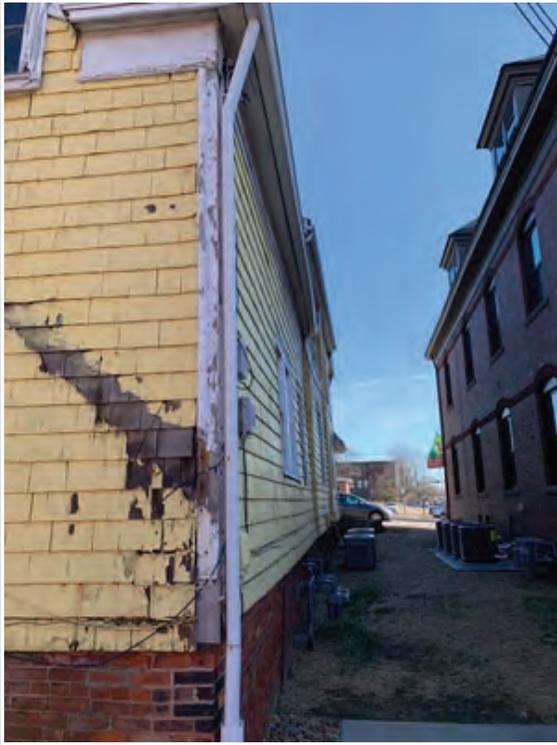
An exterior photograph of a yellow building with a brick base. The building has a white downspout and a window with a white frame. The yellow siding is peeling and damaged in several places. In the background, there is a dark brick building and a clear blue sky.
<p>Item 25:</p>	<p>SW side of the building is 1.5" out of plumb over 2'.</p>

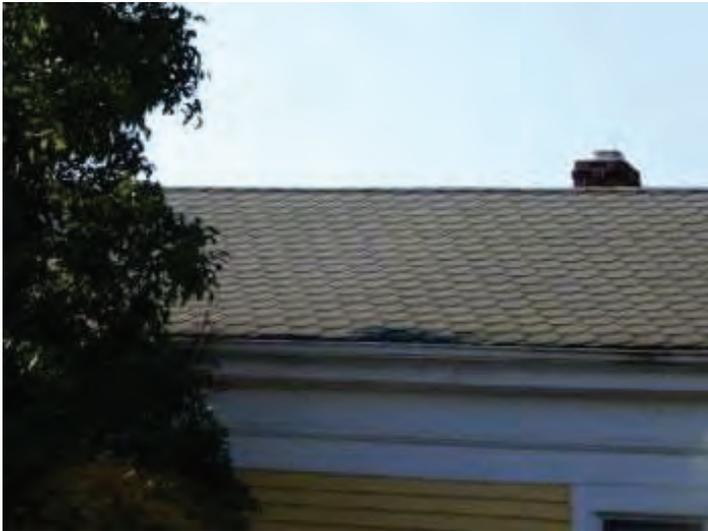
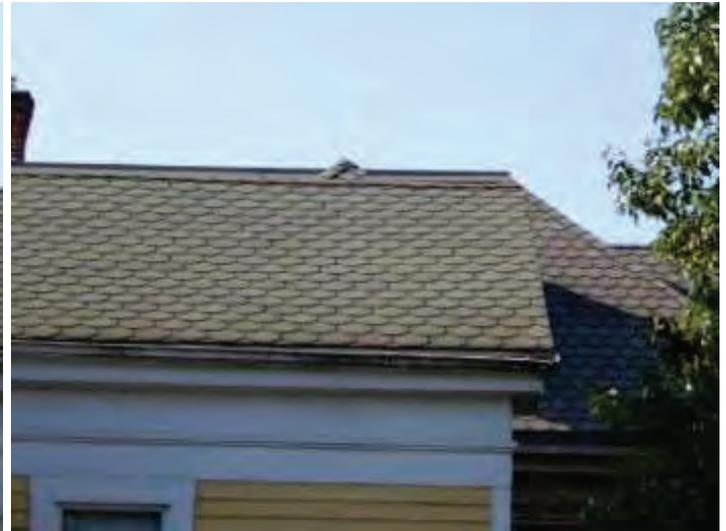
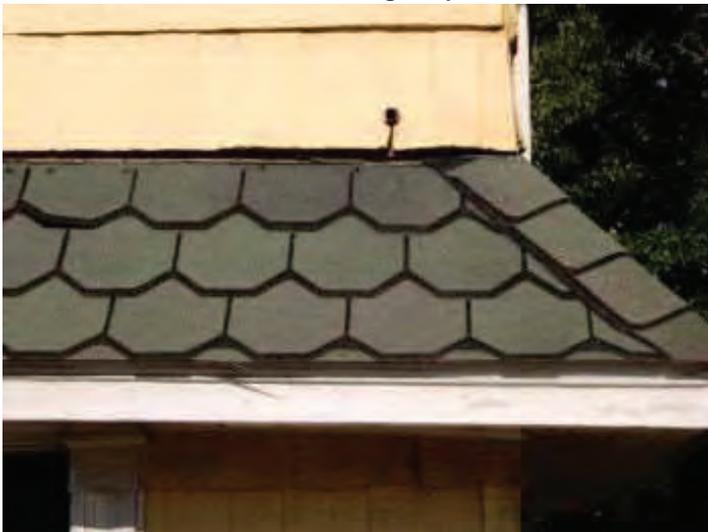
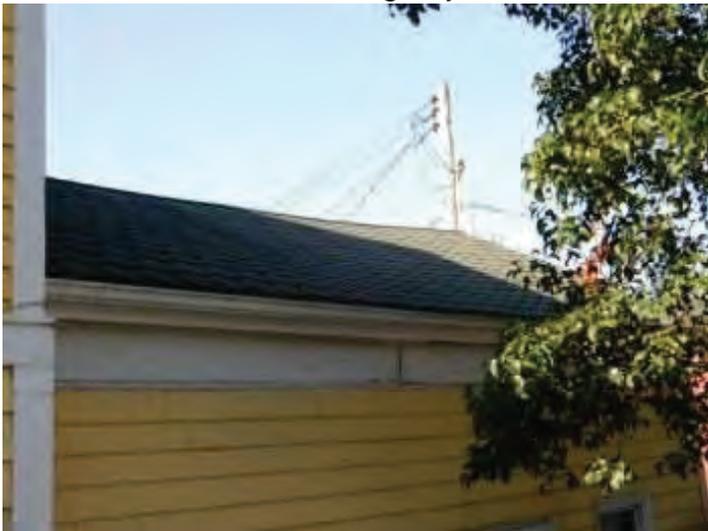
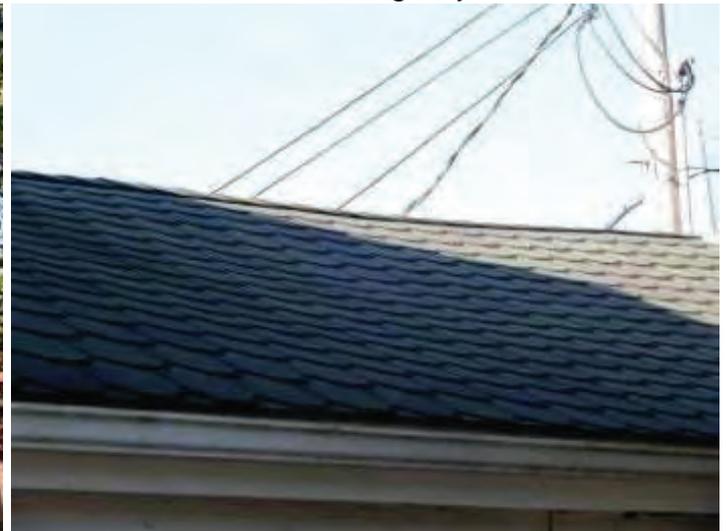
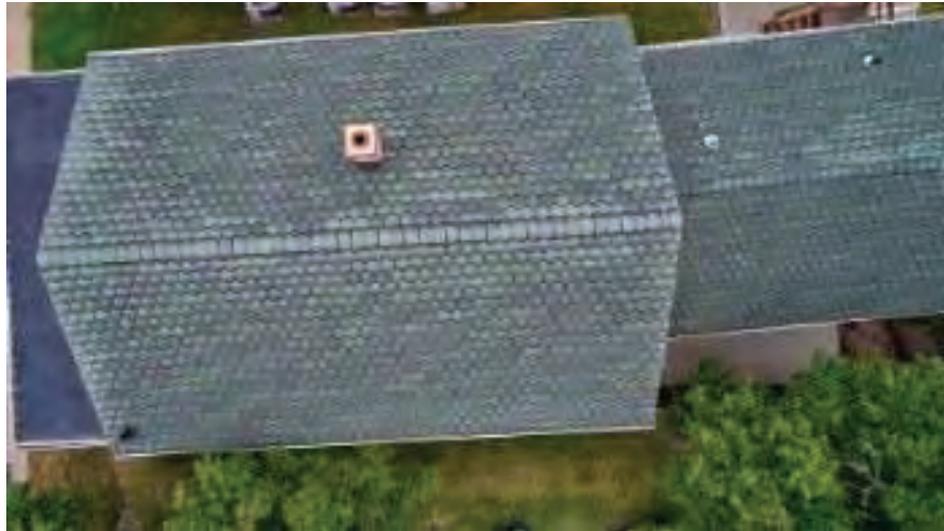
Roof & Roof Drainage System Roof

Observations: Roof system for Bldg at 277 S. Court, ROOF TYPE & LOCATION:, Flat membrane roof system noted over front porch (2nd floor), A pitched roof system was noted for the majority of the roof system, and was noted as; Certainteed Carriage House Luxury shingle, ROOF CONDITION:, Pitched roof system was noted as being newer and in good condition for age and wear at time of inspection, Front 2nd floor porch membrane roof appears to be in good condition for age and wear., ROOF VENTING:, Poor venting or lack of incoming or exhaust venting of roof system, and lead to premature failure of a roof system., Roof system was noted with a newer type perimeter roof system venting which allows for shingles to be installed over the system. This type of venting system takes the place of soffit venting. This system handles incoming air flow for roof system., Roof system was noted with no exhaust venting system in place. We recommend installing an exhaust roof venting system for proper breathing of roof and attic areas. We recommend installing a roof exhaust ventilation system for roof., It should be noted that the bathroom exhaust fan presently exhausts in the attic space (see attic section for details), VENT STACKS:, Roof system appears to have inadequate number of vent stacks for plumbing system. We recommend checking drains for proper drainage and making necessary venting corrections, which may include air admittance valves installed where needed if locally approved., A plumbing stack vent boot was noted installed over an older rusted vent plate, which could fail allowing for a roof leak and rust stains on roof surface. We recommend replacing and properly flashing., Vent stacks were noted missing vent caps, and we recommend installing., ROOF FRAMING:, Roof system was noted as a stick built rafter system. Rafter spacing appears beyond recommended spacing for rafter span., Roof framing was noted absent a ridge board, which helps maintain the roof ridge in place and to help prevent rafter spreading., The back structure was noted with a sway back roof, with ridge dipping down in the center, this may be partially caused by lack of ridge board support., We recommend considering augmenting the present roof framing by sistering on additional rafters, and installing collar ties., FLASHING:, Roof flashing was noted failing at multiple areas of the roof system interface points, which includes; roof/siding interface, roof fascia interface, etc. We recommend repairing all roof flashing, along with areas of exterior deteriorated wood from flashing failure., **We recommend repairing any defective roof flashing issues, which should include flat roof and pitched roof systems, and any interior damage caused by the flashing failures as well.**

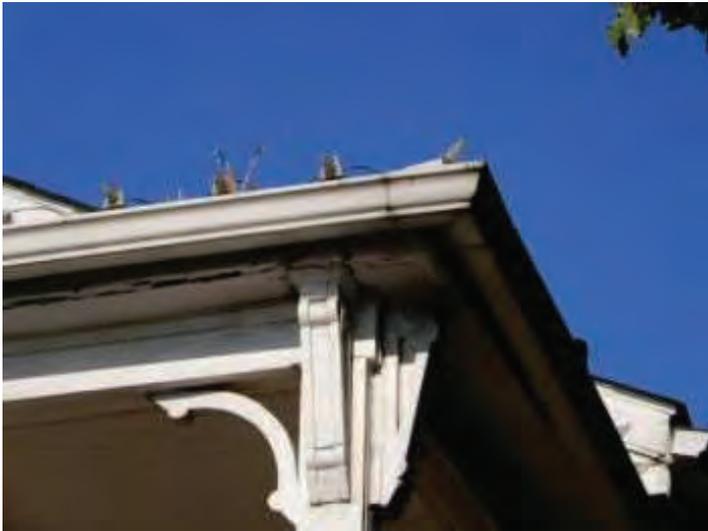
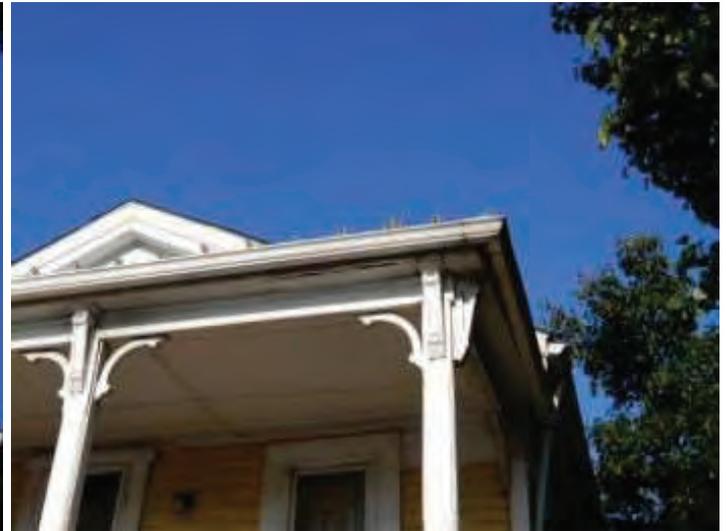
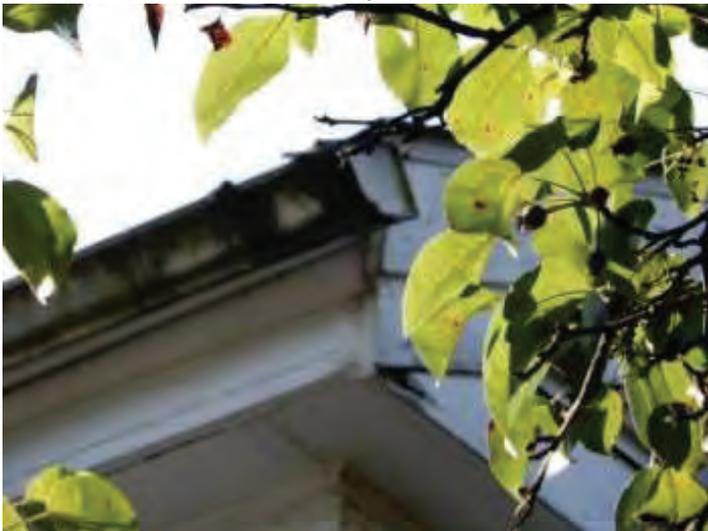
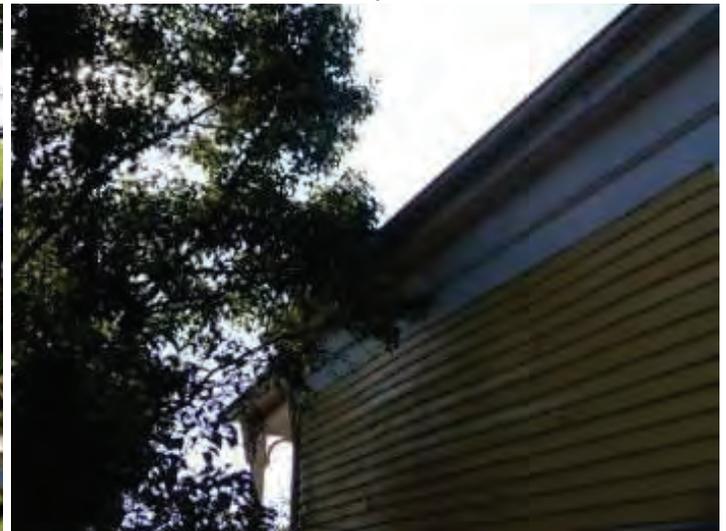
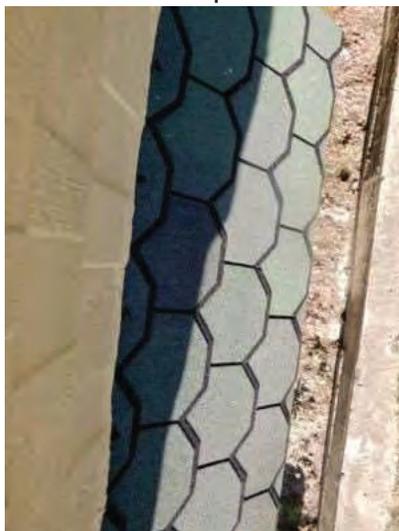
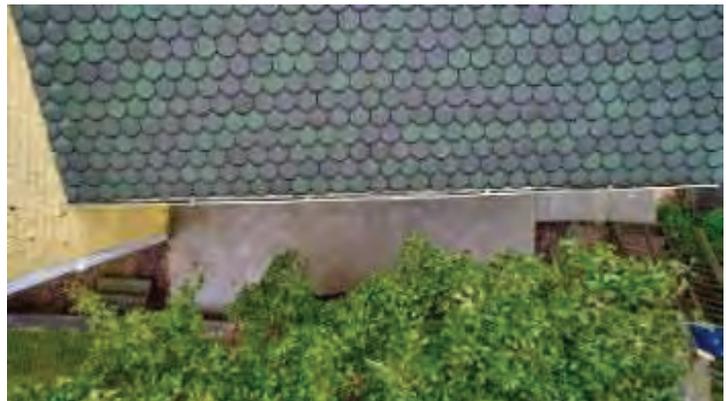
Roof & Roof Drainage System Gutters and Downspouts

- GUTTER DRAIN SYSTEM:
 - Gutter Drain system showed signs of being plugged up at time of inspection.
- GUTTER ALIGNMENT:
 - Gutters were noted not properly aligned with roof system in many areas. Gutters do not have proper support behind them and are installed at an angle and not properly collecting water. We recommend installing braces behind the gutter for proper support and placing them at the correct angle for good roof drainage collection.

- We recommend repairing the gutter downspouts and gutter drain system for bldg 277 S. Court.

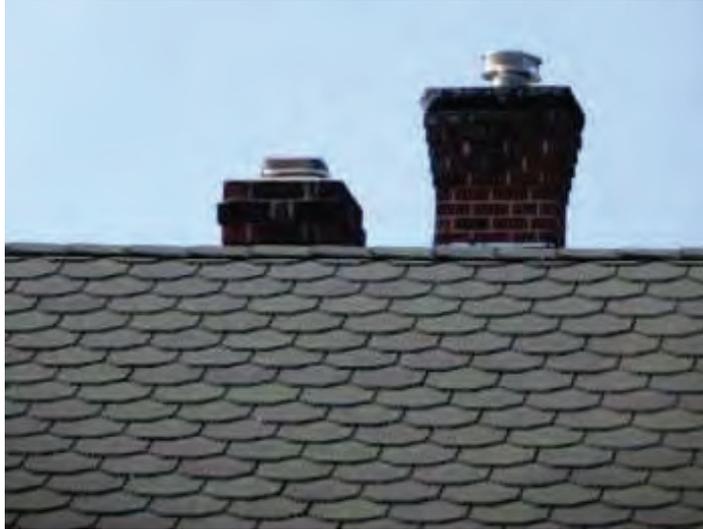
Roof & Roof Drainage System Chimney

- CHIMNEY CAP:
 - Chimney cap in place, which will help prevent debris and wildlife from entering chimney
- MASONRY:
 - Chimney masonry noted in good condition for age and wear
 - Chimney mortar noted in good condition for age and wear
- CHIMNEY FLASHING
 - Chimney flashing noted in good condition for age and wear.

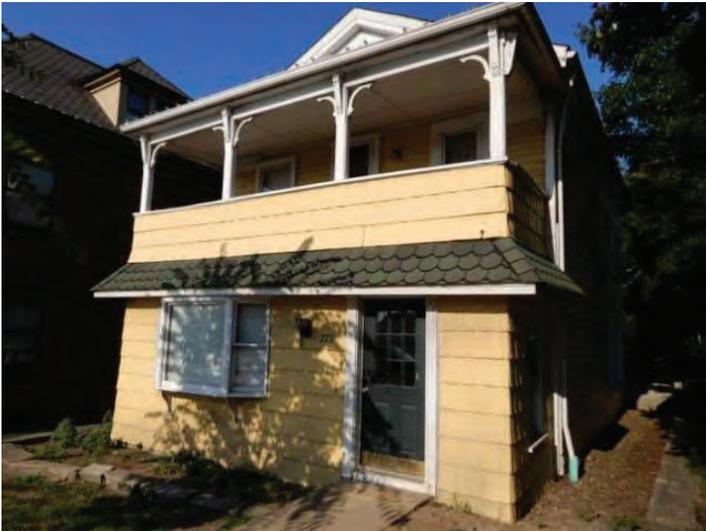
Observations: GENERAL CONDITIONS:, Note: Bldg 277 S. Court was noted with significant exterior structural defects, as follows; bulges in exterior walls, bowed walls, crooked walls, front porch pulling away from structure, etc., ., Exterior of bldg at 277 S. Court, GRADE:, Grade was noted as follows; Slopes towards the back. Mostly flat in front of structure. Slight negative grade towards the foundation on left side. Patio with slight slope away from the foundation on the right side. Back area slopes away from the foundation. We recommend increasing the grade on the left side of the house with a gentle slope going away from the foundation, LANDSCAPE AREAS:, Landscaping was noted as minimal in the front only, TRASH ENCLOSURE: , No trash enclosure present at time of inspection, SIDEWALKS:, Sidewalks were noted just recently replaced and in good condition at time of inspection., ELECTRIC:, Under ground power supply noted at back of the home., Exterior outlets noted as not **GFCI**'s., LIGHTING:, Exterior lighting was noted as minimal, and we recommend increasing., SIDING:, Siding was noted as wood siding, mostly wood shake shingle siding, with wood trim. Significant wood deterioration noted at time of inspection, and some pulling away or lifted from surface, TRIM:, Trim was noted damaged throughout the exterior, with deteriorated wood., FLASHING:, Flashing was noted not in place on the exterior to protect the exterior elements for moisture intrusion., CAULK:, Exterior caulk was noted missing or dissipated at time of inspection., PAINT:, Exterior was noted with peeling paint., **We recommend repairing the following defects for bldg 277 S. Court; replace all deteriorated wood, prep and paint exterior, replace damaged trim, replace damaged siding, repair exterior flashing, replace electrical outlets with GFCI's**

Front exterior of the home

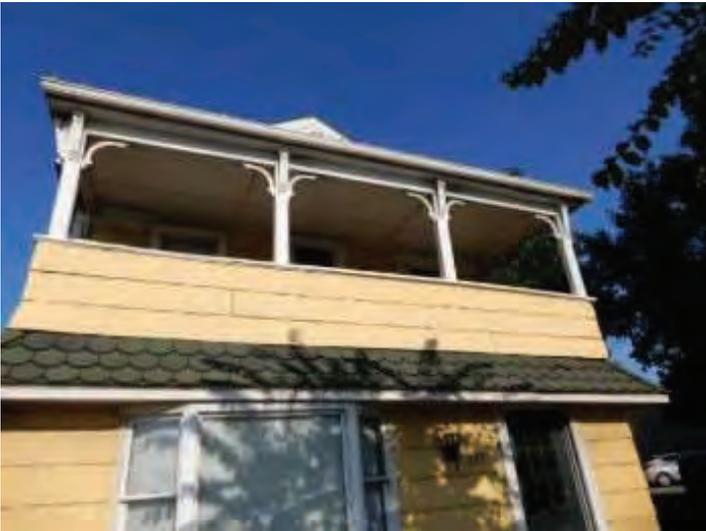
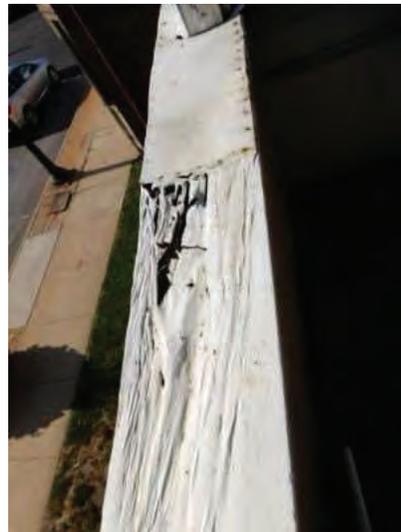
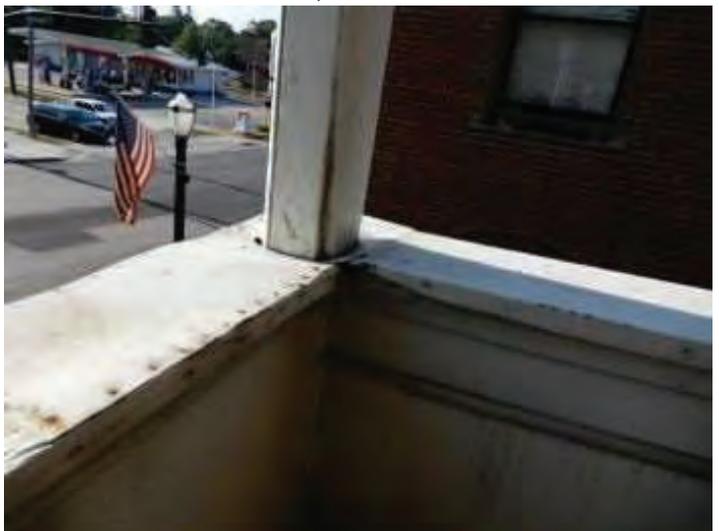
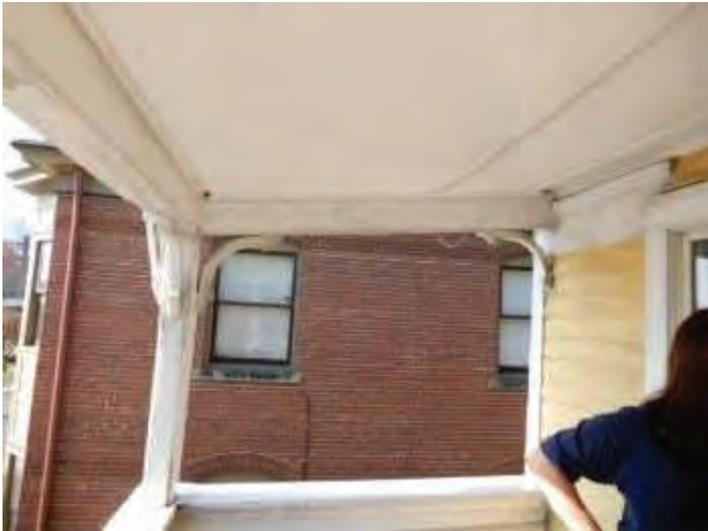
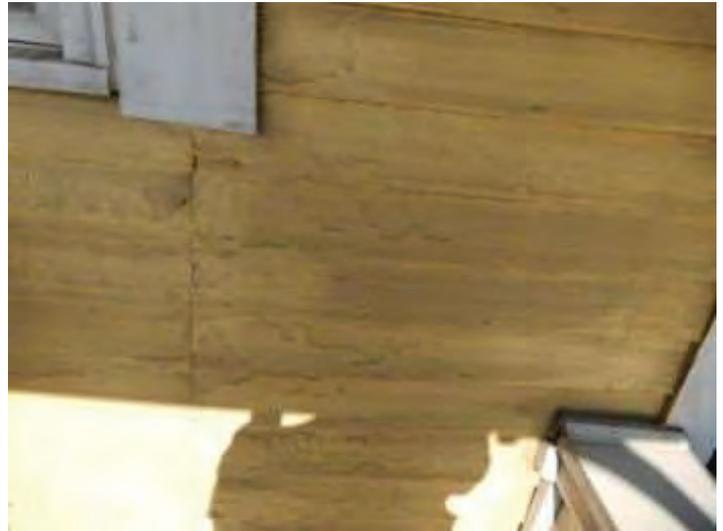
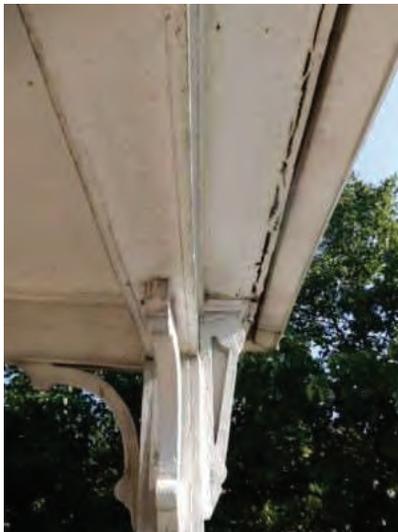
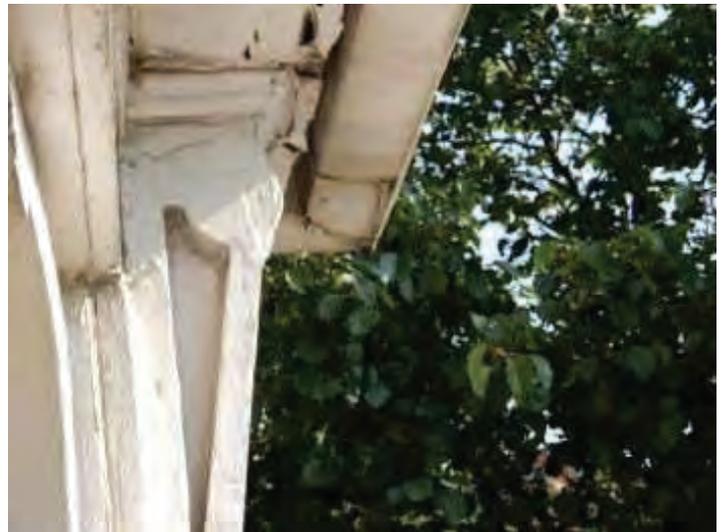
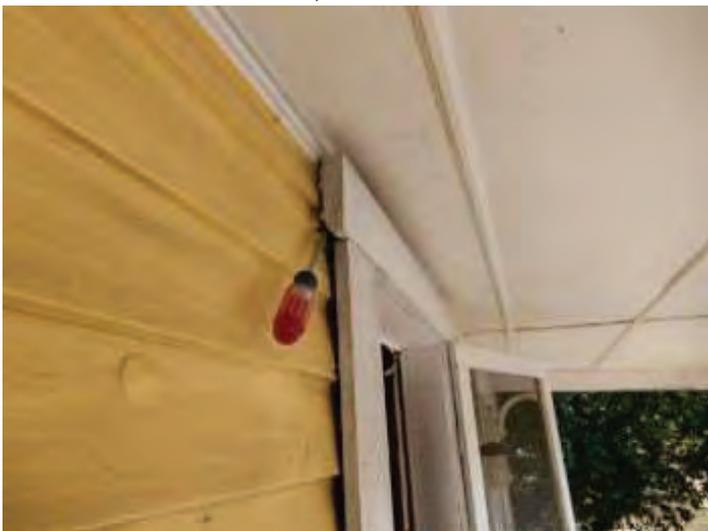
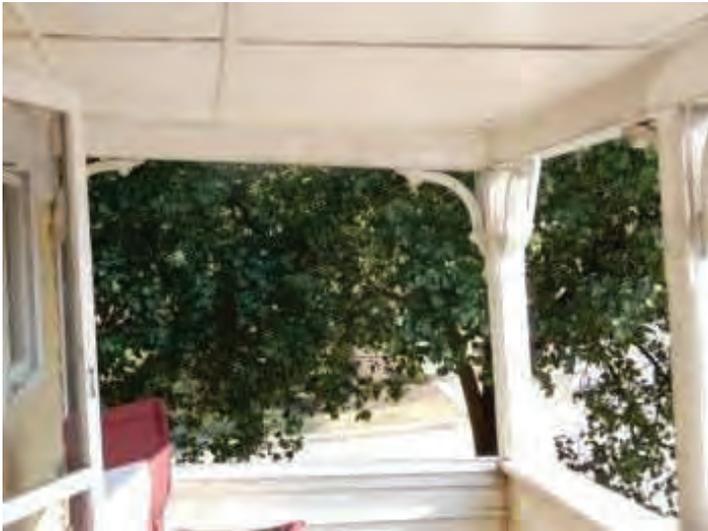
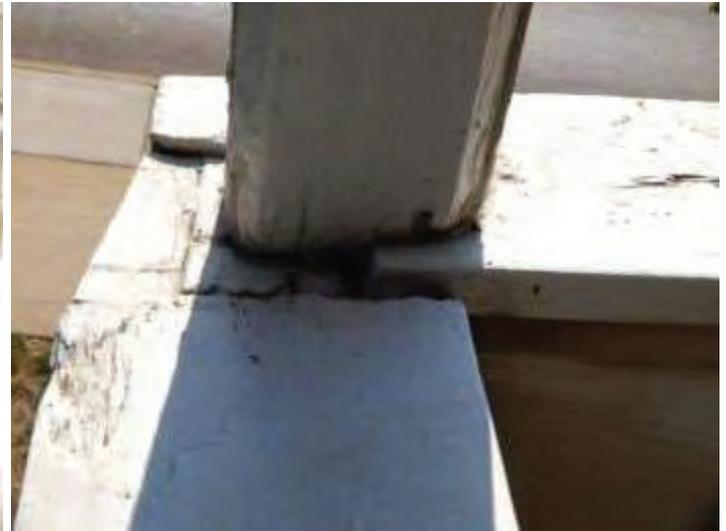
2. Patios, Porches and Decks

Observations: GENERAL CONDITIONS:, ., Exterior of bldg at 277 S. Court, PORCHES:, Front 2nd floor porch was noted with the following defects; column supports are failing, porch is pulling away from front of structure, front porch was noted with deteriorated wood which includes framing members., PATIOS:, Concrete patio was noted newer and in good condition. It should be noted that patio has been poured over and old concrete patio, that was cracked in half. The new pour may fail at the same point, A gutter drain was noted exiting at the back of the patio, with drain pipe ending at edge of patio. The same drain pipe was noted eroding the area below the patio. We recommend repairing by extending pipe further and installing some sort of a splash trough to disburse the drainage., **We recommend repair or removal of the front 2nd floor porch for bldg 277 S. Court, as it is presently deemed as a safety issue.**

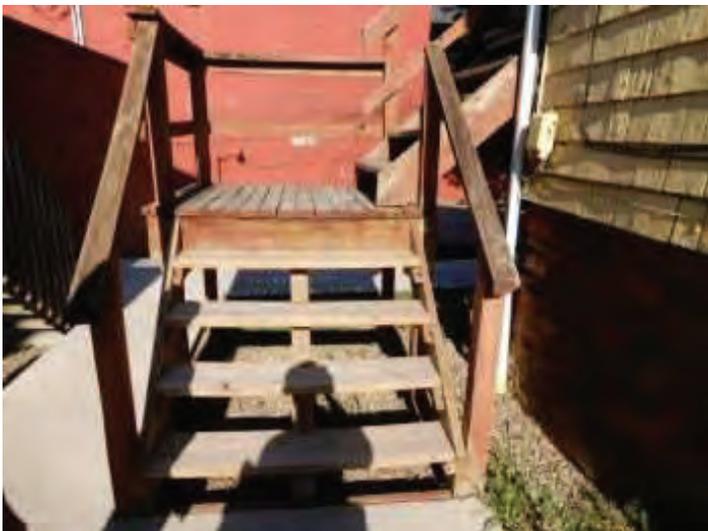
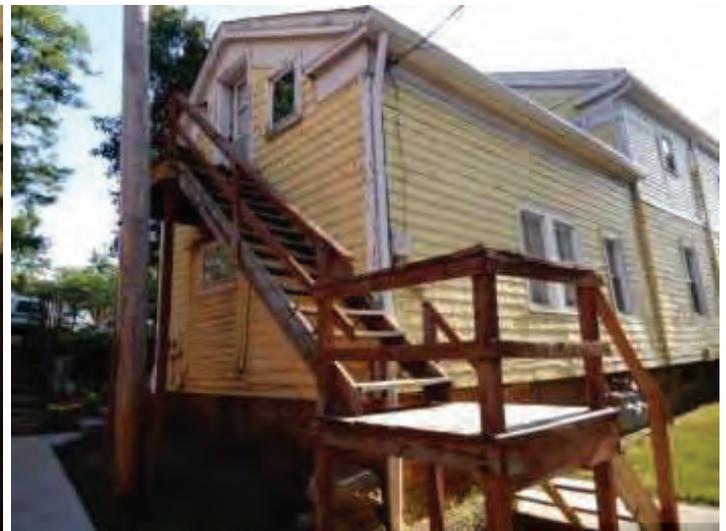
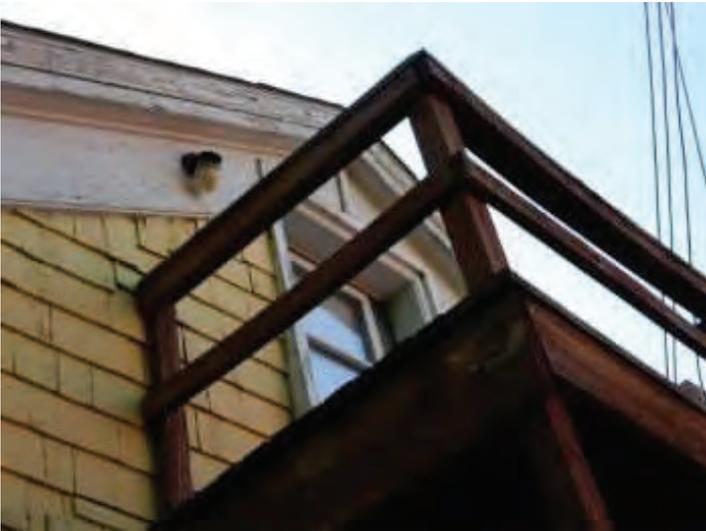
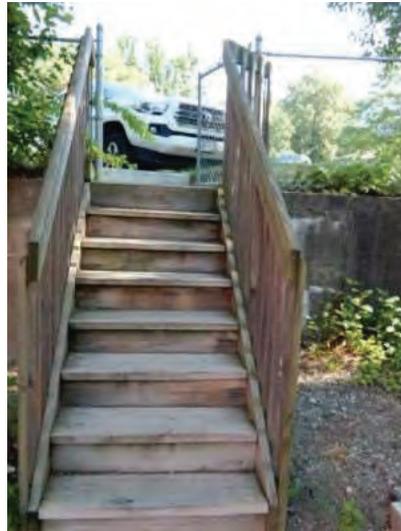
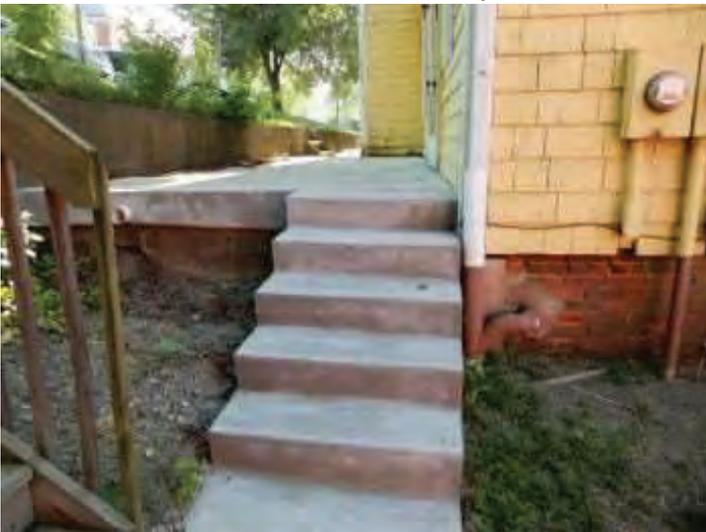
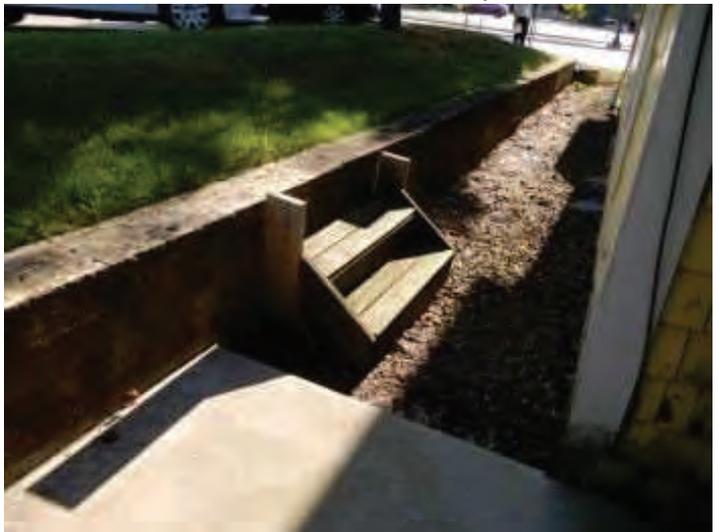
3. Exterior Steps

Materials: Exterior steps at back entrance on S. Court, were noted as wood

- GENERAL CONDITION:
- Wood steps for buildings 277 S. Court street are deemed unsafe to traverse due to condition
- .
- Exterior of bldg at 277 S. Court
- STEP CONDITION:
- Wood steps were noted with deteriorated wood
- Wood steps were noted with lifted and or loose wood decking
- Wood step treads were noted with several being defective or damaged.
- Railing was noted as not properly secured
- Step system fasteners were noted rusted or pulling out of the wood they were intended to secure.
- STEP STRUCTURE:
- Wood steps were noted with inadequate support
- Wood steps were noted being crooked due to poor support
- We recommend removal and replacement of wood steps for building 277 S. Court St., with new steps built in accordance with code
