HISTORIC PRESERVATION BOARD

Case No. H22-045

Building Demolition at 277 South Court Street

March 2, 2022

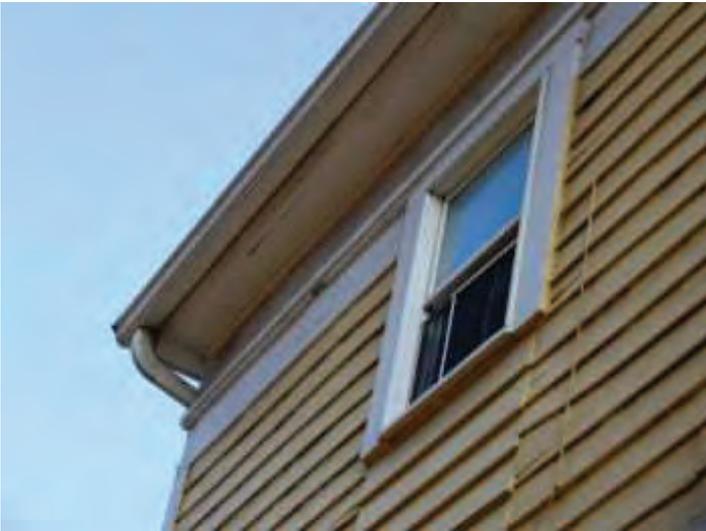
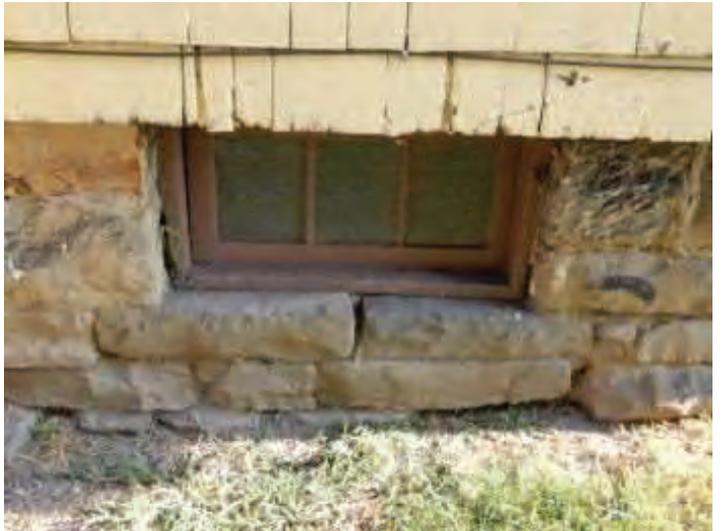
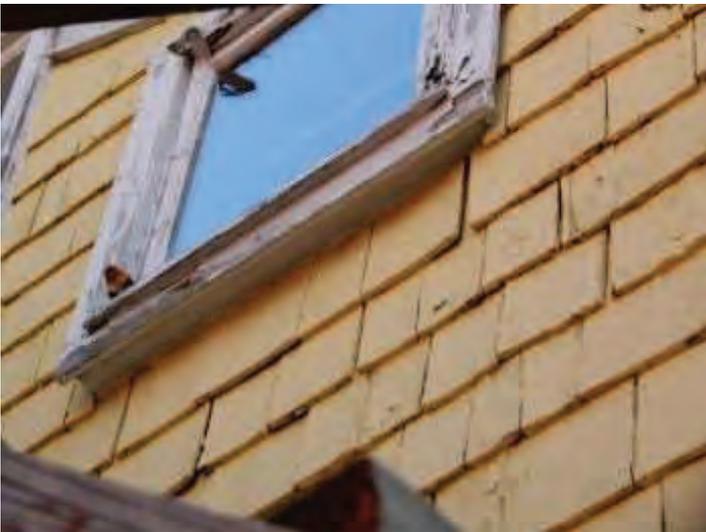
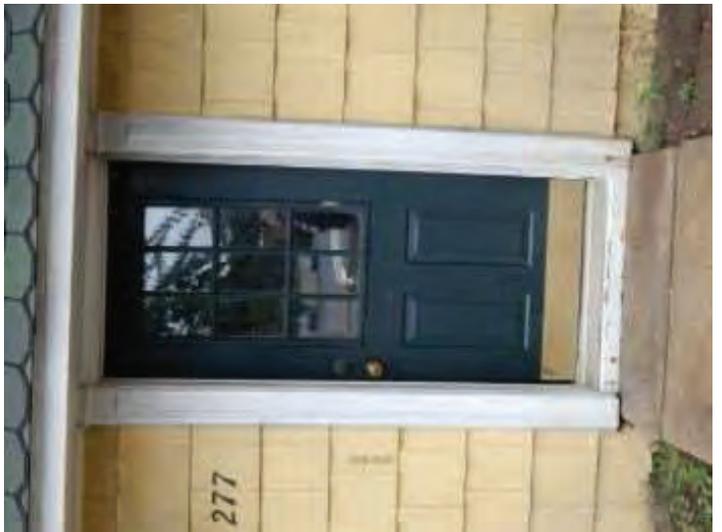
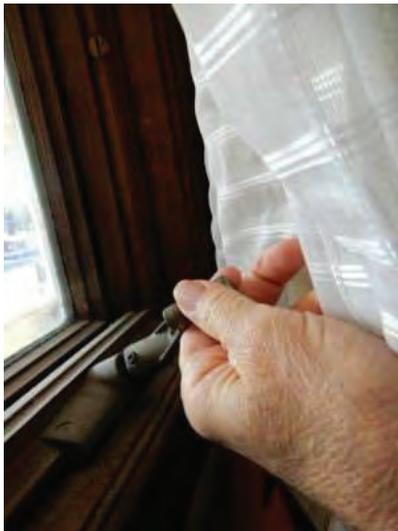
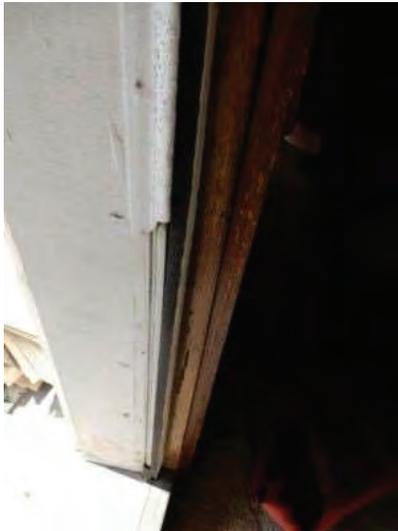
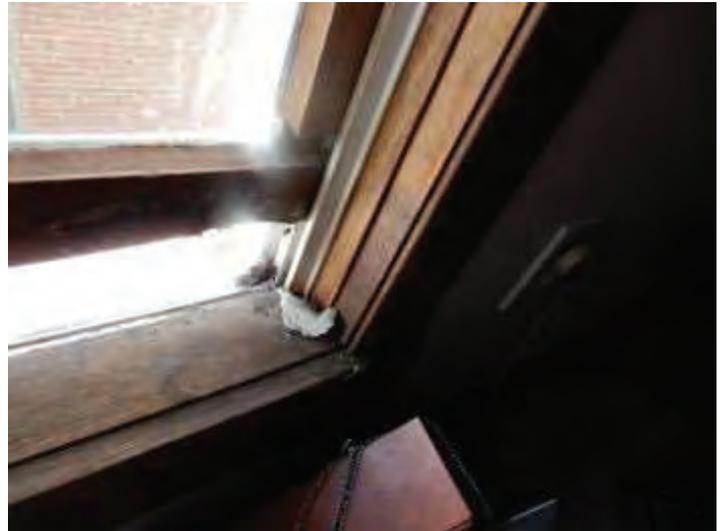
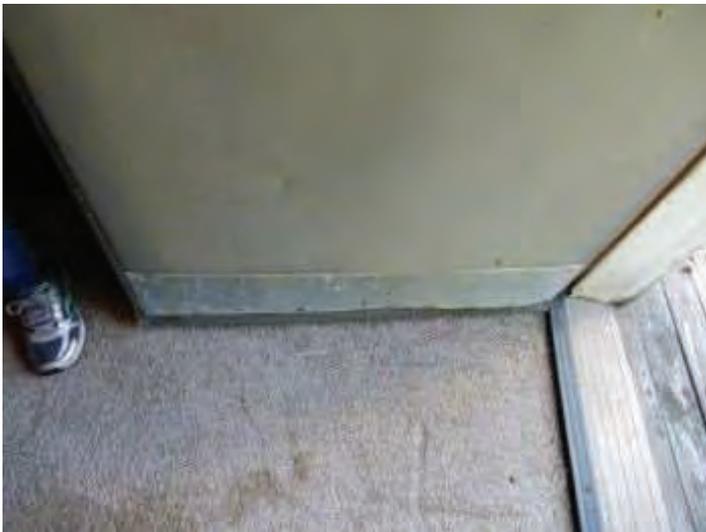
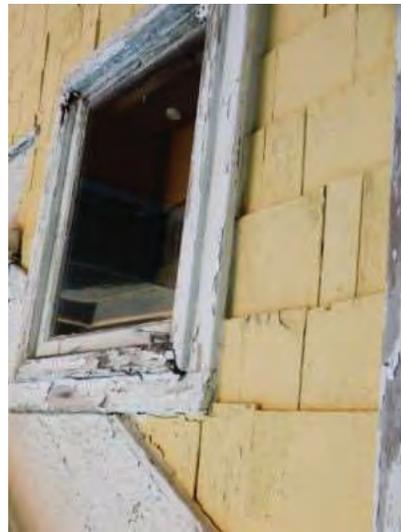
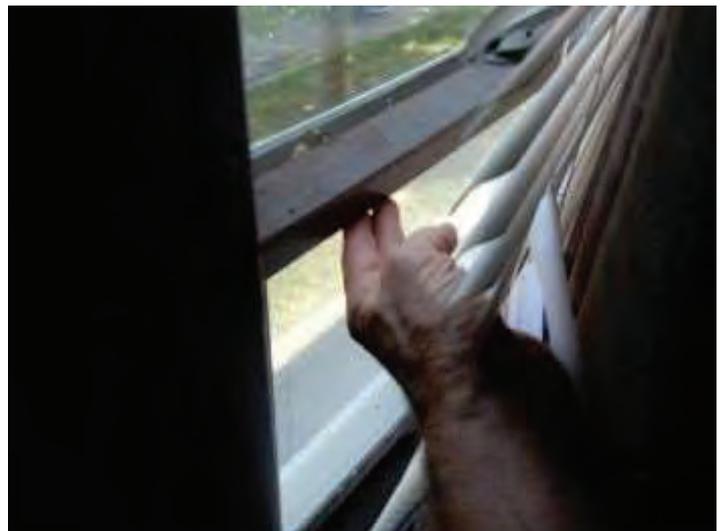
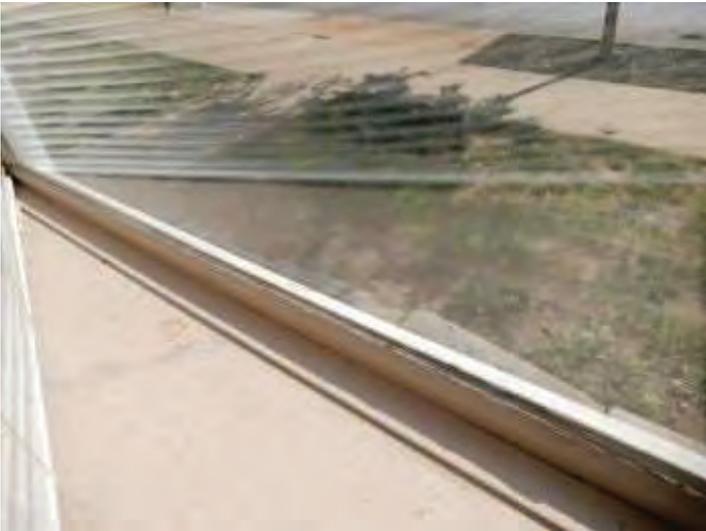
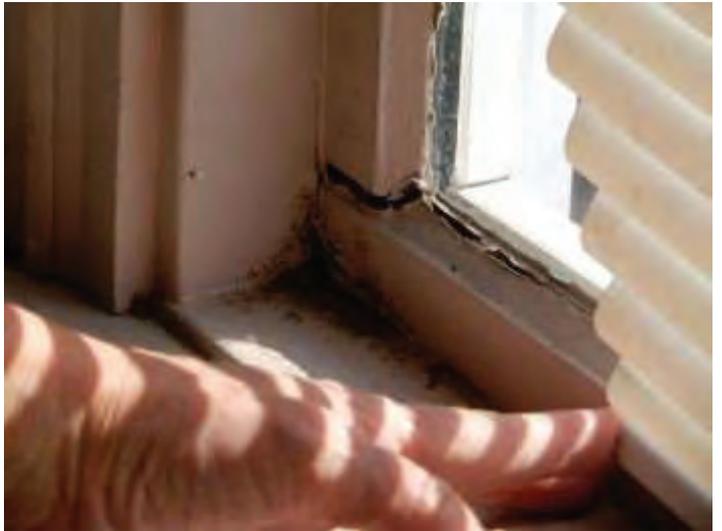
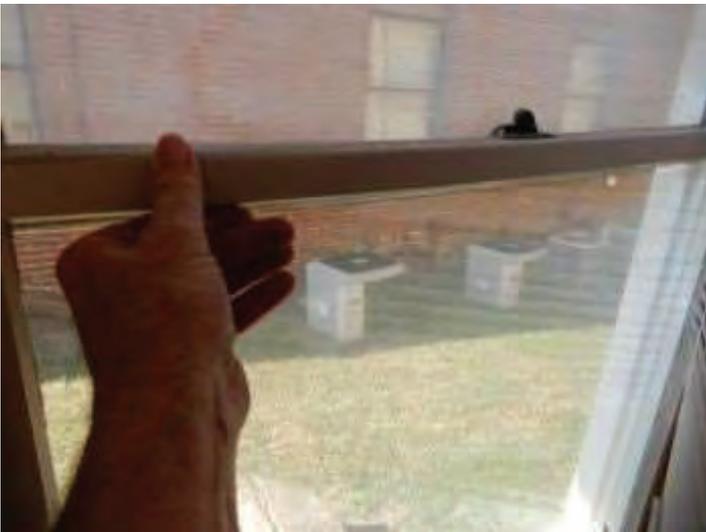
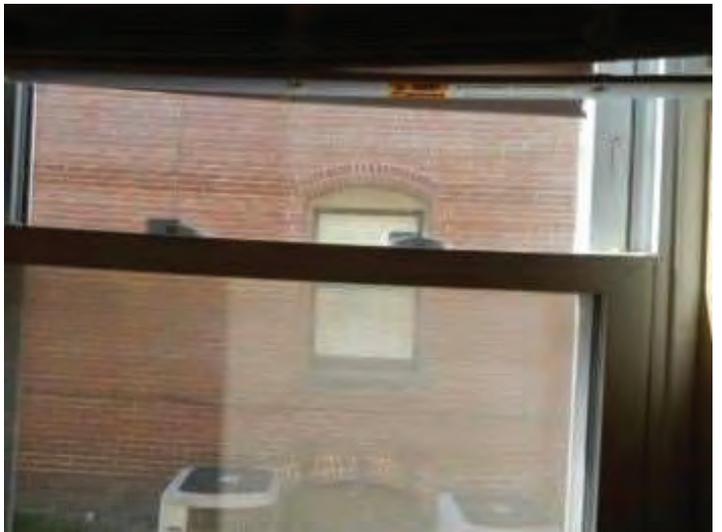
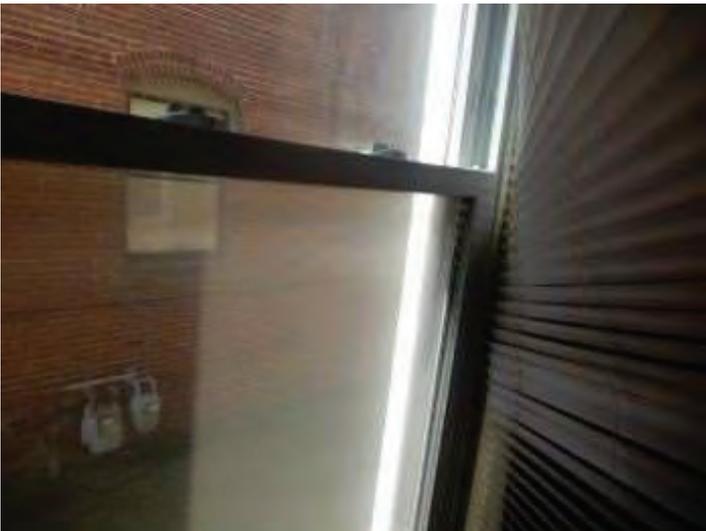
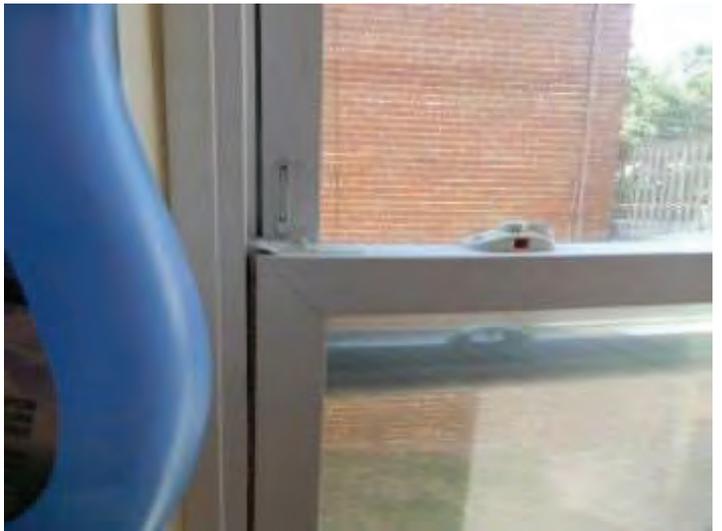
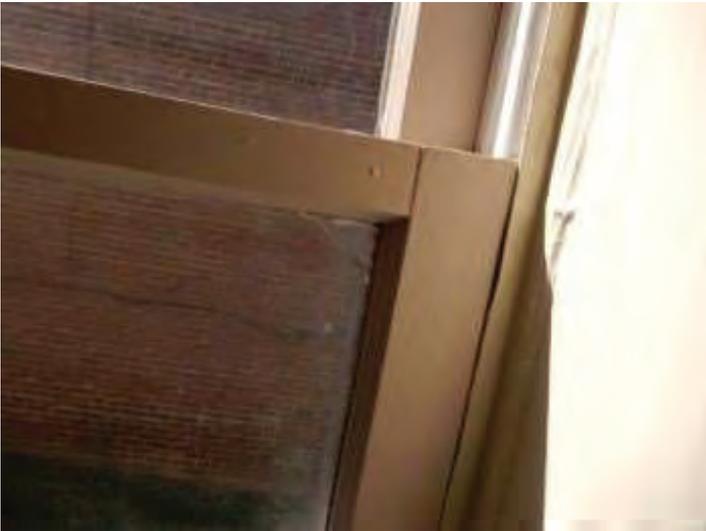
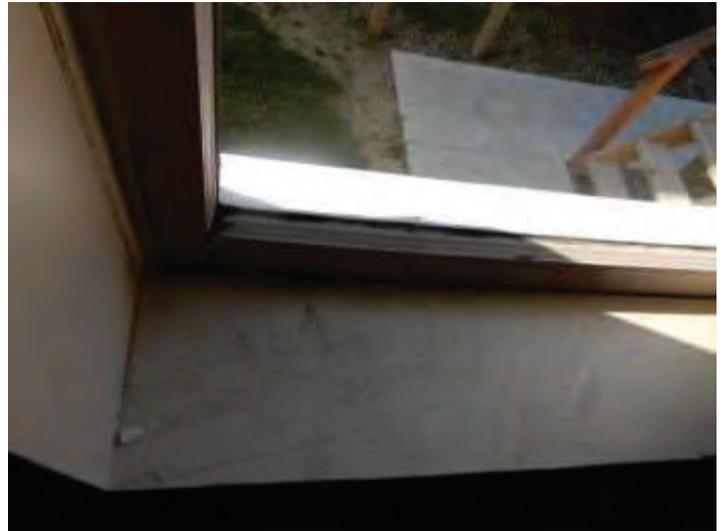
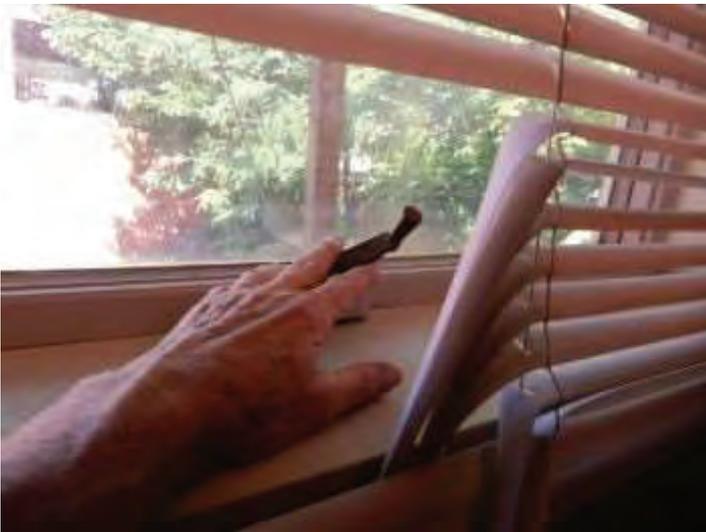
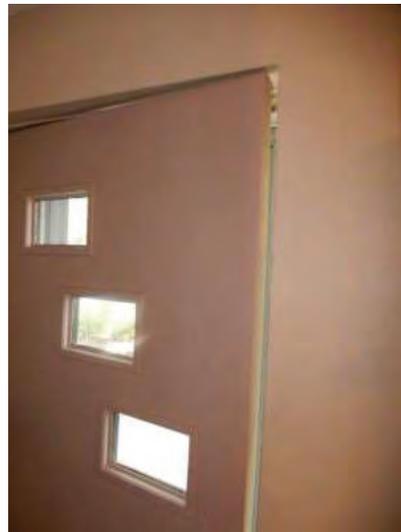
- Exterior entry doors were noted swinging in, rather than swinging out, which is the preferred swing for exterior doors for ease in case of need for emergency exit of the buildings.
- Due to the swing in, doors cannot be installed with a panic bar.
- Not all exterior doors are equipped with a lever type ADA approved door entry hardware.

- Front entry door was noted with a loose top hinge, which does not allow door to easily operate. We recommend repair
- 2nd floor back entry door was noted rusted out at the bottom, and retro fitted with an exterior replacement window. Bottom of door jam and trim noted with wood deterioration.

- 1st floor back entry door was noted over all in good condition for age and wear, but no weather stripping. We recommend installing
- 1st floor back door was noted with a storm door in place and in good condition for age and wear.

- 2nd floor exterior front porch door was noted as a steel insulated door (has thermal pane window insert) with deteriorated wood framing, with no weather stripping in place and excessive gaps. Door did not easily operate at time of inspection. An older screen door also in place which was noted in good condition for age and wear. We recommend repairing exterior door to properly open/close/latch which should include adjusting for gaps and install weather stripping

- Wood single pane windows
- Wood thermal pane windows
- Vinyl thermal pane windows
- Windows were noted a mix of the following types of windows, of which several different styles were included, such as; double hung, casements, fixed windows, hopper windows.
- Of the windows in this building, only (3) were noted in good condition for age and wear and operated properly. The rest had defects that included;
 - Deteriorated wood sashes
 - Defective window glazing
 - Would not open
 - Would not stay open
 - Cracked glass
 - Defective or missing weather stripping
 - Defective or damaged hardware (example: window crank stripped)
 - Some torn or missing screens

- We recommend replacing the exterior entry doors with out swing doors, to include panic bars and door closers for building 277 S. Court. We also recommend replace entry door hardware with ADA type lever hardware.
- We recommend replacing the 2nd floor back door in building 277 S. Court
- We recommend replacing the windows that are defective in building 277 S. Court St.

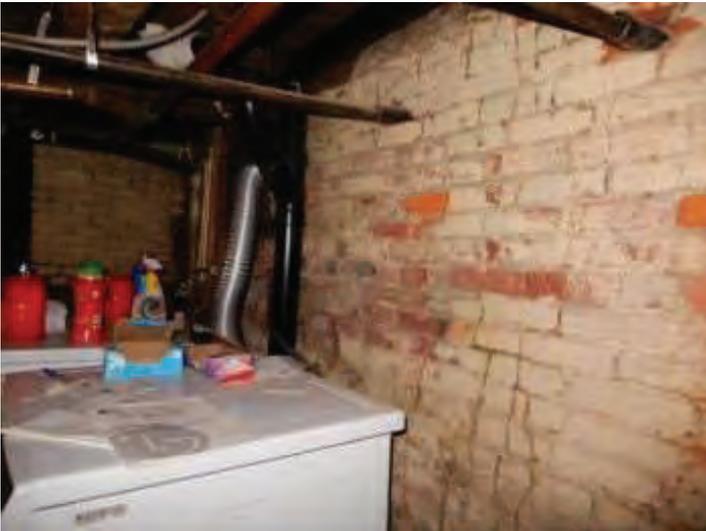
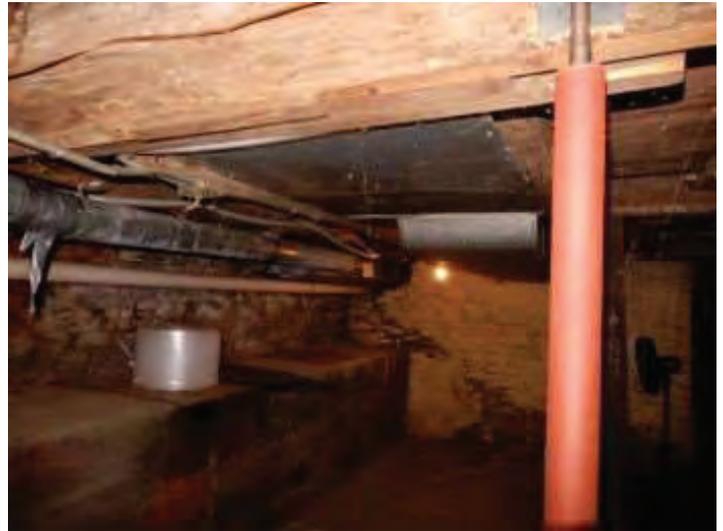
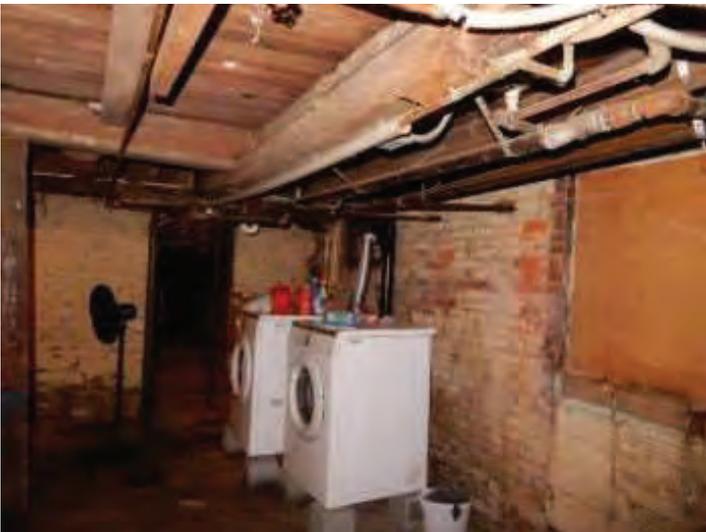
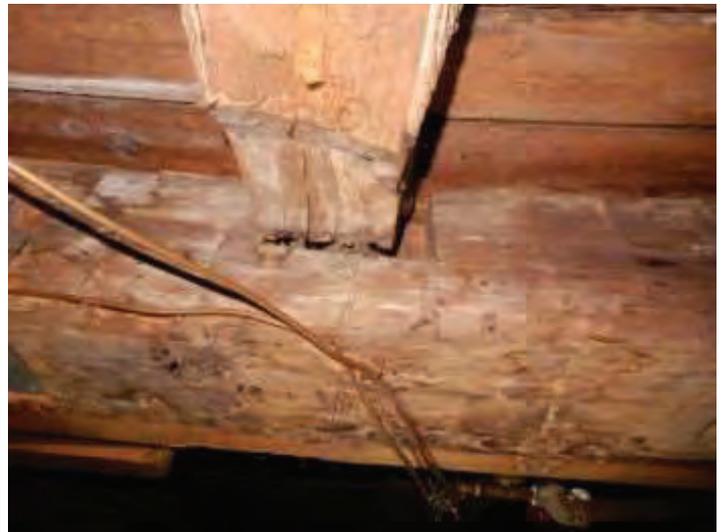
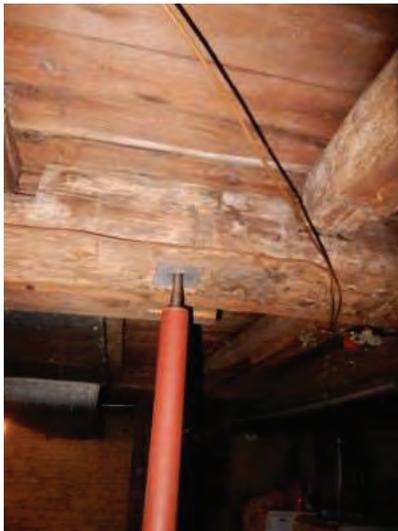
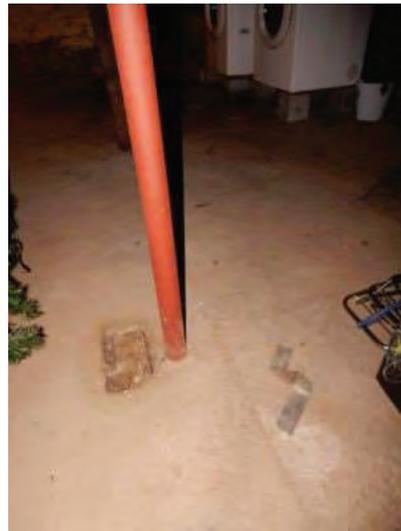
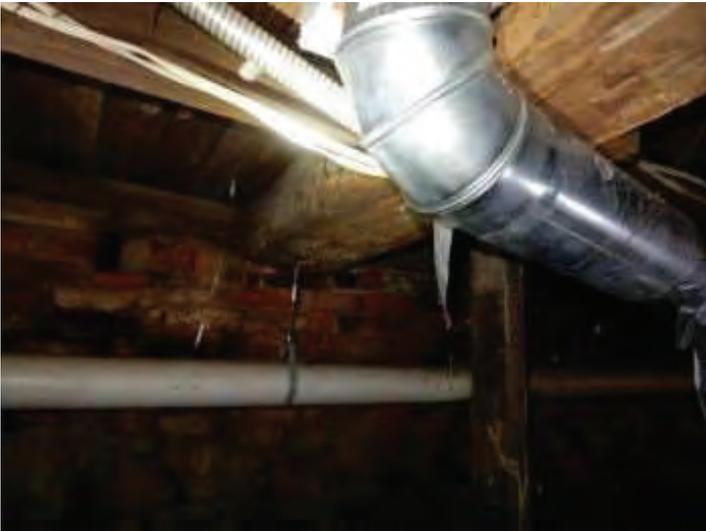
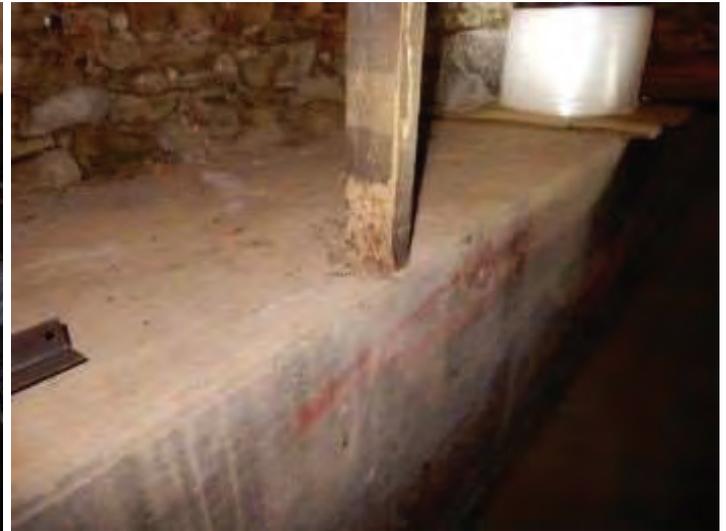
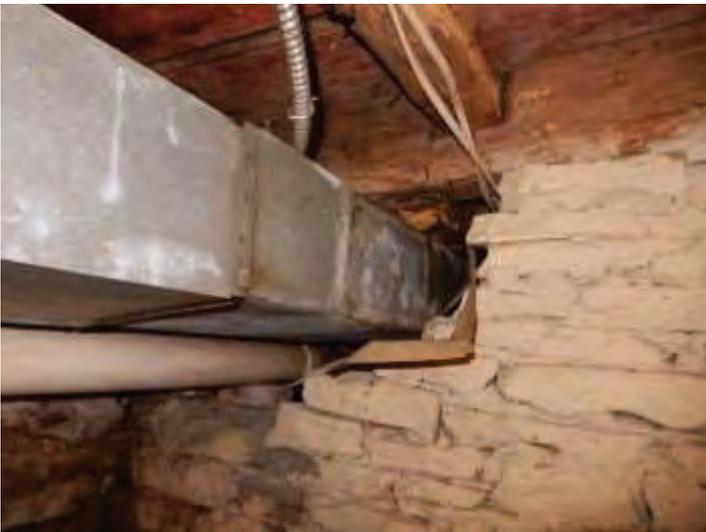
Observations: GENERAL CONDITIONS:, Basement for building 277 S. Court has significant structural issues in the basement that need to be addressed immediately, ., Basement at Bldg 277 S. Court, FLOOR JOISTS:, Several floor joists were noted damaged or defective, Floor joists and beams were noted not level due to structural components failing, BEAMS & COLUMN SUPPORTS:, Beams were noted not properly supported with support columns, Beams were noted with inadequate support columns that are not properly installed on footers, Support columns were noted at point of failure, due to deterioration and inadequate for application., Beams were noted deteriorated in several areas., BASEMENT FLOOR:, In good condition for age and wear at time of inspection., PLUMBING:, Leaking plumbing valves., Plumbing leaks noted in domestic lines, ELECTRICAL:, Open electrical junction boxes., Damaged BX cable sheathing, with exposed wires, No GFCI's noted in area, MOISTURE INTRUSION:, Moisture noted in various areas throughout the basement. We recommend repairing exterior issues and to repair basement interior walls, MASONRY WALLS:, Masonry bearing walls were noted compromised with large openings with no support above the openings, Deteriorated and spalling bricks., Voids in masonry foundation., Lintels or proper support over masonry openings was noted missing at time of inspection., MOLD:, Signs of possibility of mold being present. We recommend area be tested for mold, and to run 3-dehumidifiers in basement for an extended period of time., ASBESTOS:, Material that appears to be asbestos was noted in the basement on several older HVAC ducts, HVAC DUCTS:, Ducting rusted out in several locations, Ducting not properly secured to boots., Ducting not properly supported., **We recommend repairing the basement defects noted above for building at 277 S. Court**

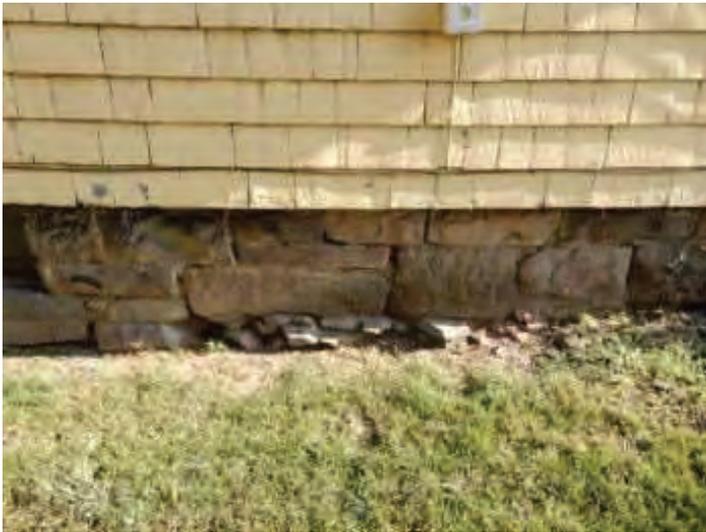
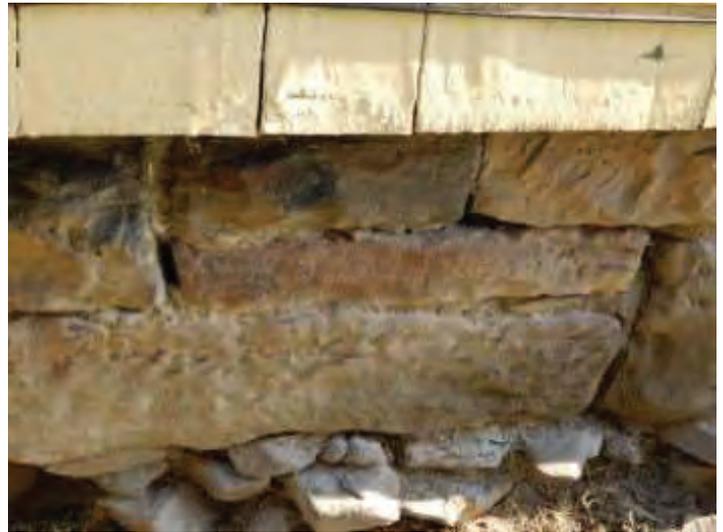
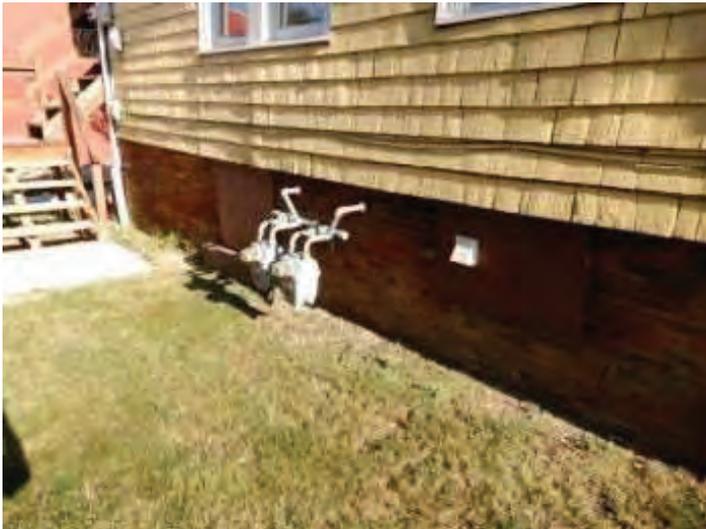
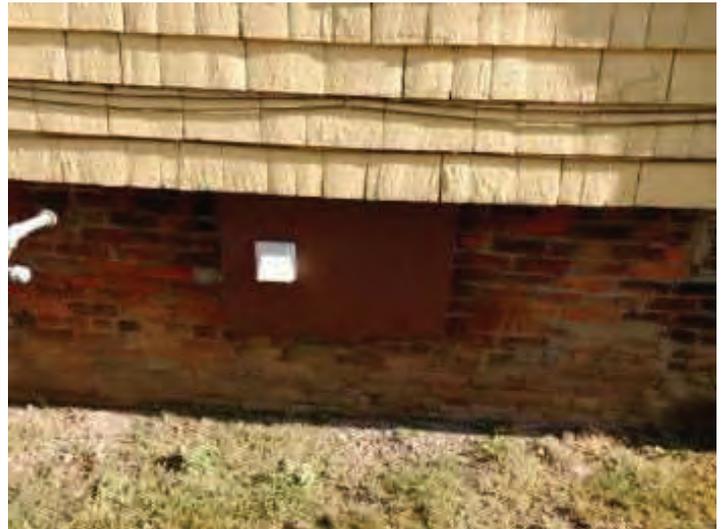
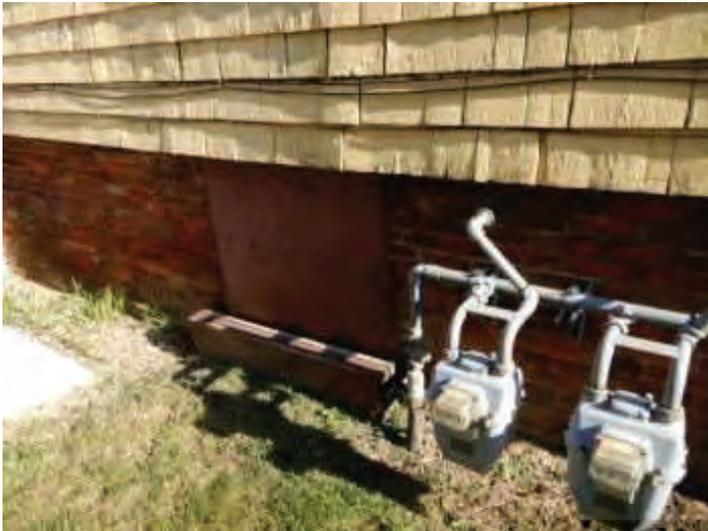
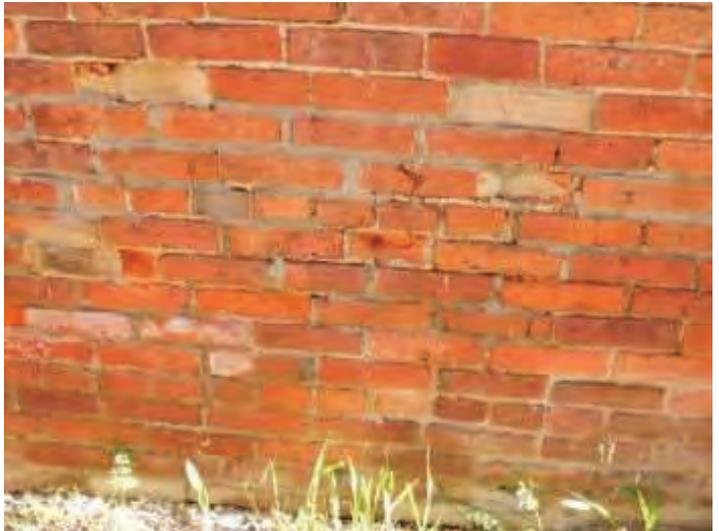
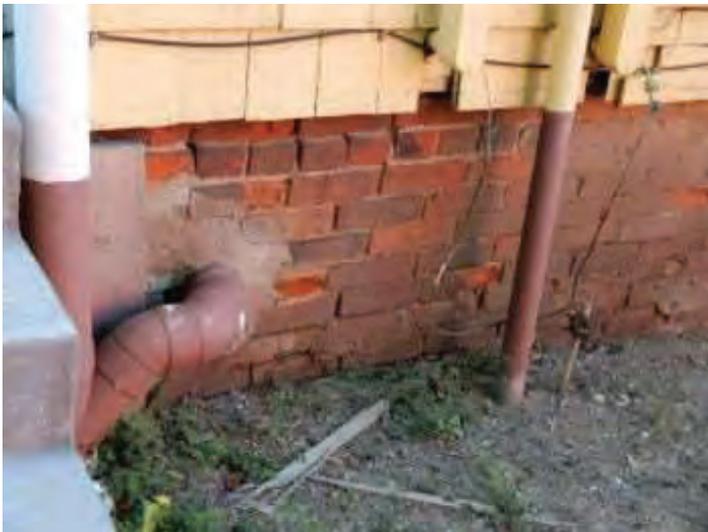
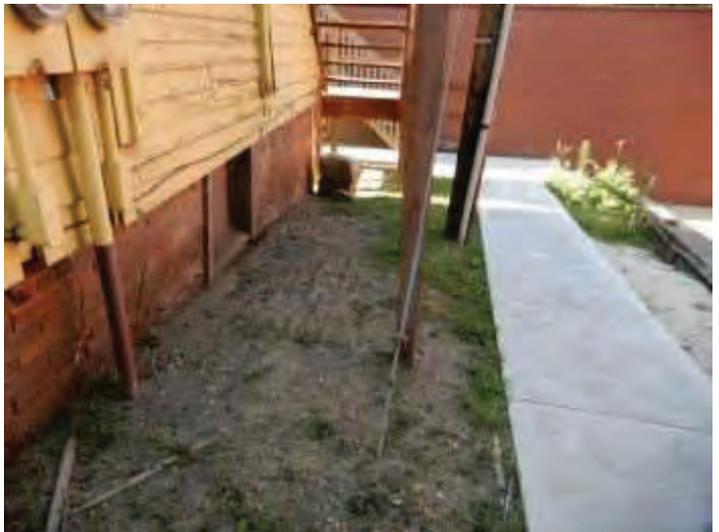
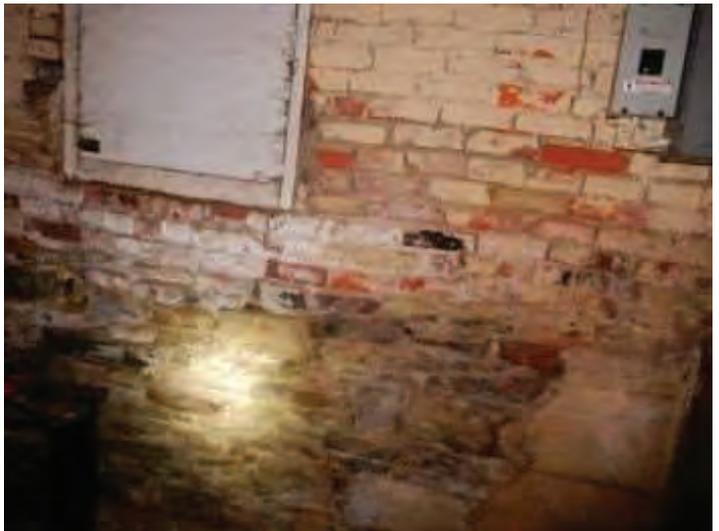
2. Foundation

Observations: GENERAL CONDITIONS:, Some safety and or functional concerns noted in some areas, with details below., , Foundation at Bldg 277 S. Court, Exterior foundation was noted with voids in the masonry, which included what appears to be missing masonry., Foundation was noted being a combination of stone and brick., Left side masonry wall was noted built with a bit of a curve, which is very apparent, but does not appear to be a structural issue., Some of the brick was noted as deteriorated and spalling., **We recommend the following for building 277 S. Court St. to include; tuck pointing masonry walls and parging, and then sealing. We further recommend excavating down about 2' to repair and parge lower areas of masonry.**

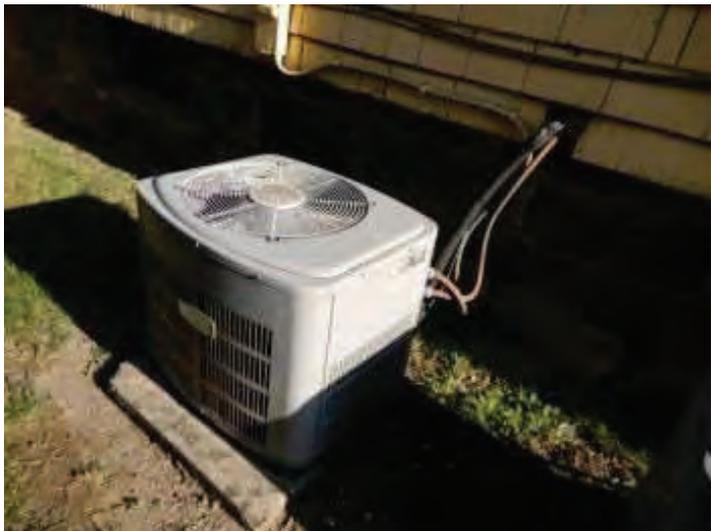
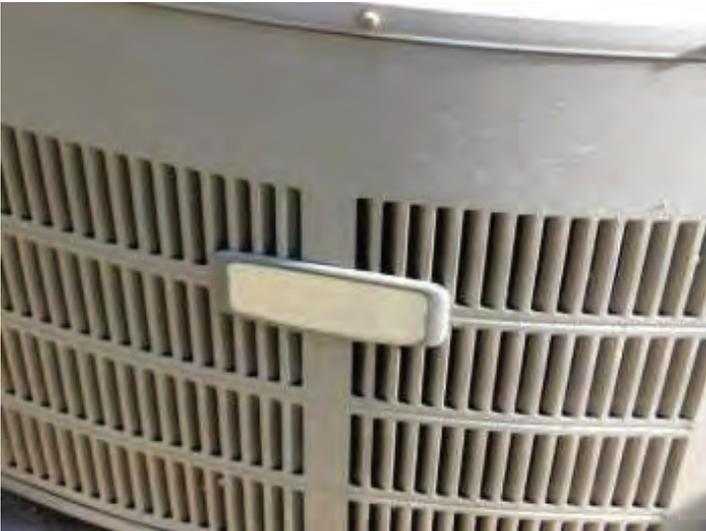
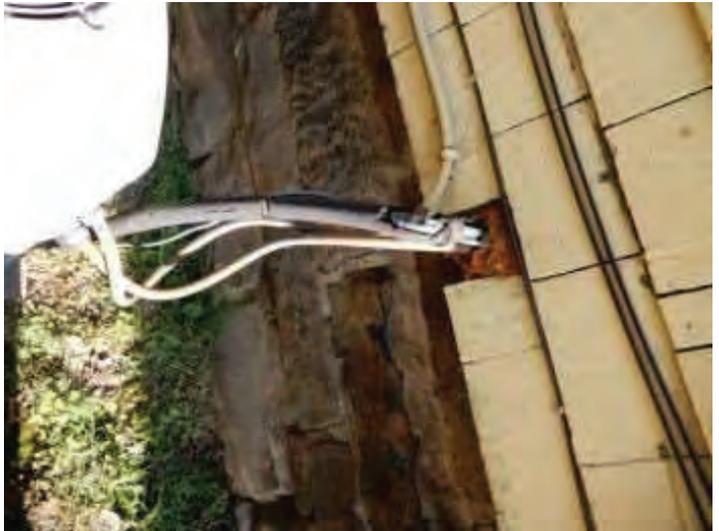
Observations: GENERAL CONDITIONS:, Note: Most units A/C units and A-coils are of the vintage that utilizes older type refrigeration (R22), which is being replaced with newer R410a. Meaning when changing out an older system, it may require complete replacement of an entire system (furnace, A/C, A-coil), MAINTENANCE:, We recommend having HVAC system cleaned and serviced along with change of filter, by a licensed HVAC contractor, ., HVAC at Bldg 277 S. Court, Each apartment had it's own HVAC System, Exhaust ducts were not sealed at all mechanical connections. We recommend sealing all exhaust ducts at mechanical connections., A/C UNIT:, Both units had American Standard A/C Units (Mfg 1999), which operated properly at time of inspection., Both condenser units were noted located on the left side of the building at grade level., A/C units line set insulation was noted deteriorated on the exterior, and we recommend replacing, THERMOSTAT:, Both thermostats operated properly at time of inspection, FURNACE TYPE:, Furnaces were noted as being gas fired units. Bot units worked properly at time of inspection, FURNACE CONDITION:, Both furnaces were noted in good condition for age and wear, but very dirty. We recommend having cleaned and serviced., CONDENSATION:, Condensation lines have been run to the exterior, with drainage being near the condenser units on left side of the building. We recommend placing splash blocks below each drainage line to prevent water going into the foundation., OTHER SYSTEMS:, Electric baseboard heat, was noted in 2nd back bedroom, but was not operated at time of inspection due to personal belongings, **We recommend repairing and replacing HVAC equipment as units go bad**

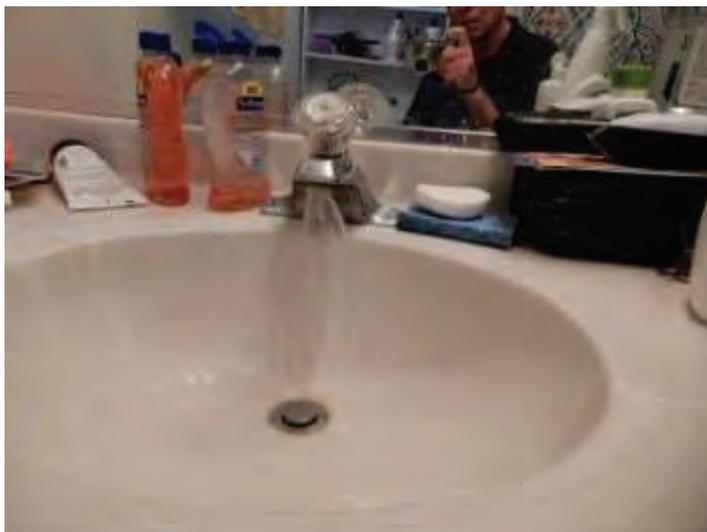
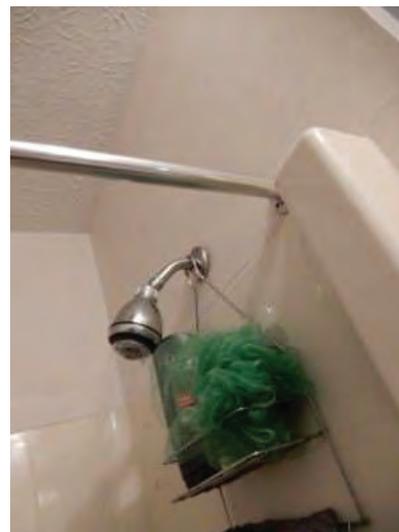
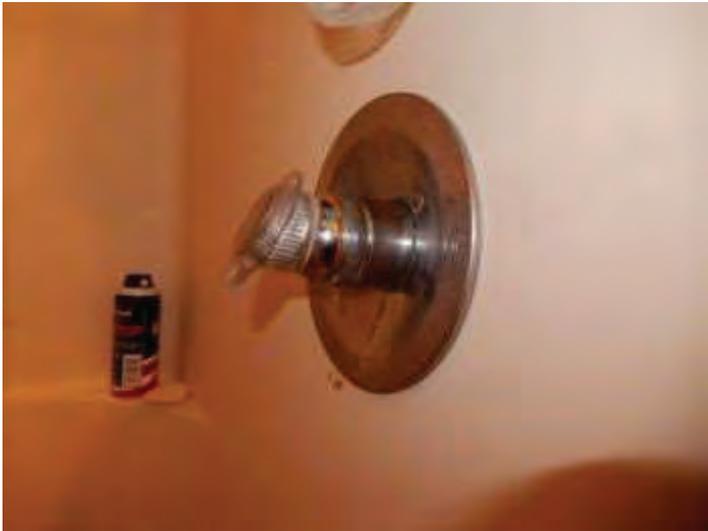
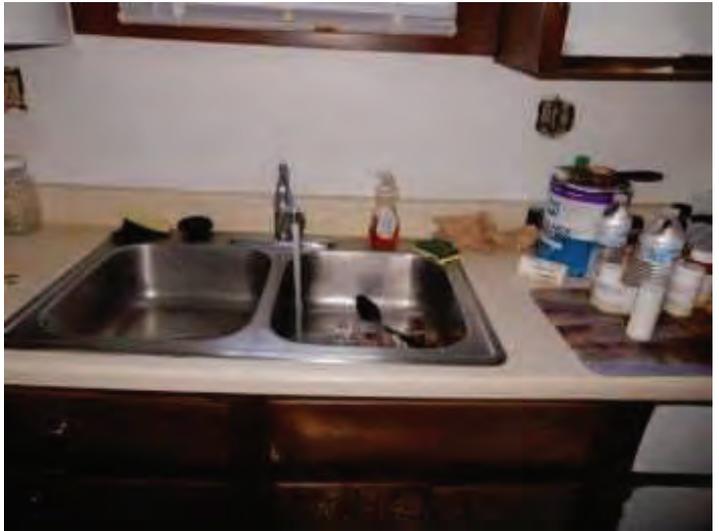
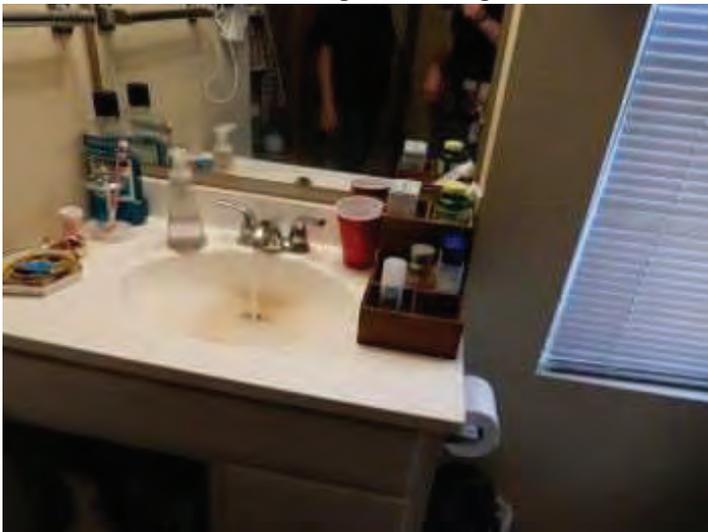
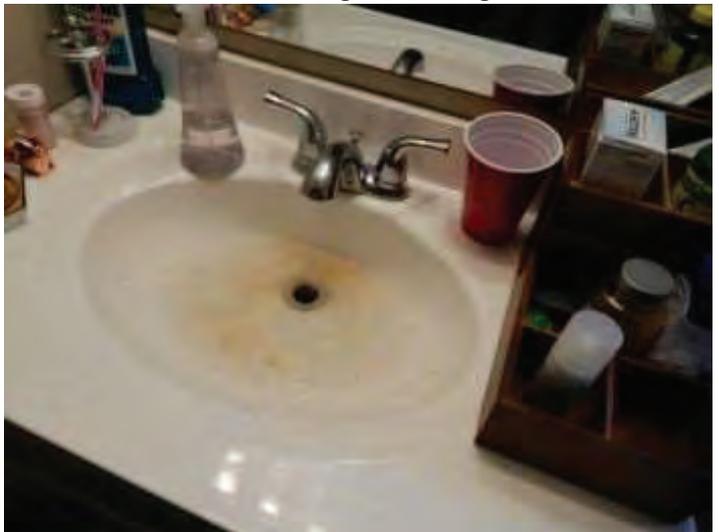
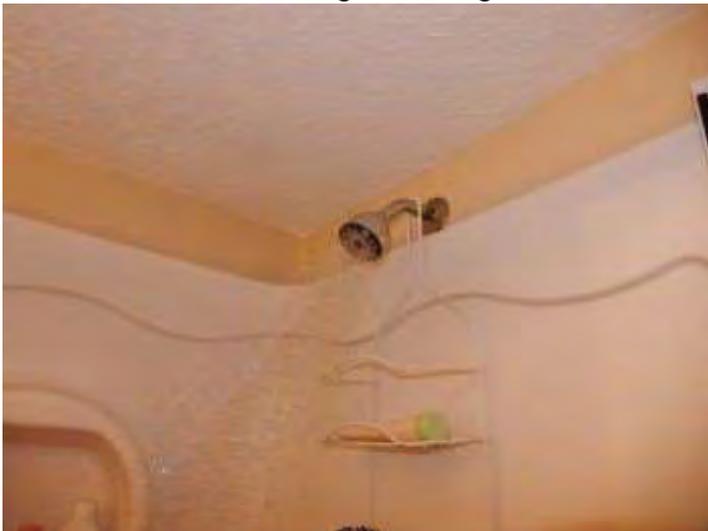
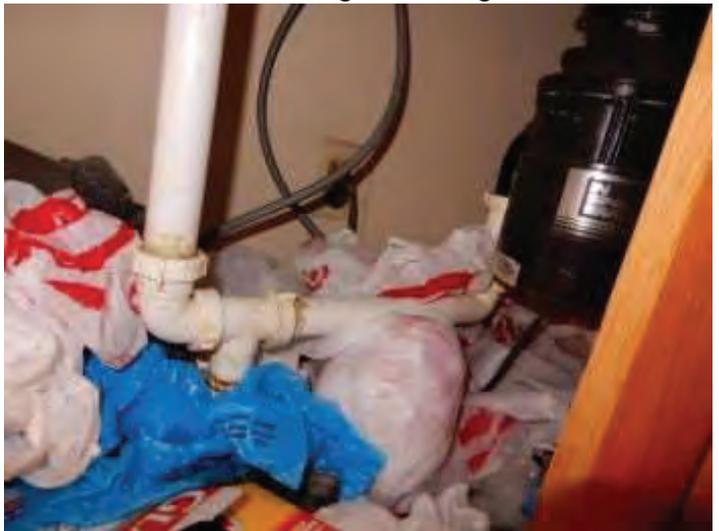
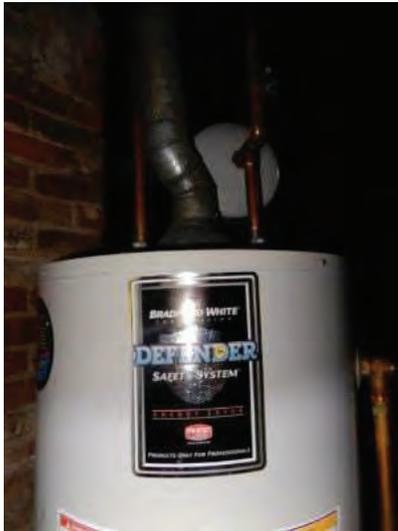
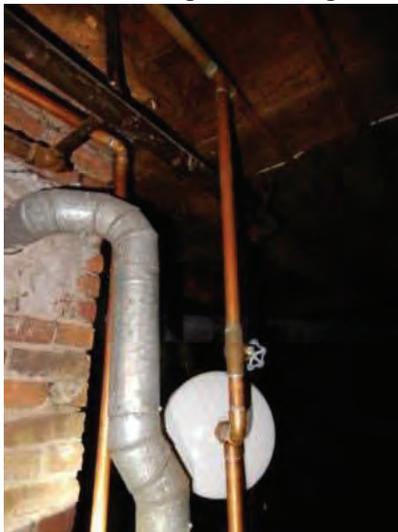
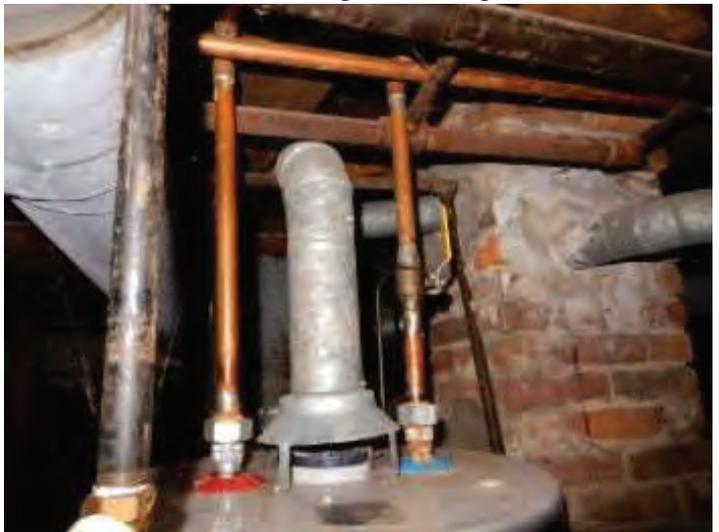
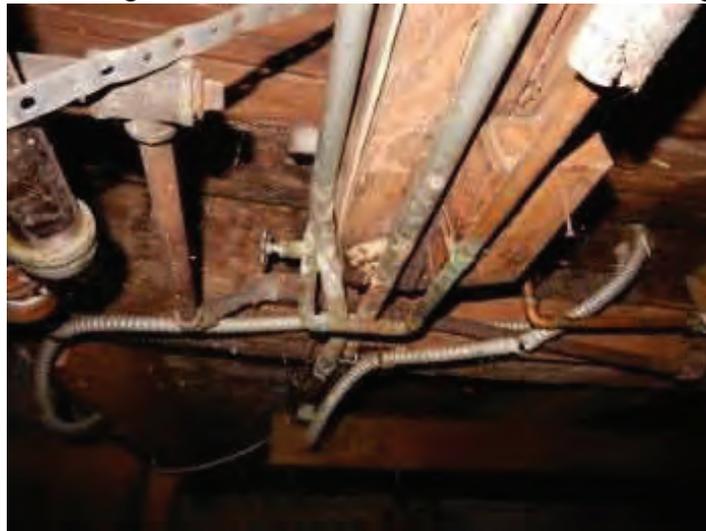
Observations: GENERAL CONDITIONS:, Some issues were noted with overall plumbing supply and waste system of areas physically able to be inspected at time of inspection, see details below, See individual sections noted below for details of plumbing for specific areas:, Kitchens, Basement, Laundry, Bathrooms, MAINTENANCE:, For proper maintenance of hot water tank system, we recommend draining the hot water tank at least (2) a year to remove any built up sediment in the bottom of the tank. This should help in extending the life of the tank, BACKFLOW PREVENTER:, Note: Backflow preventer's are required to be tested on a regular basis by a license plumber licensed for testing backflow preventer. Please check your area to make sure you are in compliance's, ., Plumbing at Bldg 277 S. Court, Many portions of drain, waste, and vent system were hidden from view. Observable portions appeared to consist of copper supply and plastic drain lines., HOT WATER TANK:, Hot water tanks noted as a gas Bradford White 40 gallon, installed in 2007, and in good condition for age and wear (uncertain which unit this tank is for), Hot water tank noted as a GE 40 gallon, gas hot water tank installed in 2013 and in good condition for age and wear (uncertain which unit this tank is for), Hot/cold ground straps were noted missing on both tanks, and we recommend installing, TPR discharge lines were properly in place and installed at the right length for both tanks at time of the inspection, Gas line properly installed with 1/4 turn gas valve for both tanks, Exhaust ducts are not properly sealed at all mechanical connections, and we recommend sealing, BACKFLOW PREVENTER:, None found in this building, WASTE SYSTEM:, Waste lines were noted mostly PVC, Cast iron and ABS plastic. Overall in serviceable condition for age and wear at time of inspection., WATER SUPPLY SYSTEM:, Supply system was noted being a mix of copper and older galvanized. Overall in fair condition for age and wear., A few plumbing connections were noted corroded with system starting to leak (mostly at copper/galvanized interface points). We recommend repair, A plumbing access panel was noted in the entry stairwell of the building, with plumbing supply line previous repairs noted and plumbing supply lines wrapped in heat tape. This indicates that plumbing system is not properly protected in a warm insulated area., FIXTURES:, See individual sections in report for details on fixtures, DRYER VENT:, Dryer vent properly exhausts to the exterior
