HISTORIC PRESERVATION BOARD

Case No. H22-045

Building Demolition at 277 South Court Street

March 2, 2022

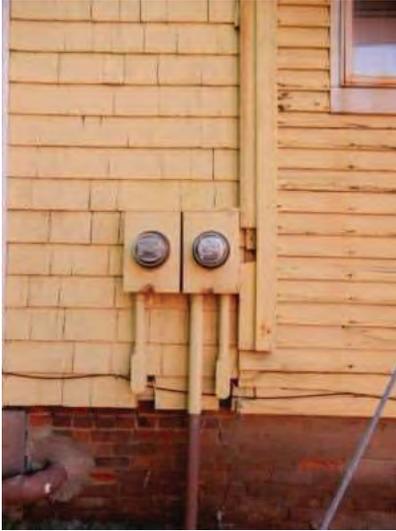
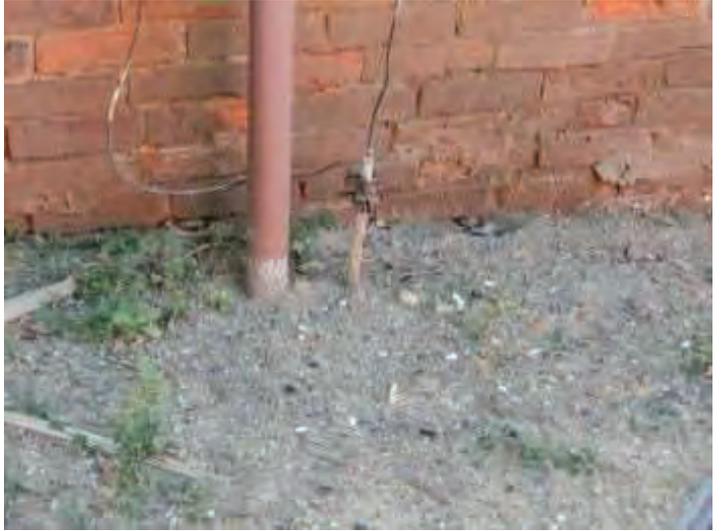
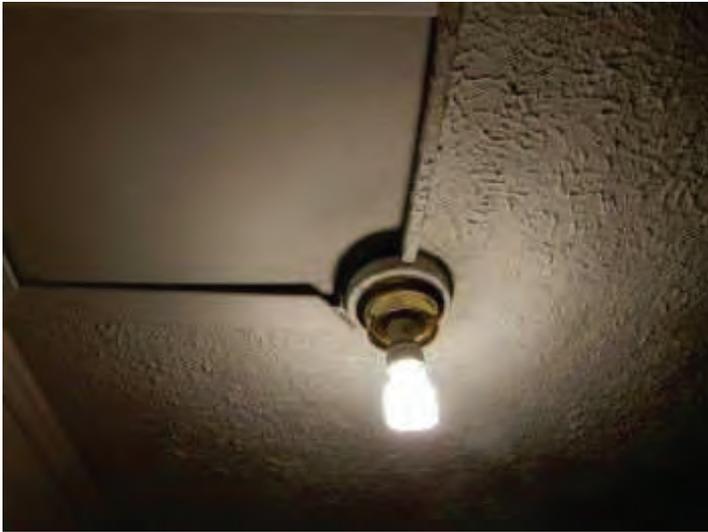
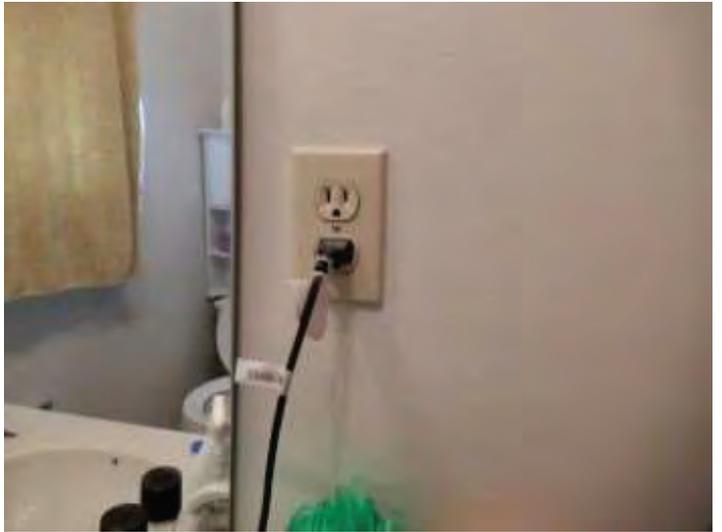
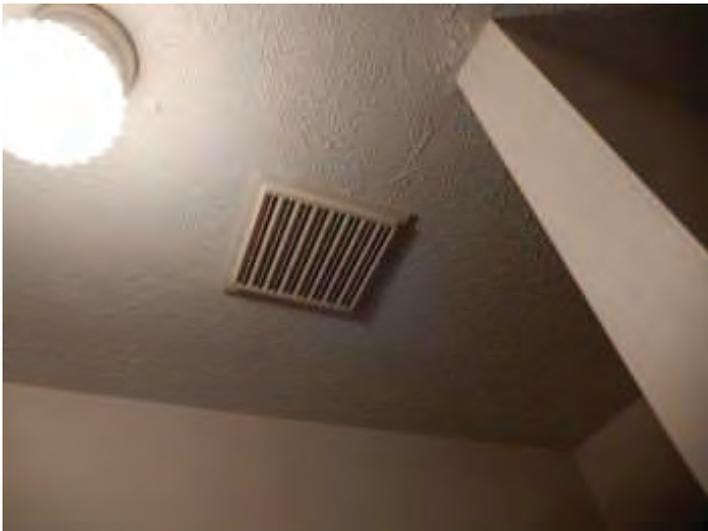
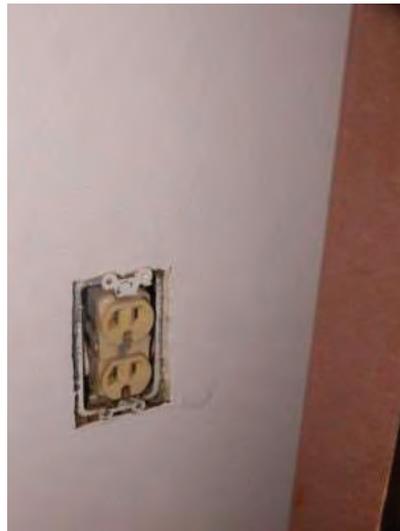
Observations: GENERAL CONDITION:, Some safety and functional concerns noted at time of inspection, with details noted below, ., Electrical at Bldg 277 S. Court, ELECTRICAL PANELS:, (3) Electrical panels noted in the basement, two were noted as 100AMP panels, one for each of the apartments, as follows (note both panels noted as at least 30-years old). Along with a sub-panel in upper unit, One 100AMP Challenger panel, note in good condition for age and wear at time of inspection., One 100AMP panel by Cutler Hammer, noted in good condition for age and wear at time of inspection, A 100AMP Cutler Hammer sub-panel was noted in the bedroom of the upper unit. Panel was noted with liquid streaming out of the bottom of the panel and was therefore not opened, Panels were noted somewhat labeled, which appears very old and faded. We doubt the labeling is current information. We recommend updating and labeling, SWITCHES & OUTLETS:, Several switches and outlets were missing covers., Several outlets were noted in wet areas not grounded., Several outlets were noted as 3-prong ungrounded outlets, which should be changed back to 2-prong outlets. This is considered a safety hazard., An outlet in the upper unit was noted taped in place., GFCI:, Several outlets in wet areas were noted as being non GFCI's., ELECTRICAL SERVICE ENTRY:, Electrical entry was noted as an underground system., BATHROOM EXHAUST FAN:, Bathroom exhaust fan was noted exhausting into the attic space. We recommend rerouting to exhaust to the exterior, EMERGENCY EXITS & LIGHTING:, No emergency lighting noted in the public common area stairwell., An exit sign appears to be missing in the common area stairwell over the front exist door, we recommend installing an emergency exit with battery back up over front entry door., WIRING & JUNCTION BOXES:, Extension cord(s) are used in place of hardwiring in some areas. It is preferable that lights and other electrical components be plugged into hard-wired outlets rather than extension cords to reduce the possibility of injury or electrical overload., Most wiring in basement and attic area, has been upgraded to BX armored cable, which is an approved wiring method in most municipalities., Open electrical junction boxes were noted in several locations., One run of BX cable in the basement was noted with broken protective sheathing., GROUNDING:, Grounding appears to be adequate for electrical panels, with grounding wires properly attached to exterior ground stake., FIXTURES:, Fixtures were noted with some defective or missing parts. We recommend repair, SMOKE & CARBON MONOXIDE DETECTOS: , Smoke detectors and carbon monoxide detectors were not found in all areas for proper protection., **We recommend repairing the electrical defects in building #227 S. Court, which should include emergency lighting and emergency exit signs.**

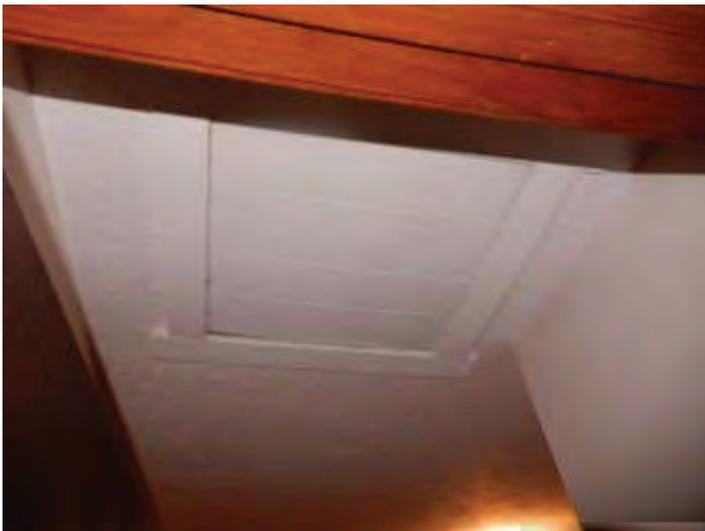
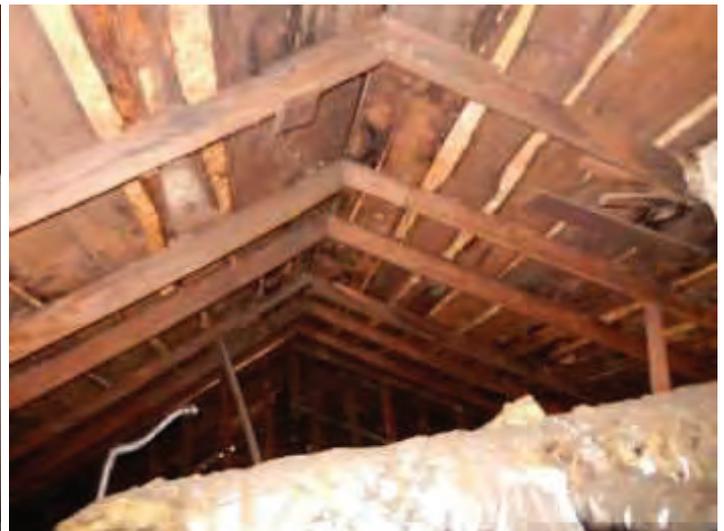
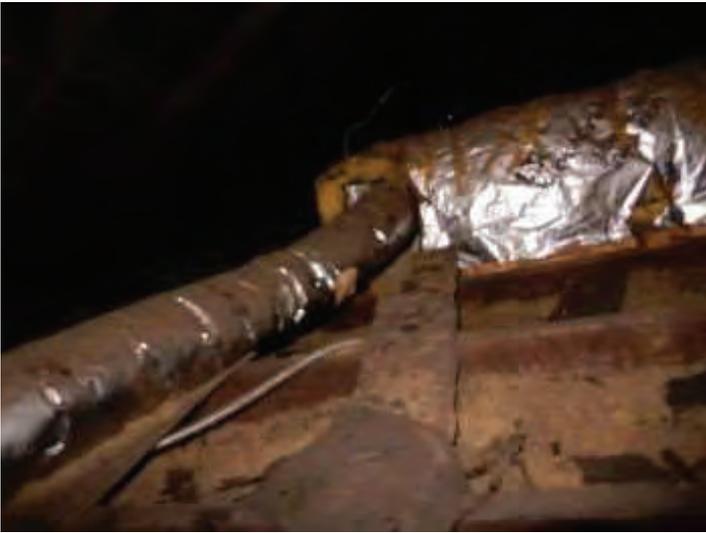
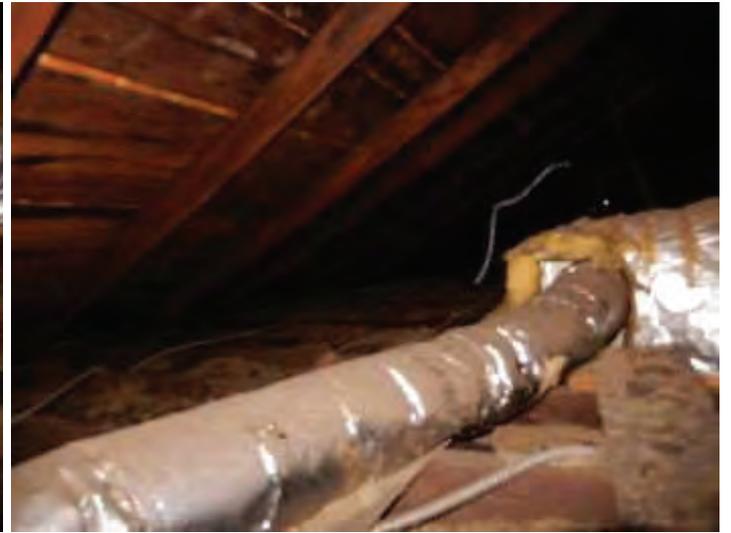
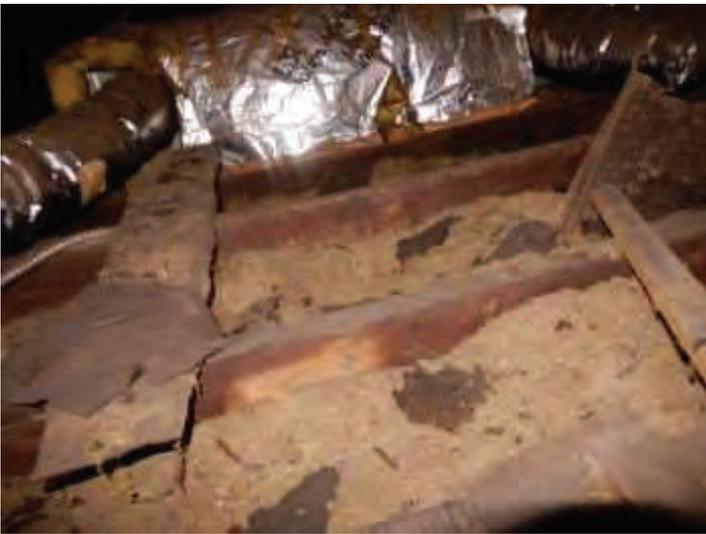
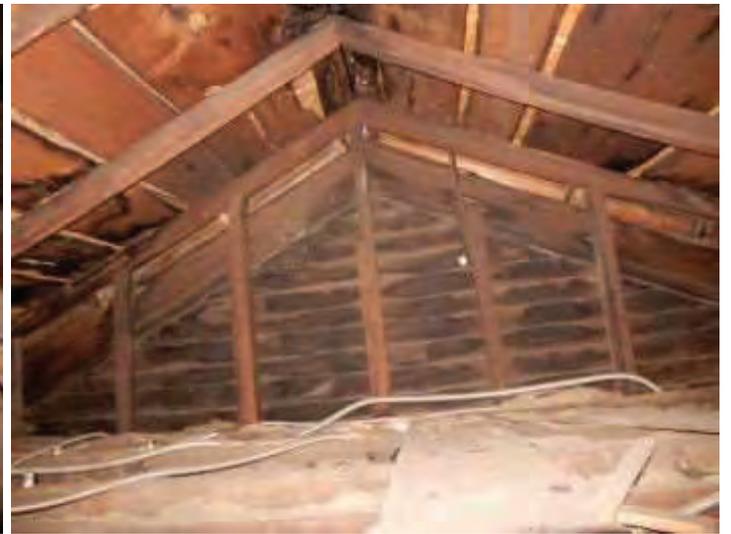
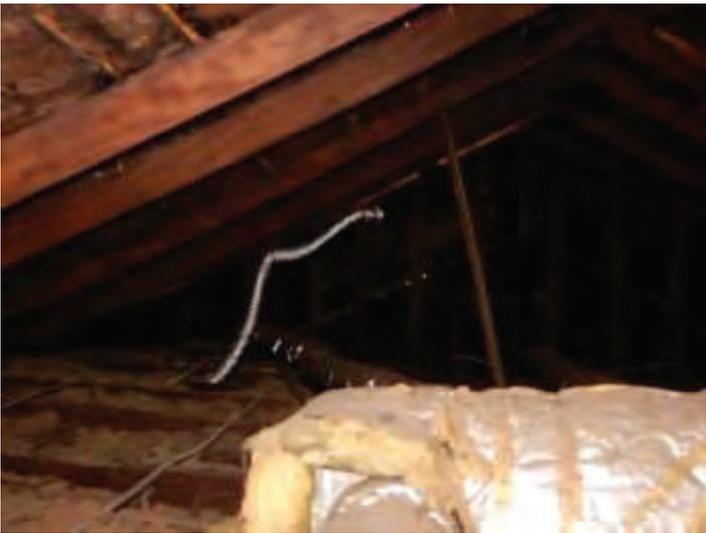
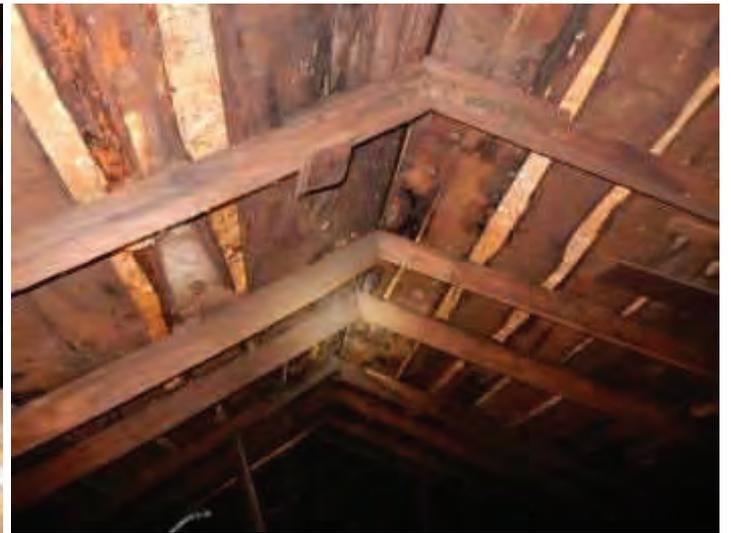
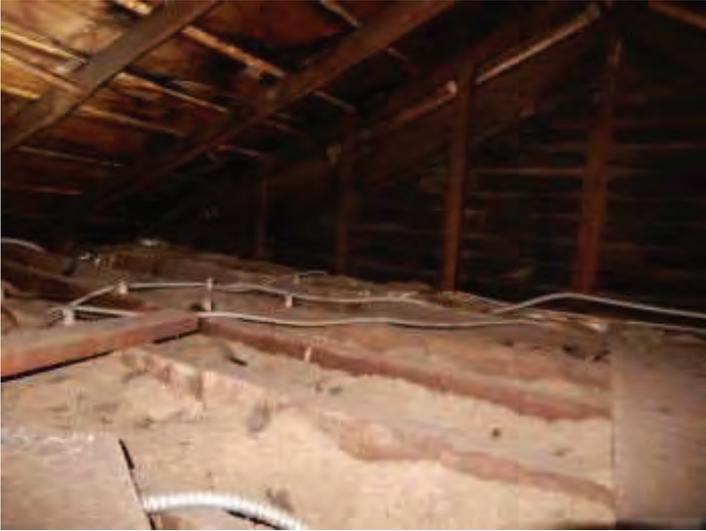
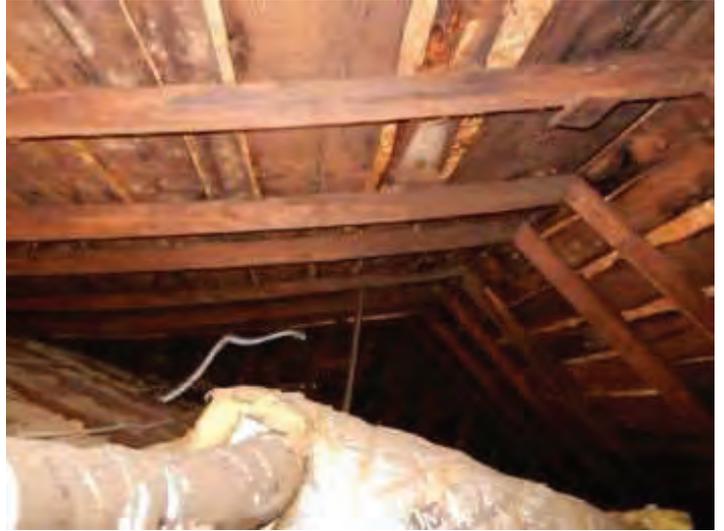
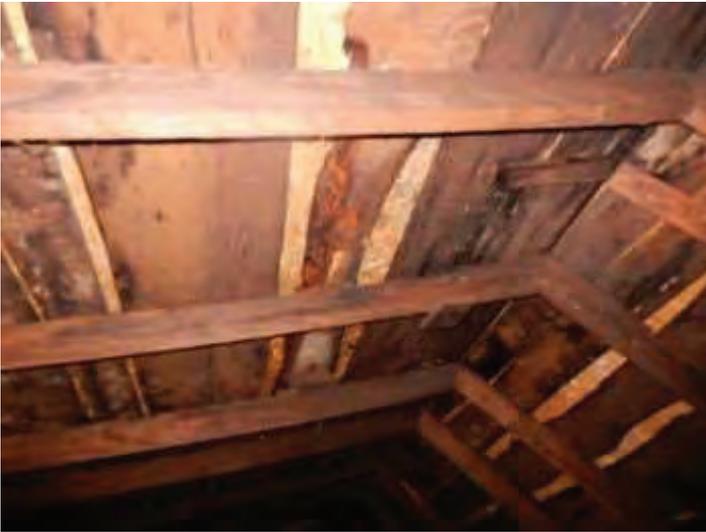
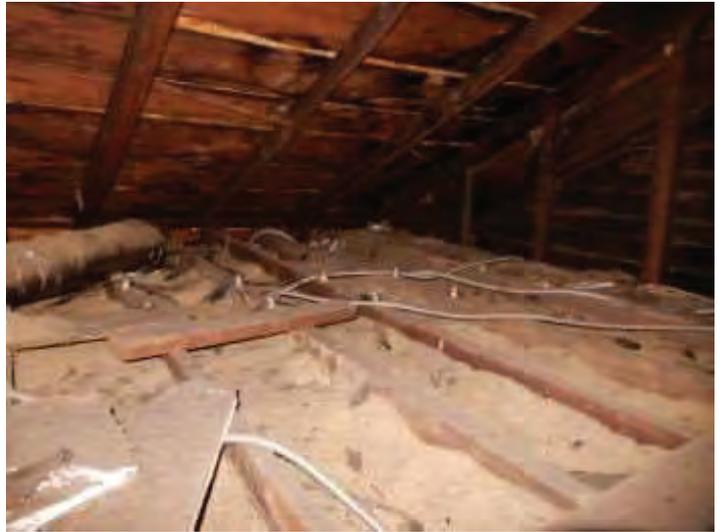
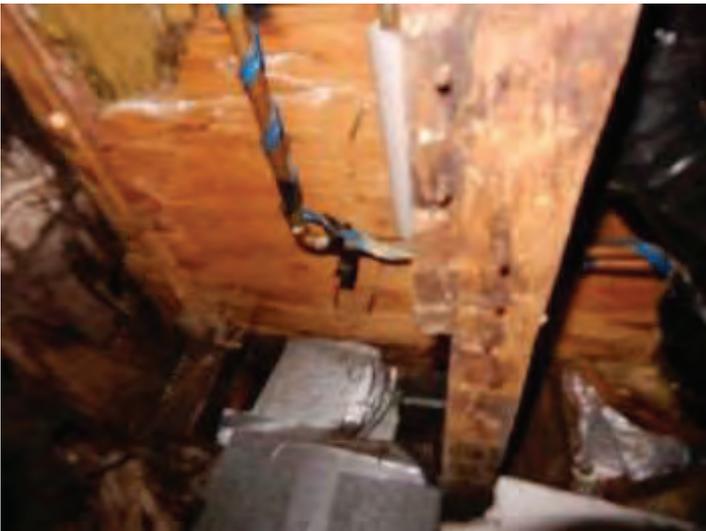
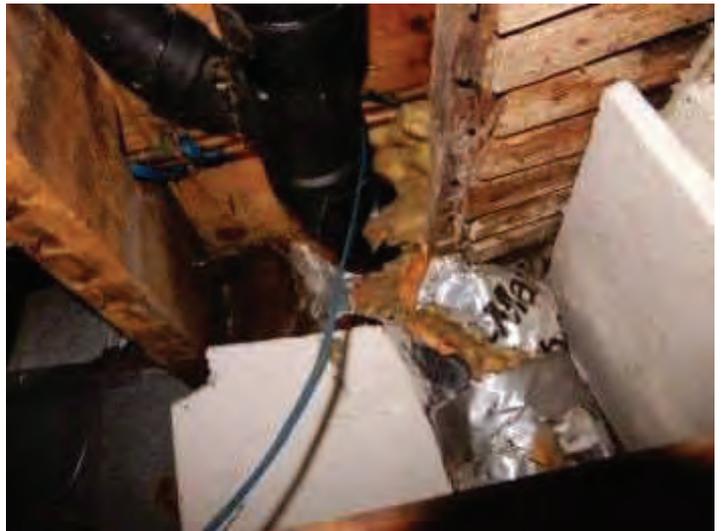
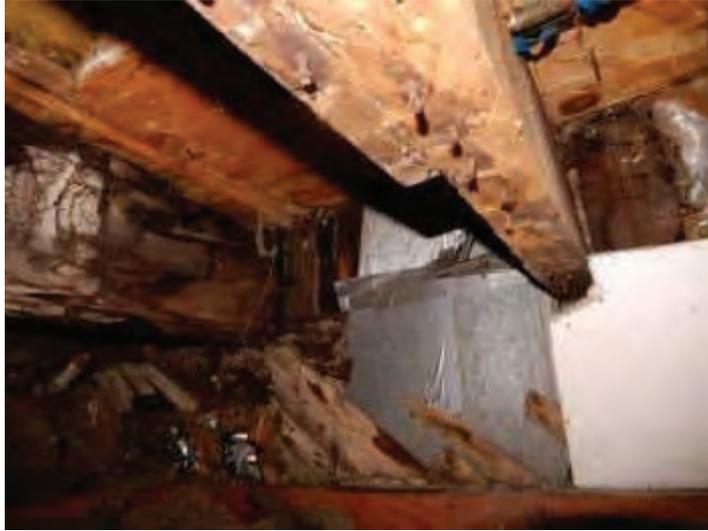
Observations: GENERAL CONDITION:, Attic areas were noted in building 277 S. Court , ., Attic at Bldg 277 S. Court, ATTIC ACCESS:, Attic access was via an attic access hatch in upper unit bedroom, INSULATION:, Insulation was noted as minimal, with less than 2", and we recommend adding additional insulation, FRAMING:, FRAMING:, Attic roof framing was noted with rafter spacing being excessive, and inadequate vertical support. Rafters were noted deflecting down in the middle of the span., Roof framing was noted as a rafter system, Roof framing was noted absent a ridge board., The aspect of the roof framing lacking collar ties and ridge board, may be a contributing factor for exterior walls being bowed out at the top, The aspect of the roof framing lacking collar ties and ridge board, may be a contributing factor for exterior walls being bowed out at the top, Attic area sheathing was noted with signs of previous leaks. It does not appear that there are any active leaks at this time, Roof sheathing consisted of older wood with slat type sheathing, which has been overlayed with newer OSB sheathing, Roof framing was noted was noted with rafter vertical bracing only in place at gable ends, with that bracing showing signs of excessive pressure and tension., BATHROOM EXHAUST:, Bathroom exhaust was noted terminated in the attic space adding unwanted moisture to attic area, and should exhaust to the exterior of the building, VENTILATION:, No incoming or exhaust ventilation noted in this attic area, and we recommend installing, ATTIC:, Attic was noted in poor condition at time of inspection, with several differing aspects needing to be addressed (see recommendations below), **We recommend augmenting the roof framing for building 277 S. Court, by sistering on additional rafters to existing system and installing collar ties. We also recommend adding vertical bracing in the attic for rafter system. We also recommend addressing other defects noted above**

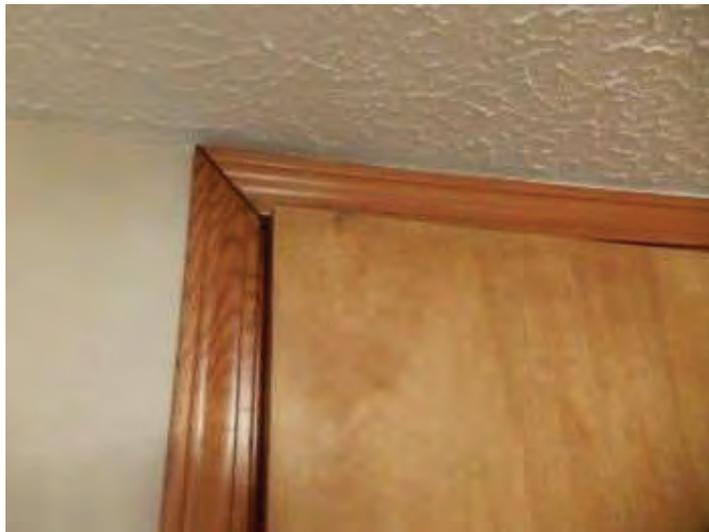
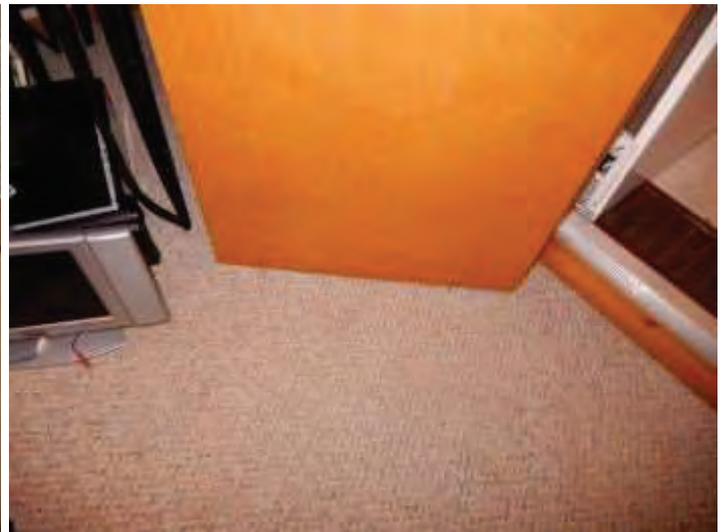
Observations: GENERAL: Overall interior doors were noted in good condition for age and wear, except as noted below., Interior doors at Bldg 277 S. Court, INTERIOR UNIT ENTRY DOORS: Interior doors were noted being newer type interior doors, Interior entry doors noted in good condition for age and wear and properly operated., INTERIOR DOORS: 2nd bedroom and 1st floor bedroom (2) and bathroom doors do not easily operate. We recommend adjust, MISSING DOORS: Back bedroom on 2nd floor was noted with a door opening very small and not to code with no door in place, 2nd floor closet near top of steps, was noted missing closet door, and we recommend installing, DOOR HARDWARE: Overall in good condition for age and wear, with some slightly loose, and we recommend adjust, Lower unit entry door was noted with lock difficult to operate. We recommend replacing

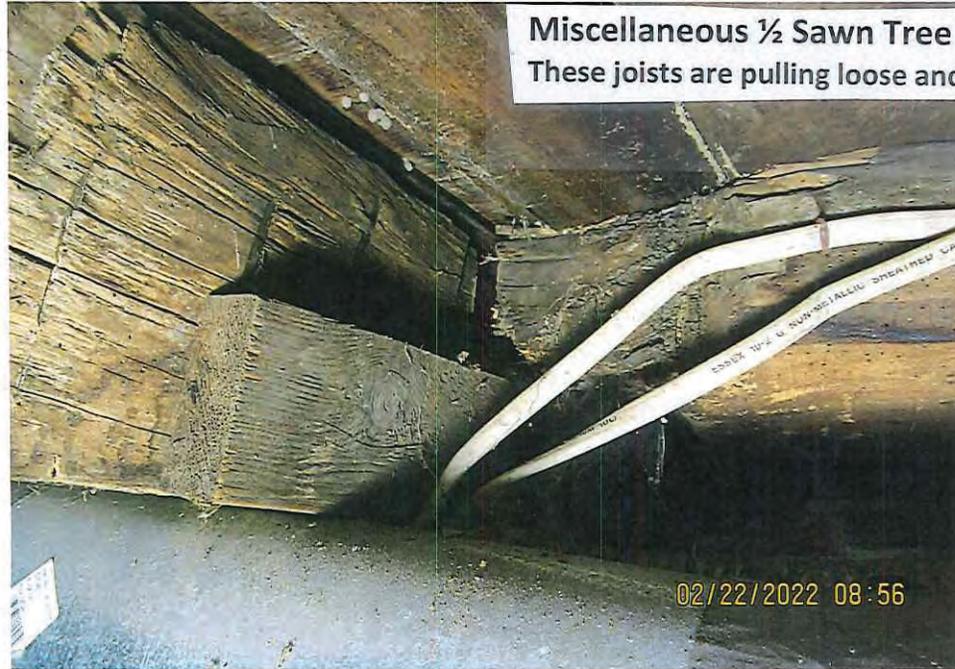
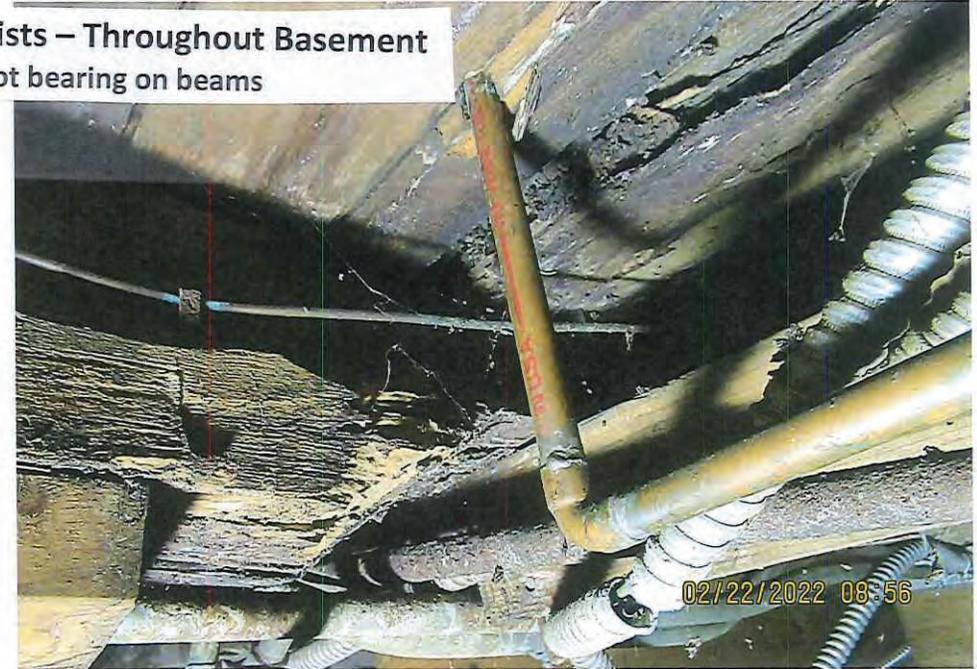
Miscellaneous ½ Sawn Tree Joists – Throughout Basement
These joists are pulling loose and not bearing on beams

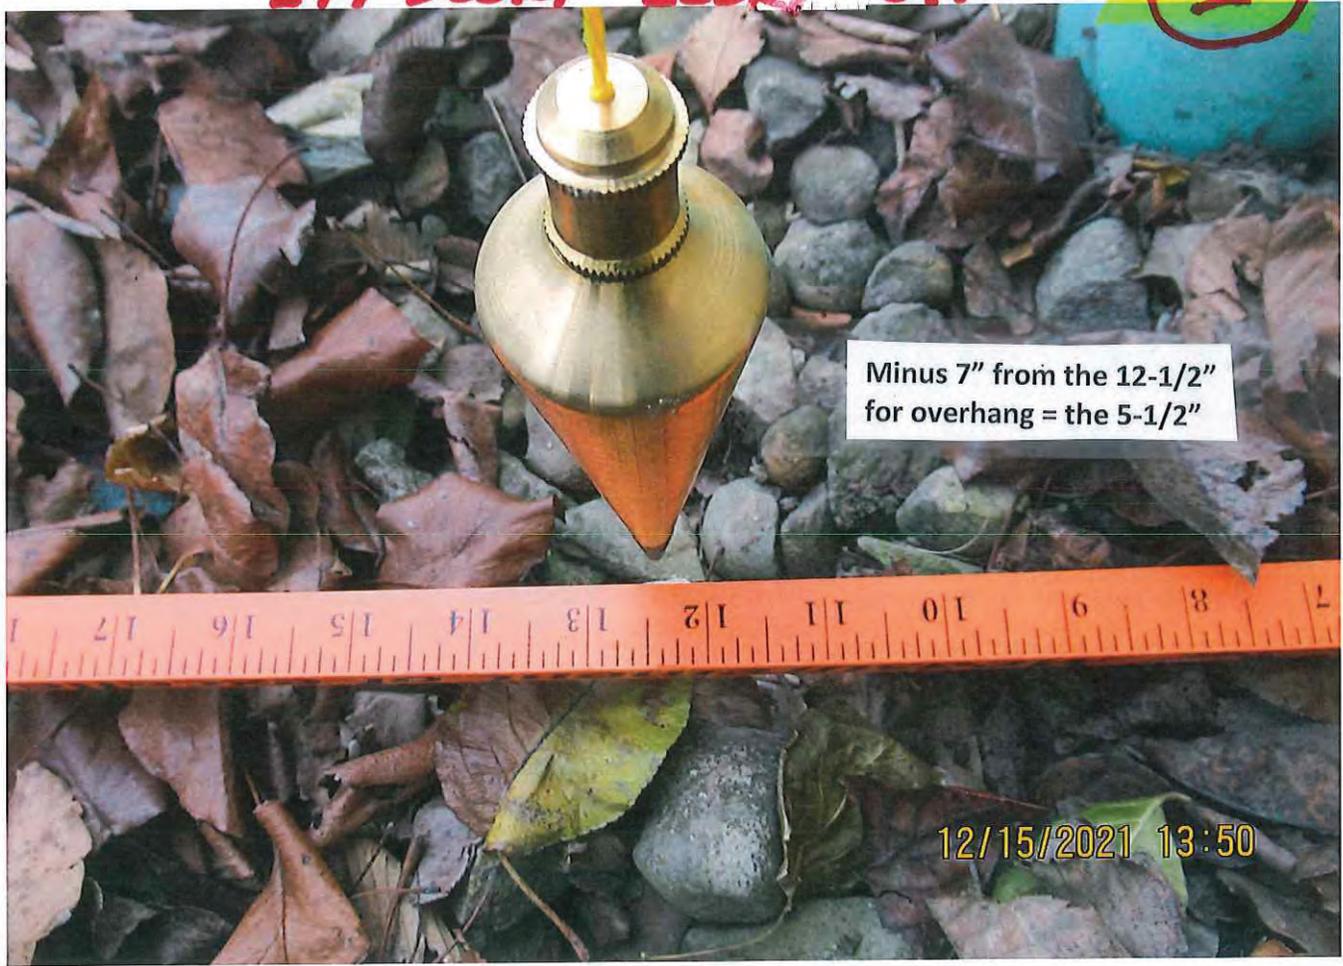
①

House is out of plumb to the North
5-1/2" in 17' ←

Minus 7" from the 12-1/2"
for overhang = the 5-1/2"

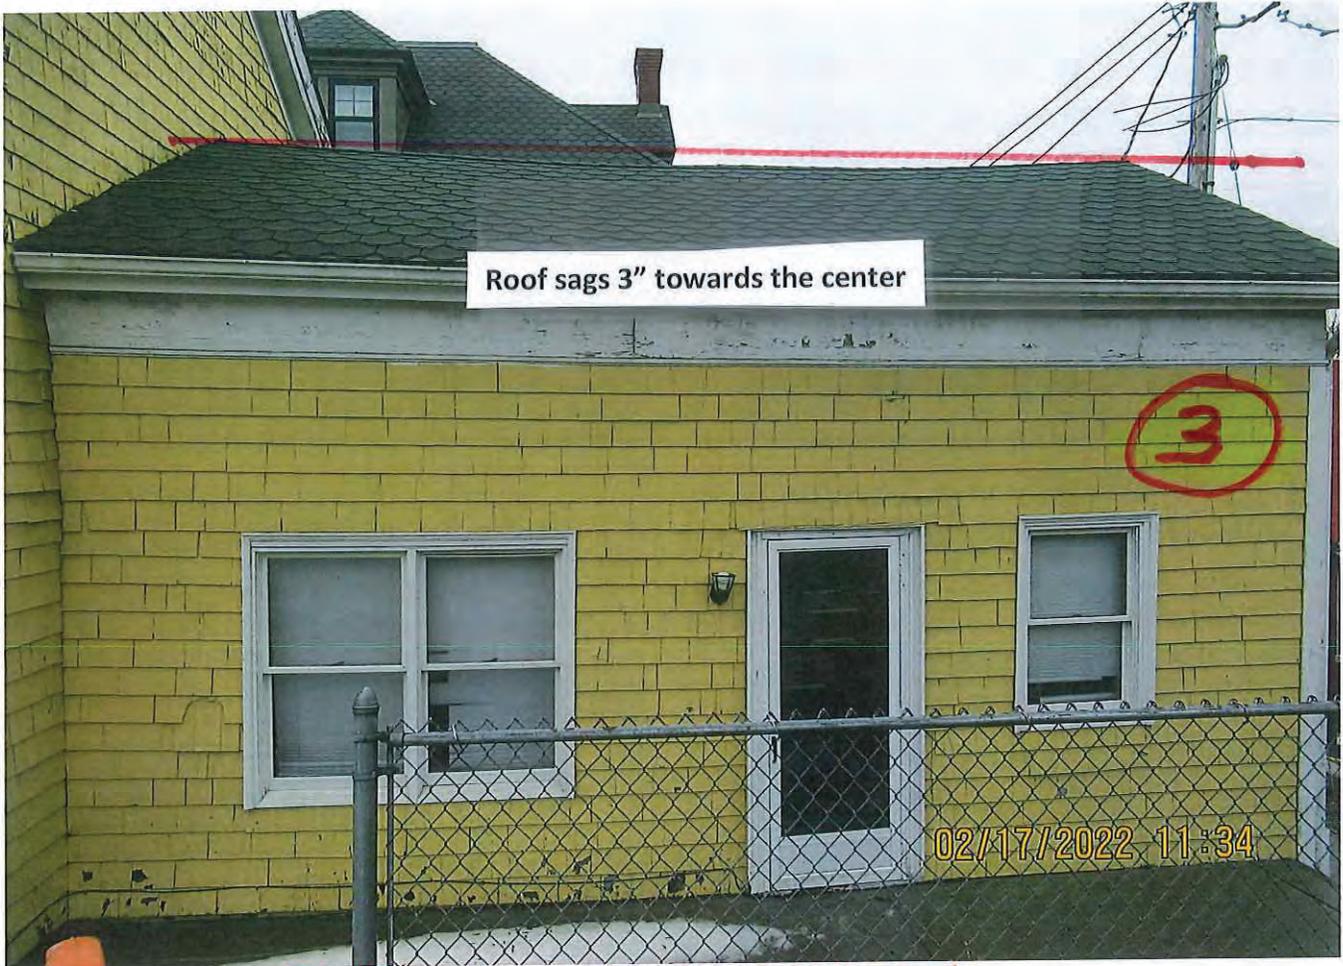
3

Roof sags 3" towards the center

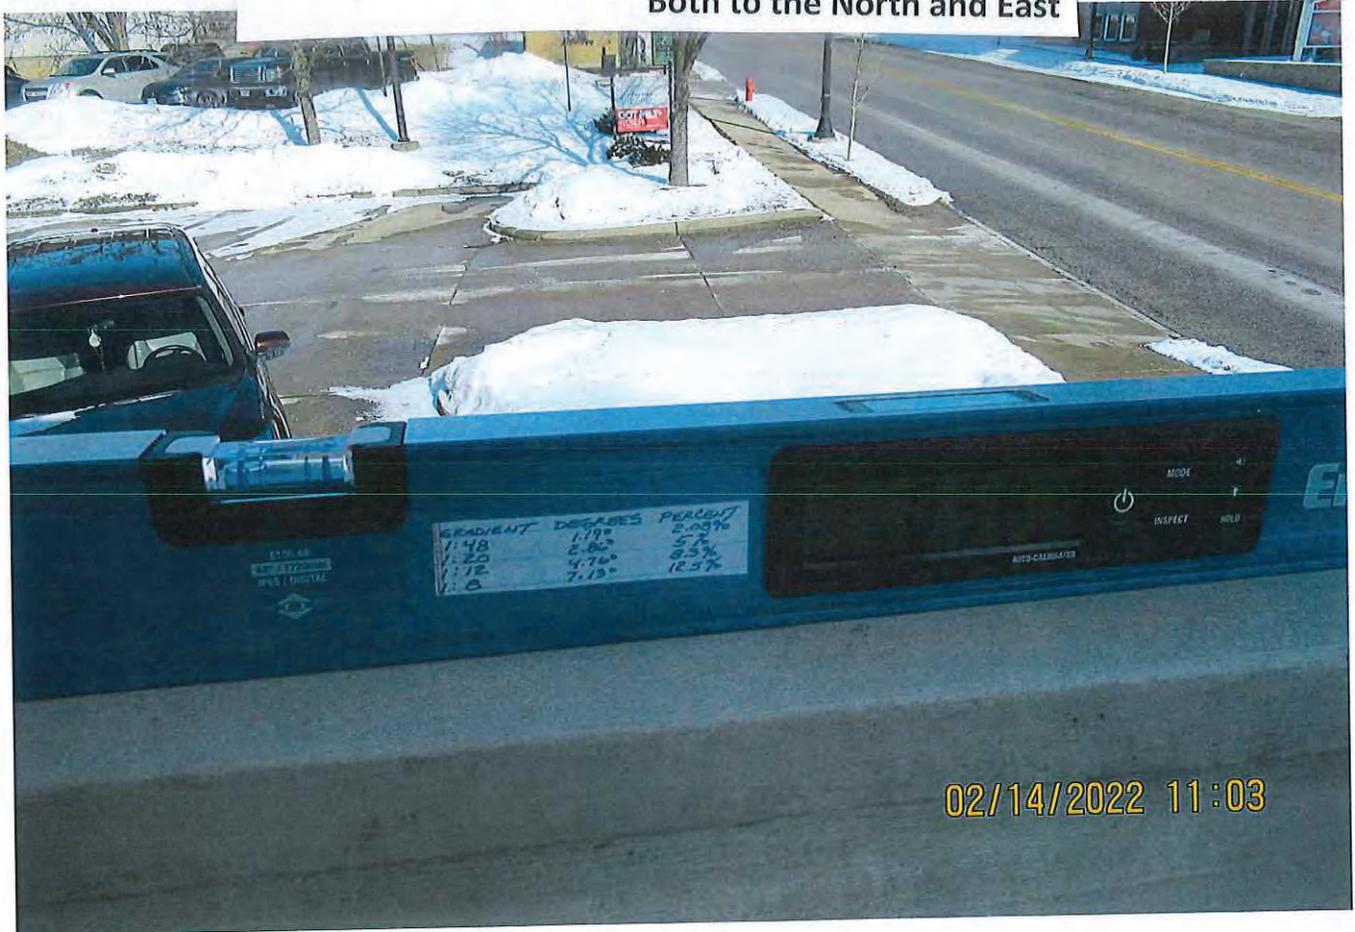
**Photo - #5 Front Porch – Out of level ½” per foot
Both to the North and East**

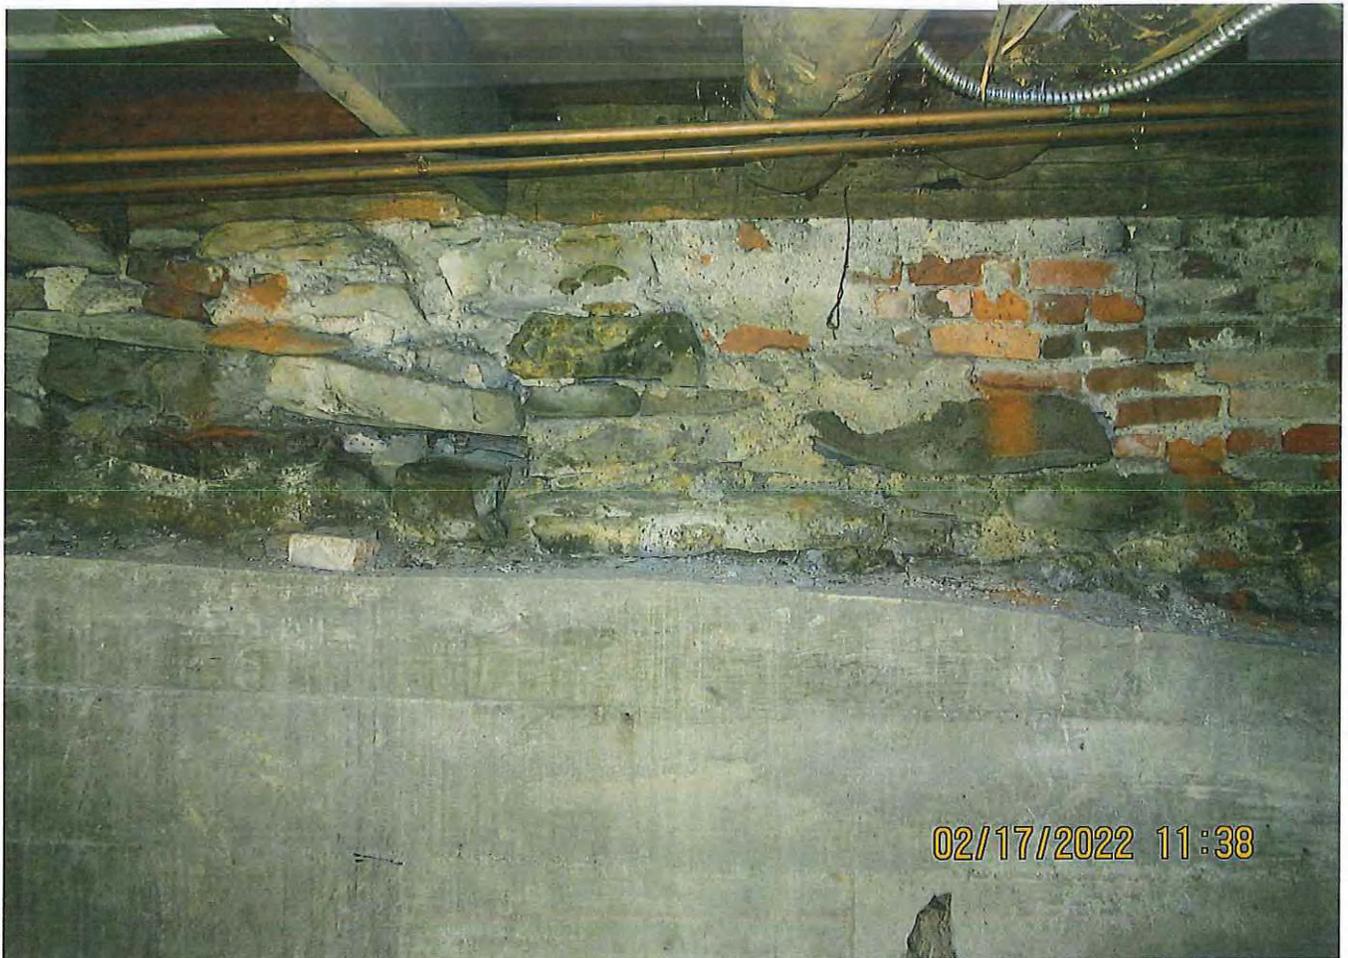
- Flooring system is failing and settling towards the center of the basement.
- Foundation walls consist of concrete, stones and brick.
- Rain water is leaking through all four foundation walls.

**Photo - #5 Foundation walls
Constructed of concrete, stone and bricks**

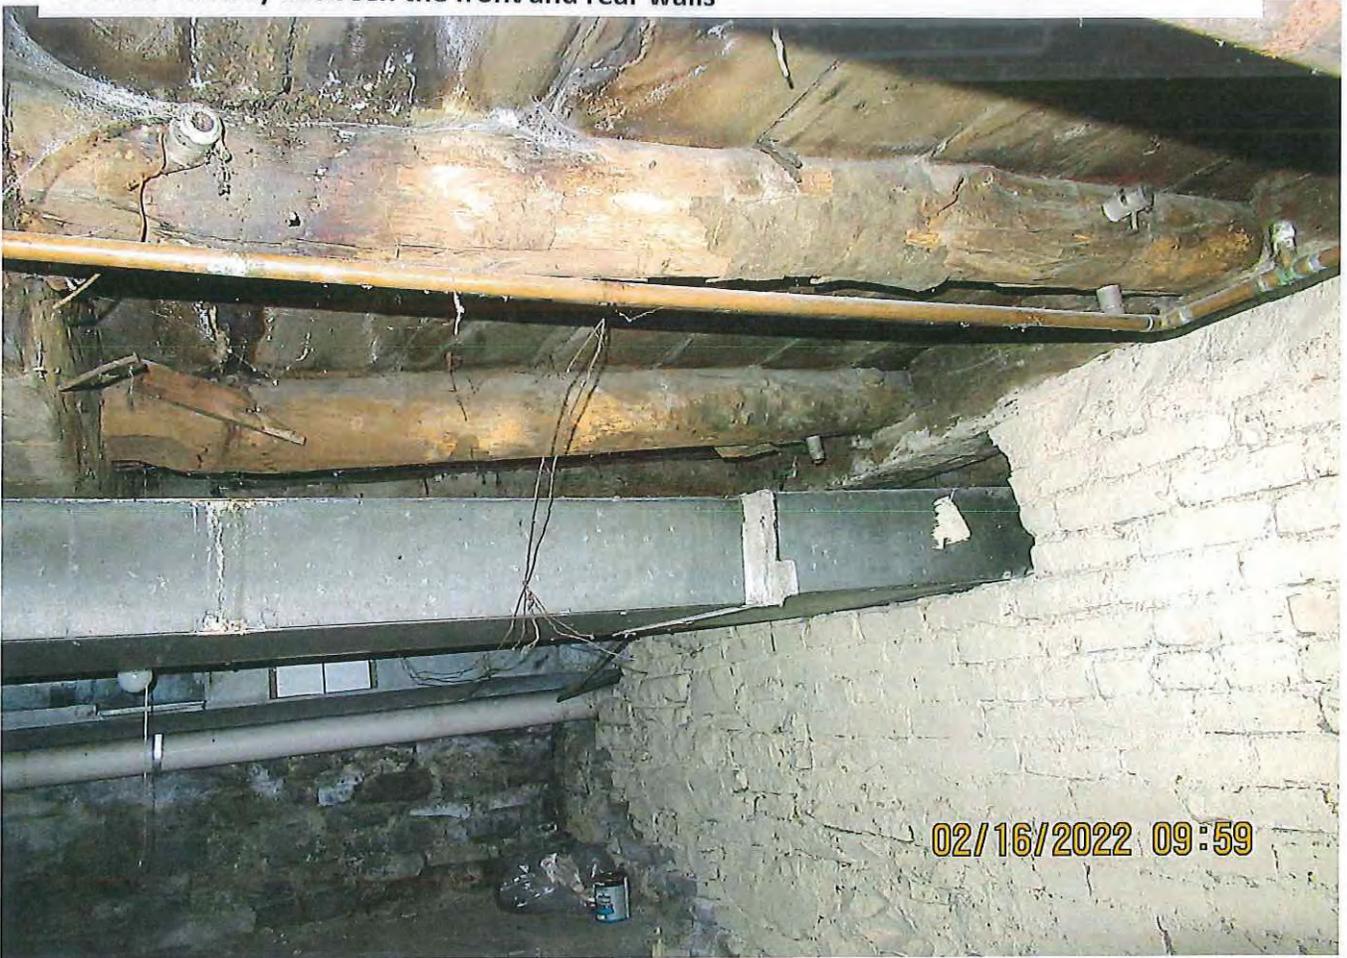
- Several of the main flooring ½ sawn tree joists have pulled loose from the main beams due to the failure of the main beams.
- One entire section of the ½ sawn tree joists are out of level ½" per foot. This is midway between the front and rear foundation walls.

Photo - #7 Section of floor framing out of level $\frac{1}{2}$ " per Foot (ductwork is level)
This is a section between the brick wall and one of the main beams.
Located midway between the front and rear walls

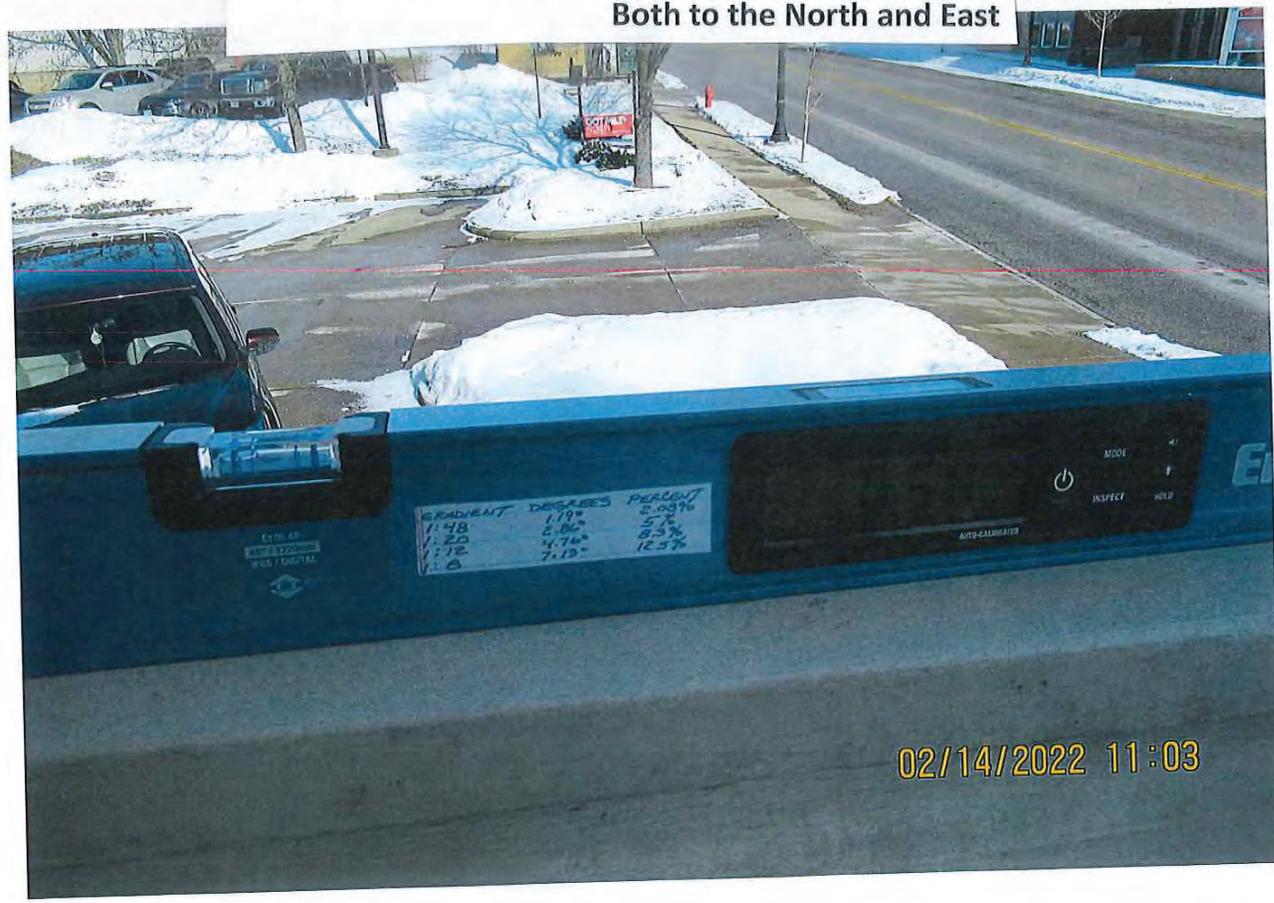
Photo - #5 Front Porch – Out of level ½” per foot
Both to the North and East

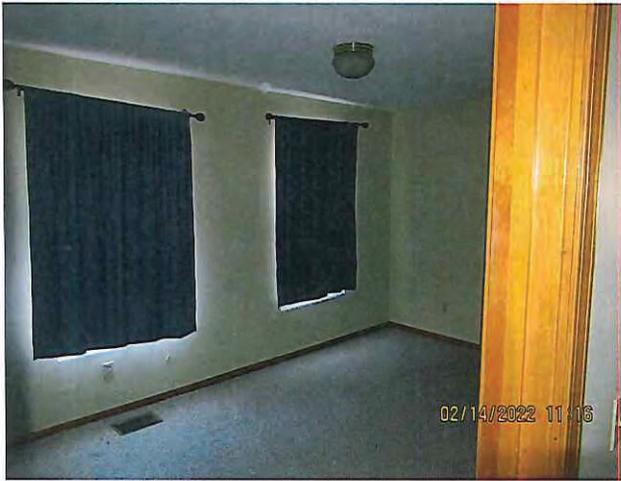
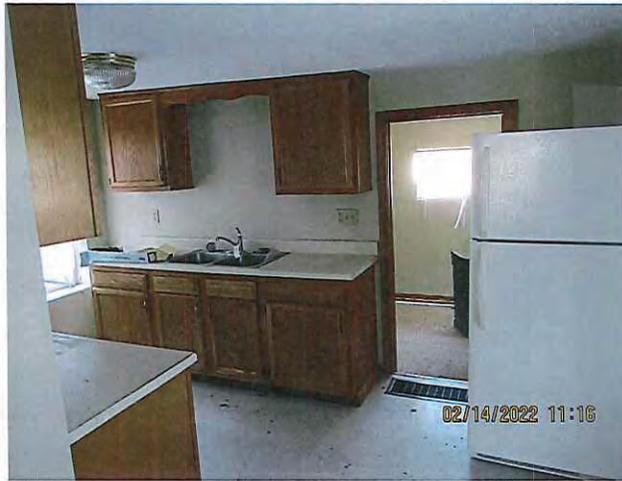
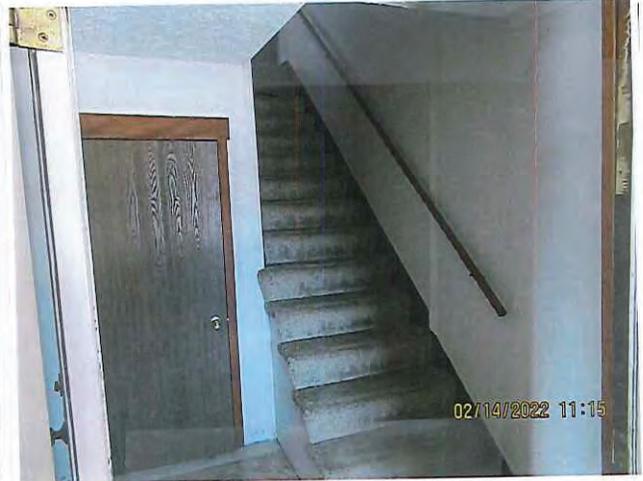
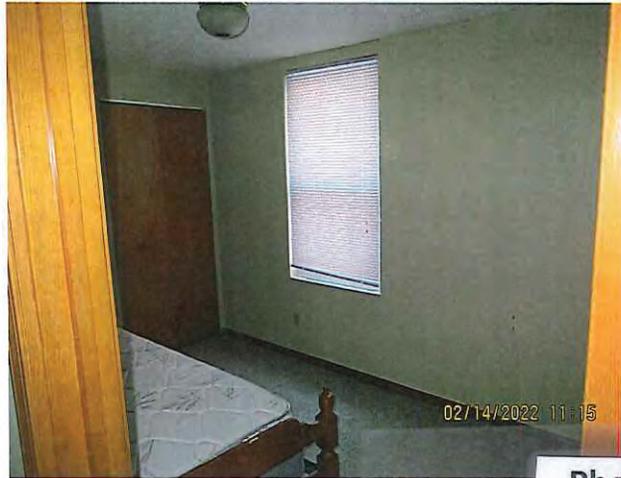
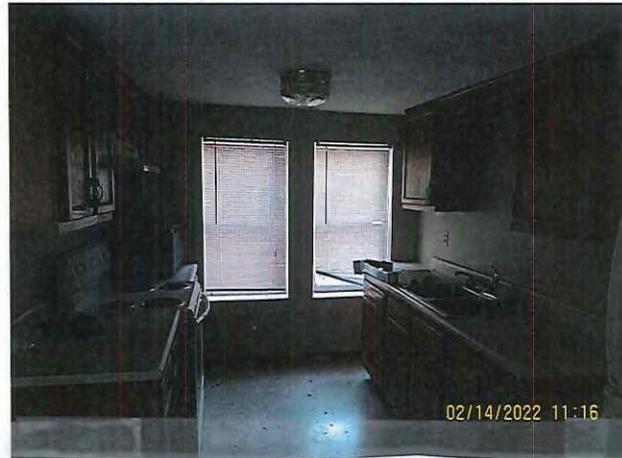
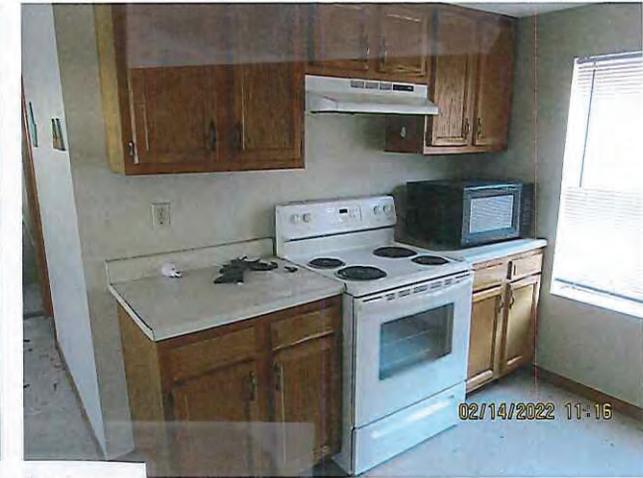
Photo - #1 First Floor – Miscellaneous Interior photos

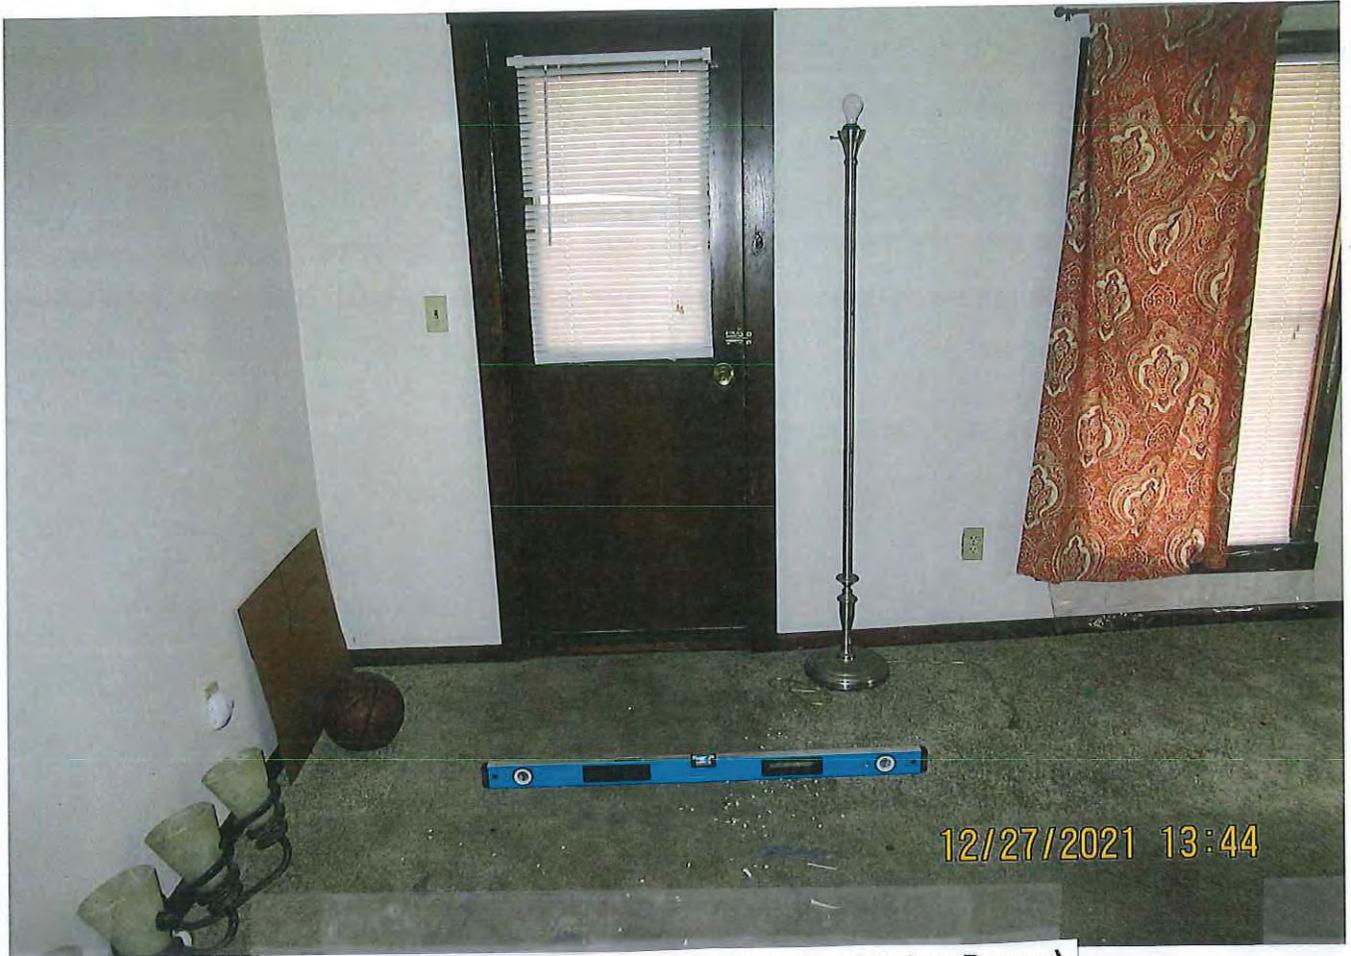
Photo - #1 Second Floor - front of house (Living Room)
