HISTORIC PRESERVATION BOARD

Case No. H22-045

Building Demolition at 277 South Court Street

March 2, 2022

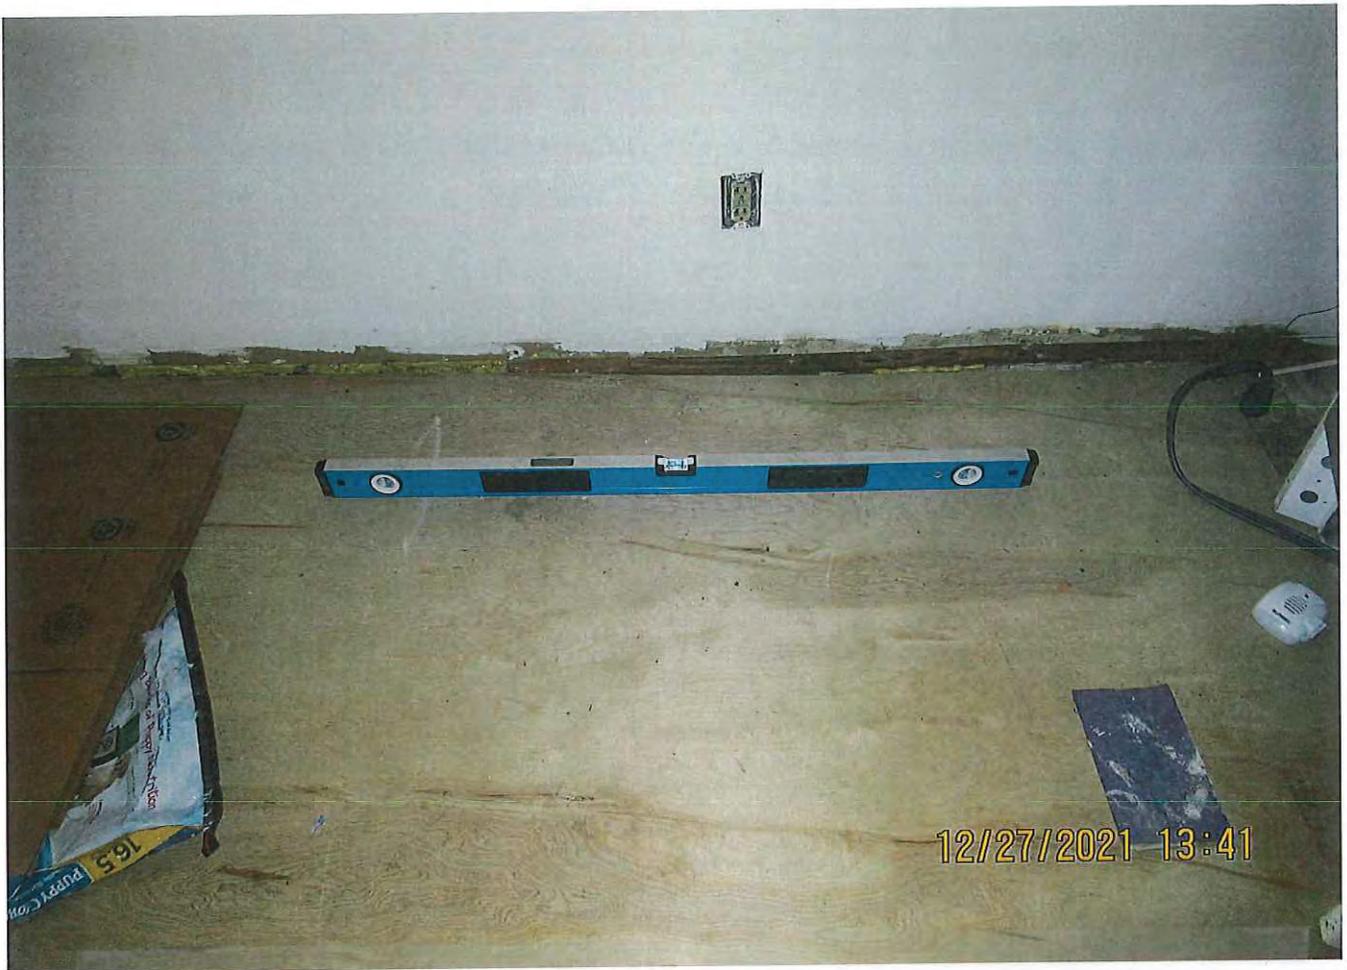
Photo – #2 Second Floor - middle of house (Kitchen)

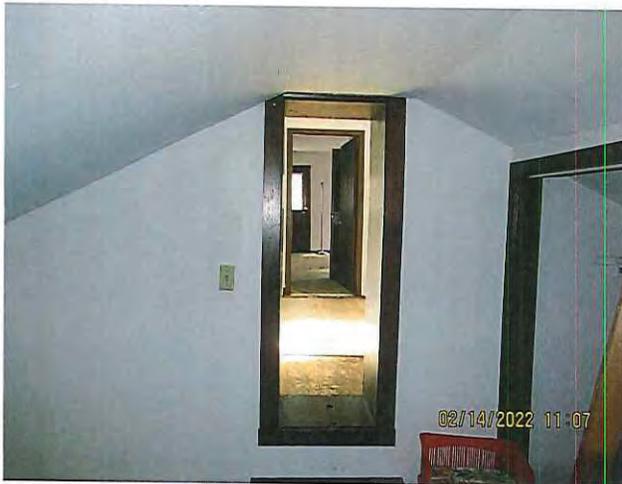
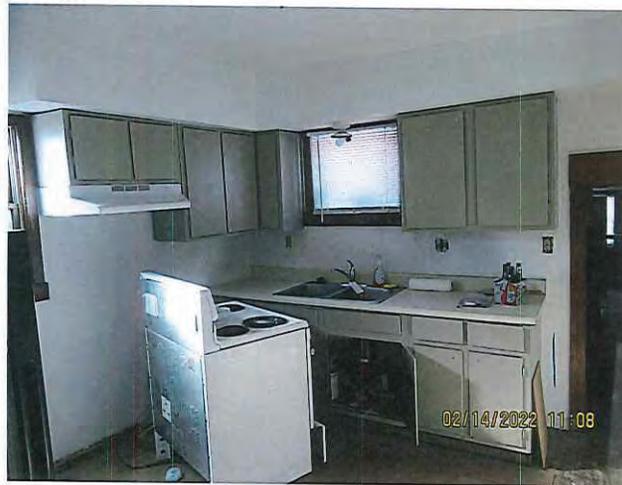
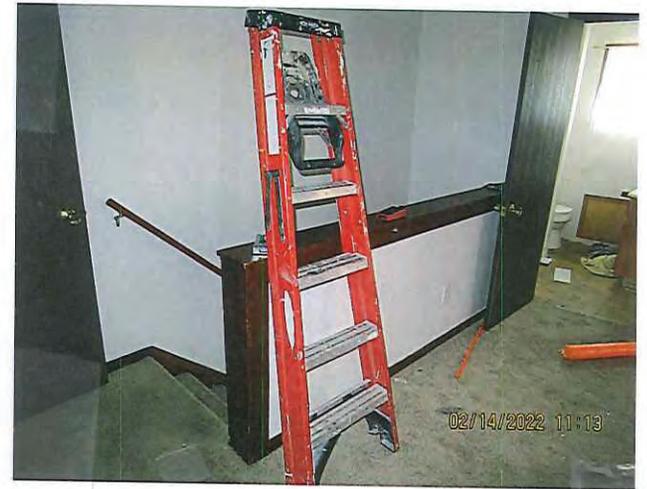
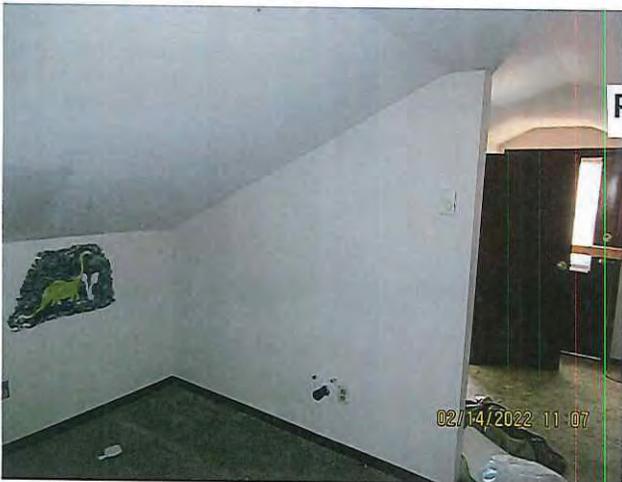
Photo - #3 Second Floor - Miscellaneous Photos

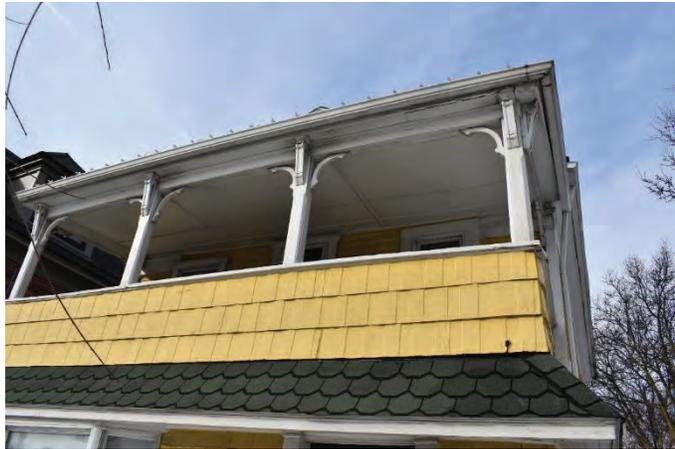
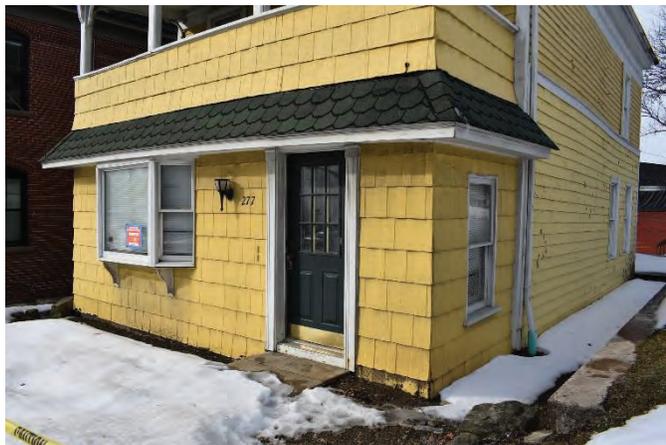
Wide shingle siding covers an enclosed balustrade at the second floor with exposed Eastlake style chamfered columns with single brackets that likely were originally repeated at the first-floor porch before enclosure.

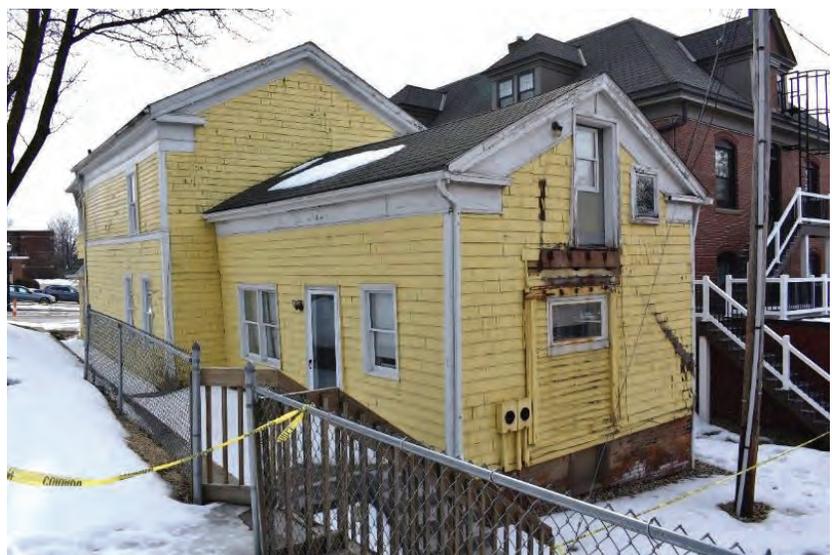
The rear wing repeats the cornice returns, wide frieze, corner boards, proportion, and scale of the front portion of the house. A north full width side roof porch with entry was added to the addition between 1892 and 1902 and has been removed. The overall roof is asphalt shingle. The windows are wood and vinyl replacement and do not exhibit the characteristic 6/6 configuration of the Greek Revival style.

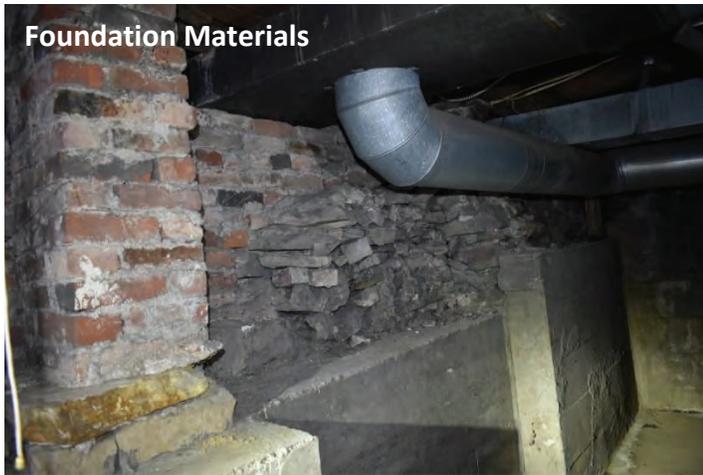
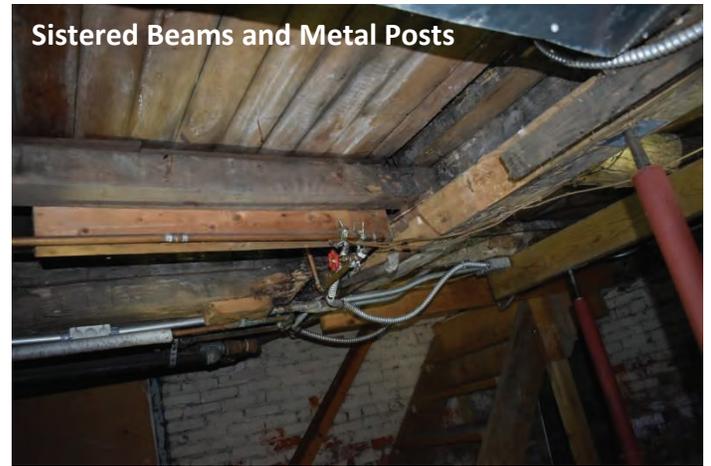
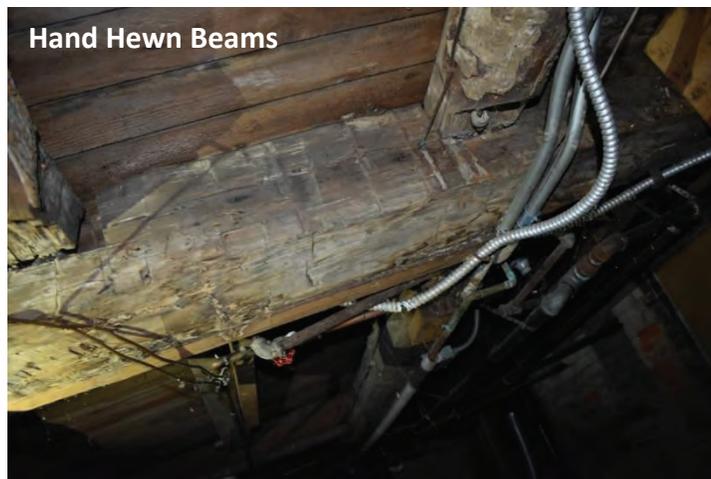
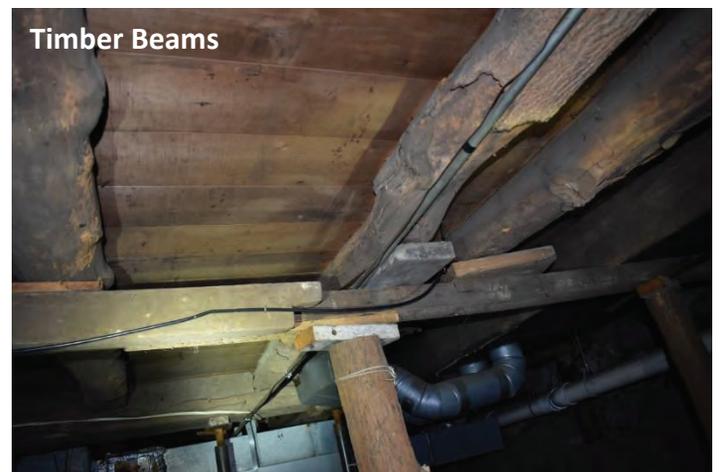
Basement

The basement foundation materials are composed of brick, stone and formed concrete and support relocation of the building 20' north of the original on the property. The basement exhibits hand hewn and timber beams which have been sistered with milled wood and reinforced with contemporary wood beams. Metal posts and timbers reinforce the first floor.

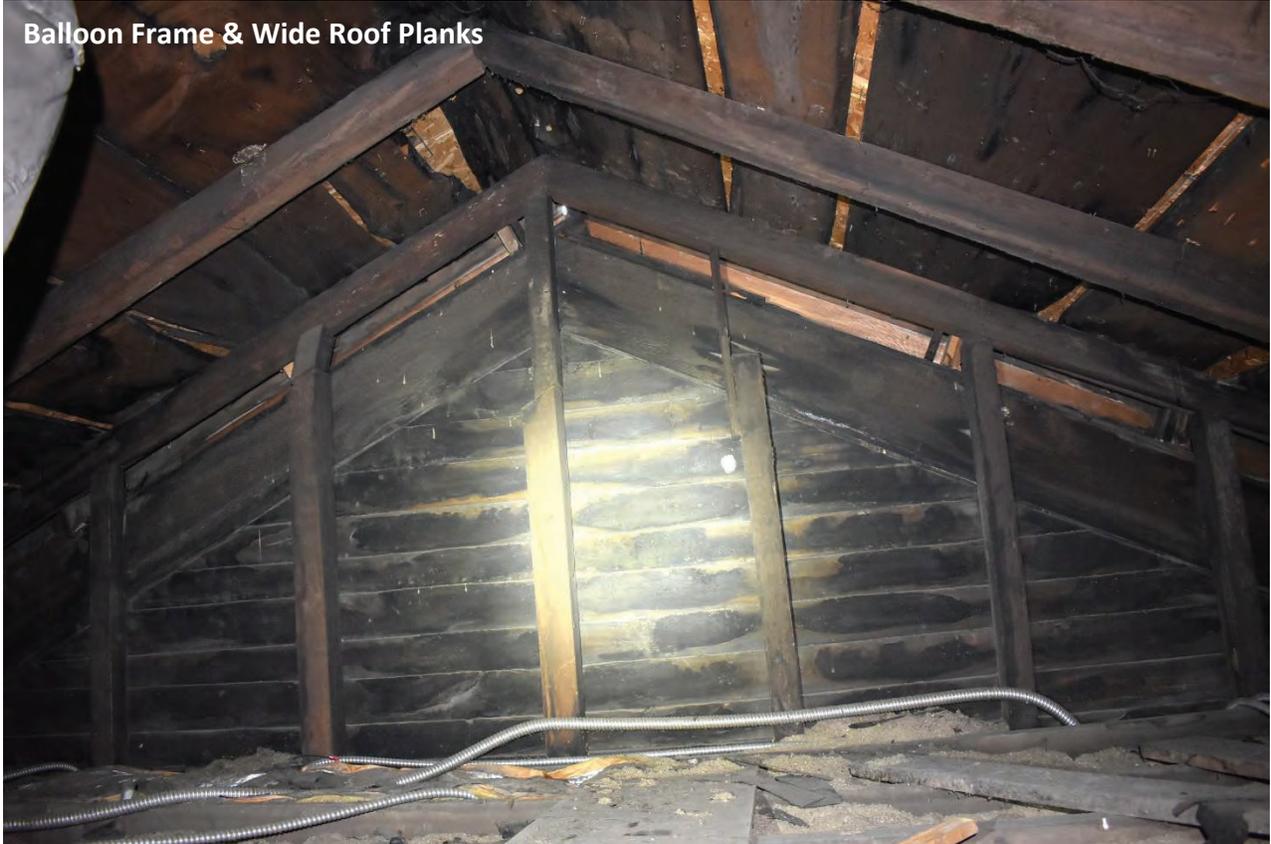
Attic

The attic reveals balloon framing and wide wood plank sheathing below an asphalt shingle roof.

Balloon Frame & Wide Roof Planks
